GOVERNMENT OF  
NEWFOUNDLAND  
AND LABRADOR  
Department of Transportation and Infrastructure

**BRIDGE INSPECTION REPORT  
B08012024-1**

Date: 8/1/2024

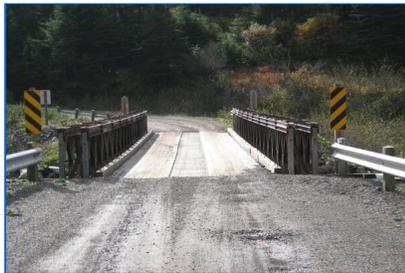
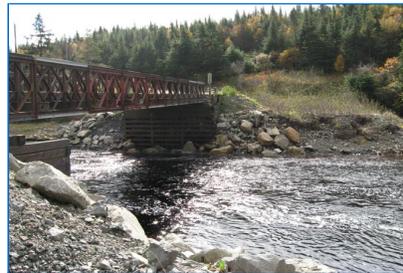
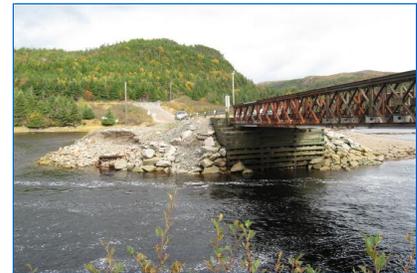
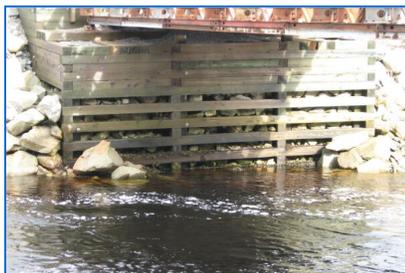
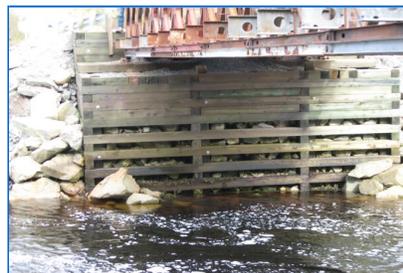
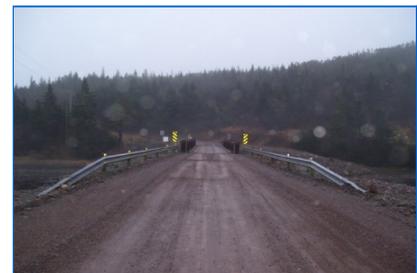
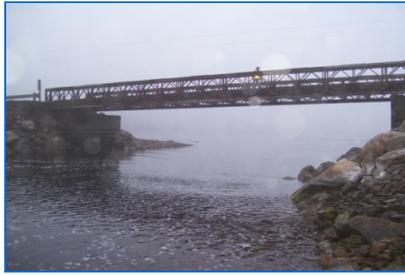
<b>Condition:</b>	F2 - Fair	<b>Bearings:</b>	F2 - Fair
		<b>Bearing Seat:</b>	F1 - Fair
<b>Comments:</b>	Timber abutments and bearing seats. Heavy sediment compiled on abutments and near bearings. Open cribbing abutments with some rip rap washing away into streambed. Top of abutment 2 timbers are slightly tipped towards streambed, and some starting to crack.

<b>Condition:</b>	F2 - Fair	<b>Expansion Joints:</b>	I - Inapplicable
<b>Comments:</b>	9 panel bailey bridge, assembled from used parts. Some minor dents in various panels along structure. Roughly 15-20 cotter pins missing and some are heavily rusted. Entire structure is rusted. Cross members rods below the timber deck are bent near abutment 2.

<b>Condition:</b>	F2 - Fair	<b>Curbs:</b>	F2 - Fair
<b>Hand Rail:</b>	F2 - Fair	<b>Roadway Condition:</b>	F1 - Fair
<b>Approach Rail:</b>	F1 - Fair		
<b>Comments:</b>	50mm timber deck with 50mm wearing surface. Raceway deteriorating with minor cracking/holes in timbers. Approach rail has minor damage and denting. Installed snow fence material is now missing, and zip ties are littering several panels along the bridge.

<b>Water Velocity:</b>	Tidal m/s	<b>Ice Problem:</b>	N - No Problem
<b>Water Depth:</b>	Tidal m	<b>Scour Problem:</b>	N - No Problem
<b>Waterway:</b>	01 - Adequate	<b>Debris Problem:</b>	K - Known Problem
<b>Comments:</b>	Rip rap sliding into waterway.

<b>Next Rehab. Date:</b>		<b>Replacement Year:</b>	
<b>Antic. Rehab. Cost:</b>	\$TBD	<b>Replacement Cost:</b>	\$TBD
<b>Recommendations:</b>	Implement "Narrow Bridge" sign on approaches, clean sand and sediment from abutments/bearing seats, replace cotter pins, repair rip rap, install new snow fence material.
