**BRIDGE INSPECTION REPORT
B12032019-1**

Date: 12/3/2019

Site:	2-166 - ROUNDABOUT BRIDGE (OLD)			Overall Length:	11.5 m
Route:	220			Overall Width:	6.2 m
Year Built:	1940	Est: No		Roadway Width:	5.8 m
Year Last Rehab.:		Est: No		Sidewalk Width:	0 m
Region:	CENTRAL EAST			Clearance to R.D. or N.W.L.:	5 m
Jurisdiction:	Provincial			Max Depth of N.W.L.:	1 m
Type of Structure:	04 - Rigid Frame			Spans:	
Purpose of Structure:	04 - Over Non-Navigable Waters				
Type of Handrail:	02 - Concrete Rail			<u>Span No.:</u>	<u>Length</u>
Roadway Surface:	01 - Concrete			1	5.5
Alignment Vertical:	01 - Good			2	0
Alignment Horizontal:	01 - Good			3	0
Restrictions:	No			4	0
				5	0
				6	0

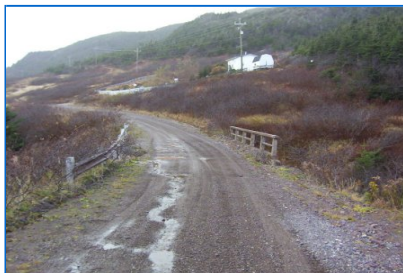
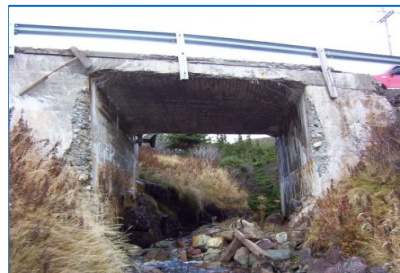
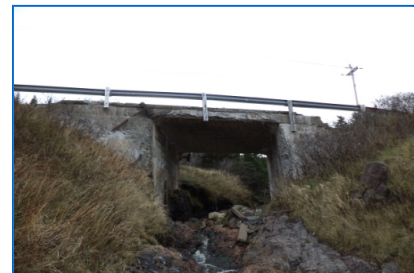
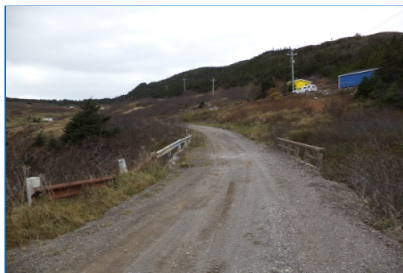
BRIDGE PHOTOS

Condition:	P - Poor	Bearings:	I - Inapplicable
		Bearing Seat:	I - Inapplicable
Comments:	Extensive deterioration throughout. Footings on bedrock.

SUPERSTRUCTURE			
Condition:	P - Poor	Expansion Joints:	I - Inapplicable
Comments:	Deck covered with gravel. Extensive deterioration of deck, especially the edges/fascia where there is exposed rebar.		
DECK			
Condition:	P - Poor	Curbs:	P - Poor
Hand Rail:	P - Poor	Roadway Condition:	P - Poor
Approach Rail:	I - Inapplicable		
Comments:	Rail is cobbled together with sections of concrete and flex beam, majority is detached and falling off. No approach rail. Poor roadway alignment.		
HYDROLOGY			
Water Velocity:	1.0 m/s	Ice Problem:	N - No Problem
Water Depth:	0.3 m	Scour Problem:	N - No Problem
Waterway:	01 - Adequate	Debris Problem:	N - No Problem
Comments:			
REPLACEMENT/REHABILITATION			
Next Rehab. Date:	2019	Replacement Year:	2019
Antic. Rehab. Cost:	\$0	Replacement Cost:	\$250000
Recommendations:	Replace with culvert.		
OBSERVATIONS			
Overall Condition:	P - Poor	Requires Further Inspection:	No
Additional Observations:	Located on old road between Lawn and Lord's Cove. Road is used as cabin access.
