GOVERNMENT OF NEWFOUNDLAND AND LABRADOR Department of Transportation and Infrastructure	BRIDGE INSPECTION REPORT B09012023-4	
Date: 8/21/2023	Inspected By: Darrell Avery	Category: Eng. - Engineering	
BRIDGE INFORMATION			
Site:	2-070 - RYDER'S BROOK BRIDGE		
Route:	232	Overall Length:	55 m
Year Built:	1977	Est: No	Overall Width: 10 m
Year Last Rehab.:	2020	Est: No	Roadway Width: 9 m
Region:	CENTRAL EAST	Sidewalk Width:	0 m
Jurisdiction:	Provincial	Clearance to R.D. or N.W.L.:	6 m
Type of Structure:	01 - AASH to Girder	Max Depth of N.W.L.:	1 m
Purpose of Structure:	04 - Over Non-Navigable Waters		
Type of Handrail:	01 - Aluminum Rail	Spans:	
Roadway Surface:	02 - Asphalt	Span No.:	Length
Alignment Vertical:	02 - Adequate	1	38
Alignment Horizontal:	02 - Adequate	2	0
Restrictions:	No	3	0
		4	0
		5	0
		6	0
BRIDGE PHOTOS

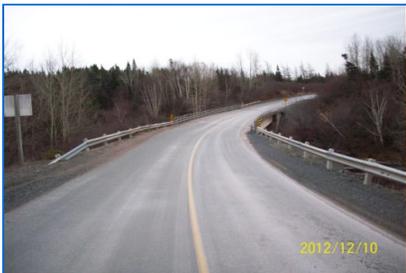
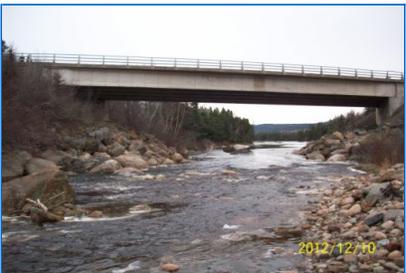
Comments:	Concrete footings, abutments & wingwalls set back high on slopes. Typical map cracking on all concrete surfaces except for areas repaired during 2020 rehab project.		
SUPERSTRUCTURE			
Condition:	F2 - Fair	Expansion Joints:	F2 - Fair
Comments:	Previous inspection - Some spalling and exposed rebar on Girders.- New inspection - Spalls on girders appear to be patched. Some map cracking on girders and #5 has rusting rebar on bottom near abut #2. New asphalt plug joints installed during 2020 rehab project.		
DECK

Condition:	F2 - Fair	Curbs:	F2 - Fair
Hand Rail:	G - Good	Roadway Condition:	F2 - Fair
Approach Rail:	F2 - Fair		
Comments:	Previous inspection - Bolt on left side hand rail expansion is sheared off. New inspection - 2020 rehab project included new deck & approach asphalt, rebuilt curbs new steel bridge rail(4) & new approach guiderail. Shoulder washouts at right approaches.		
HYDROLOGY			
Water Velocity:	. m/s	Ice Problem:	N - No Problem
Water Depth:	1 m	Scour Problem:	N - No Problem
Waterway:	01 - Adequate	Debris Problem:	N - No Problem
Comments:			
REPLACEMENT/REHABILITATION			
Next Rehab. Date:		Replacement Year:	
Antic. Rehab. Cost:	\$0	Replacement Cost:	\$0
Recommendations:	Repair approach shoulders.		
OBSERVATIONS			
Overall Condition:	F2 - Fair	Requires Further Inspection:	No
Additional Observations:
