Department of Transportation and Infrastructure, Government of Newfoundland and Labrador 2024.

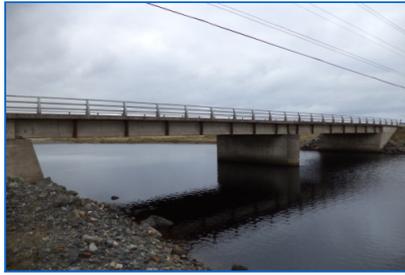
Overall Condition:	F1 - Fair	Requires Further Inspection:	No
Additional Observations:	- Bridge overall in fair condition. - Close proximity to water. Limited inspection due to deep water under the bridge. No access along abutment faces.

Next Rehab. Date:	2025	Replacement Year:	2050
Antic. Rehab. Cost:	\$175,000	Replacement Cost:	\$3,500,000
Recommendations:	- Install end blocks. - Replace guiderail completed with regulation post spacing connected to end blocks and with regulation hazard markers. Overlay the concrete deck. - Resurface approaches. - Waterproof and pave bridge deck if capacity exists. Replace expansion joints.
