GOVERNMENT OF NEWFOUNDLAND AND LABRADOR Department of Transportation and Infrastructure	<b>BRIDGE INSPECTION REPORT</b> <b>B04282021-13</b>	
<b>Date:</b> 4/22/2021	<b>Inspected By:</b> Butler	<b>Category:</b> Eng. - Engineering	
<b>BRIDGE INFORMATION</b>			
<b>Site:</b>	TCH-018 - SHOAL HARBOUR CNR OVERPASS		
<b>Route:</b>	1	<b>Overall Length:</b>	30 m
<b>Year Built:</b>	1965	<b>Est:</b> No	<b>Overall Width:</b> 14 m
<b>Year Last Rehab.:</b>		<b>Est:</b> No	<b>Roadway Width:</b> 12.6 m
<b>Region:</b>	CENTRAL EAST	<b>Sidewalk Width:</b>	0 m
<b>Jurisdiction:</b>	Provincial	<b>Clearance to R.D. or N.W.L.:</b>	9 m
<b>Type of Structure:</b>	04 - Rigid Frame	<b>Max Depth of N.W.L.:</b>	0 m
<b>Purpose of Structure:</b>	02 - Highway Railway Separation	<b>Spans:</b>	
<b>Type of Handrail:</b>	02 - Concrete Rail	<u>Span No.:</u>	<u>Length</u>
<b>Roadway Surface:</b>	02 - Asphalt	1	11
<b>Alignment Vertical:</b>	01 - Good	2	0

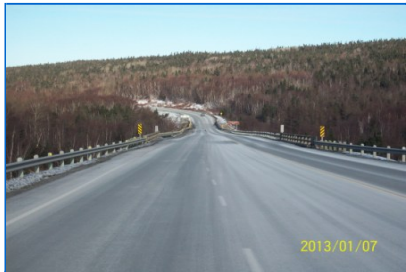
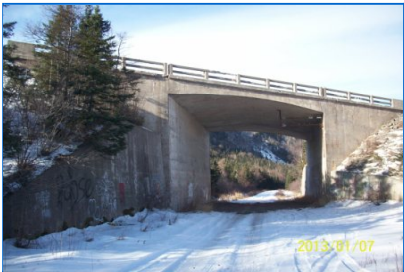
<b>SUBSTRUCTURE</b>			
<b>Condition:</b>	F2 - Fair	<b>Bearings:</b>	I - Inapplicable
		<b>Bearing Seat:</b>	I - Inapplicable
<b>Comments:</b>	Concrete abutments, wing walls and retaining walls. Light to medium cracking throughout. Light scaling throughout. Some small spalled sections. Small washout at abutment two left side.		
<b>SUPERSTRUCTURE</b>			
<b>Condition:</b>	P3 - Poor	<b>Expansion Joints:</b>	I - Inapplicable
<b>Comments:</b>	Medium cracking with efflorescence of soffit. Medium cracking and scaling in fascia.		
<b>DECK</b>			
<b>Condition:</b>	F2 - Fair	<b>Curbs:</b>	P3 - Poor
<b>Hand Rail:</b>	P - Poor	<b>Roadway Condition:</b>	P3 - Poor

**Comments:** Concrete bridge rail and endblocks in poor condition with disintegration and exposed rebar throughout; one section repaired with 150mm pressure treated timber. Concrete curbs in poor condition with disintegration and exposed rebar throughout. Asphalt wearing surface. Approach rail attached to 200mm treated post mounted to end blocks; post is detached at abutment one left side.

<b>Overall Condition:</b>	P3 - Poor	<b>Requires Further Inspection:</b>	No
<b>Additional Observations:</b> There is a new structure constructed at this location. This one will be removed once the highway re-alignment is completed
