GOVERNMENT OF NEWFOUNDLAND AND LABRADOR Department of Transportation and Infrastructure	BRIDGE INSPECTION REPORT B04282021-14	
Date: 4/22/2021	Inspected By: Butler	Category: Eng. - Engineering	
BRIDGE INFORMATION			
Site:	TCH-019 - SHOAL HARBOUR RIVER BRIDGE		
Route:	1	Overall Length:	67 m
Year Built:	1965	Est: No	Overall Width: 9.8 m
Year Last Rehab.:	1995	Est: No	Roadway Width: 8.4 m
Region:	CENTRAL EAST	Sidewalk Width:	0 m
Jurisdiction:	Provincial	Clearance to R.D. or N.W.L.:	10 m
Type of Structure:	01 - AASH to Girder	Max Depth of N.W.L.:	1 m
Purpose of Structure:	04 - Over Non-Navigable Waters		Spans:
Type of Handrail:	01 - Aluminum Rail	Span No.:	Length
Roadway Surface:	02 - Asphalt	1	26
Alignment Vertical:	01 - Good	2	26
Alignment Horizontal:	01 - Good	3	0
Restrictions:	No	6	0
BRIDGE PHOTOS

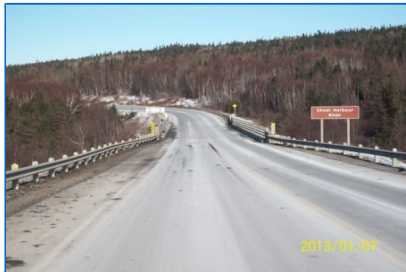
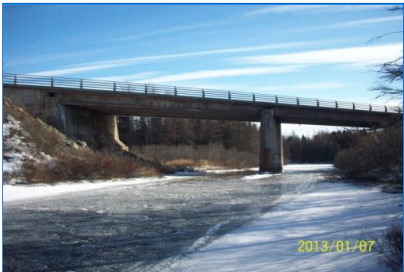
Comments:	Concrete abutments, wing walls and centre pier. Light to large cracking throughout abutments, wing walls and pier. Scaling, efflorescence, rust staining and some spalling. Rust staining on abutment one due to leaking expansion joint. Bearing seats at the abutments showing deterioration due to leaking expansion joints. Ice protection on center pier has a vertical crack at bend.		
SUPERSTRUCTURE			
Condition:	F2 - Fair	Expansion Joints:	P3 - Poor
Comments:	Five AASHTO girders in each span, two spans. Abutment one girder ends have staining, delamination and exposed rebar due to leaking expansion joint. Span one girder five has spalled areas. Span two girder one has delamination, spalling and exposed rebar. Span two girder two has spalling at the bottom near the centre. Span two girders four and five have spalled areas. Expansion joint one and three leaking. Expansion joint two possibly leaking. Expansion joint dams and armour have impact damage from snow plows.

DECK			
Condition:	F2 - Fair	Curbs:	P3 - Poor
Hand Rail:	F2 - Fair	Roadway Condition:	P3 - Poor
Approach Rail:	F2 - Fair		
Comments:	Asphalt wearing surface. Several potholes, especially near the expansion joints. Aluminum 4 rail system with concrete end blocks. Impact damage to left bridge rail. End blocks have light cracking and scaling. Sections of the curbs show disintegration with exposed rebar. Could not inspect deck surface due to high volume of traffic and narrow bridge.		
HYDROLOGY			
Water Velocity:	.5 m/s	Ice Problem:	N - No Problem
Water Depth:	.5 m	Scour Problem:	N - No Problem
Waterway:	01 - Adequate	Debris Problem:	N - No Problem
Comments:	Center pier not checked for scour.		
REPLACEMENT/REHABILITATION			
Next Rehab. Date:		Replacement Year:	
Antic. Rehab. Cost:	\$0	Replacement Cost:	\$0
Recommendations:			
OBSERVATIONS			
Overall Condition:	P3 - Poor	Requires Further Inspection:	No
Additional Observations:	Rock fill is currently placed upstream of this structure for the new structure.
