GOVERNMENT OF NEWFOUNDLAND AND LABRADOR Department of Transportation and Infrastructure	BRIDGE INSPECTION REPORT B10102023-7	
Date: 10/5/2023	Inspected By: Darrell Avery	Category: Eng. - Engineering	
BRIDGE INFORMATION			
Site:	2-202 - SNOOKS BROOK BRIDGE (OLD)		
Route:	232	Overall Length:	10 m
Year Built:	1945	Est: No	Overall Width: 5.6 m
Year Last Rehab.:		Est: No	Roadway Width: 0 m
Region:	CENTRAL EAST	Sidewalk Width:	0 m
Jurisdiction:	Provincial	Clearance to R.D. or N.W.L.:	1 m
Type of Structure:	03 - Reinforced Concrete Beam/Slab	Max Depth of N.W.L.:	1 m
Purpose of Structure:	04 - Over Non-Navigable Waters	Spans:	
Type of Handrail:	06 - None	<u>Span No.:</u>	<u>Length</u>
Roadway Surface:	01 - Concrete	1	6
Alignment Vertical:	01 - Good	2	0
Alignment Horizontal:	01 - Good	3	0
Restrictions:	Yes	<u>Span No.:</u>	<u>Length</u>
Describe Restrictions:	Located upstream from Route 232 culvert. Not used.

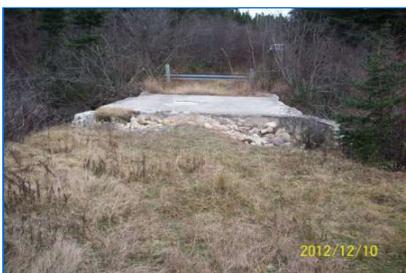
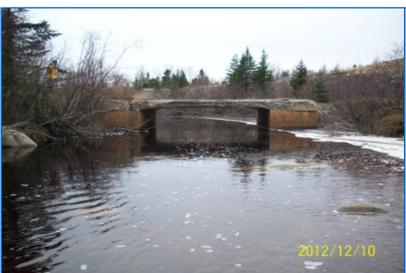
SUBSTRUCTURE			
Condition:	C - Unsafe (Closed to Public)	Bearings:	C - Unsafe (Closed to Public)
		Bearing Seat:	C - Unsafe (Closed to Public)
Comments:	Concrete abutments and wing walls. Severe disintegration, cracking and delamination of all.		
SUPERSTRUCTURE			
Condition:	C - Unsafe (Closed to Public)	Expansion Joints:	I - Inapplicable
Comments:	Soffit has disintegration, delamination and spalling.		
DECK			
Condition:	C - Unsafe (Closed to Public)	Curbs:	C - Unsafe (Closed to Public)
Hand Rail:	C - Unsafe (Closed to Public)	Roadway Condition:	C - Unsafe (Closed to Public)

Approach Rail:	C - Unsafe (Closed to Public)		
Comments:			
HYDROLOGY			
Water Velocity:	2 m/s	Ice Problem:	N - No Problem
Water Depth:	1.5 m	Scour Problem:	P - Possible Problem
Waterway:	01 - Adequate	Debris Problem:	P - Possible Problem
Comments:	Unable to check for scour		
REPLACEMENT/REHABILITATION			
Next Rehab. Date:		Replacement Year:	
Antic. Rehab. Cost:	\$0	Replacement Cost:	\$0
Recommendations:	Remove structure.		
OBSERVATIONS			
Overall Condition:	C - Unsafe (Closed to Public)	Requires Further Inspection:	No
Additional Observations:	Approach abutment one washed out, approach abutment two barricaded with guide rail. Bridge is inaccessible. Bridge located upstream from 3000mm culvert across R232.
