GOVERNMENT OF NEWFOUNDLAND AND LABRADOR Department of Transportation and Infrastructure	<b>BRIDGE INSPECTION REPORT</b> <b>B06282024-1</b>	
<b>Date:</b> 6/27/2024	<b>Inspected By:</b> D. Burns/J. Rowe	<b>Category:</b> Eng. - Engineering	
<b>BRIDGE INFORMATION</b>			
<b>Site:</b>	2-196 - SOCK POND BRIDGE (OLD)		
<b>Route:</b>	210	<b>Overall Length:</b>	10 m
<b>Year Built:</b>	1960	<b>Est:</b> No	<b>Overall Width:</b> 7.5 m
<b>Year Last Rehab.:</b>		<b>Est:</b> No	<b>Roadway Width:</b> 7 m
<b>Region:</b>	CENTRAL EAST	<b>Sidewalk Width:</b>	0 m
<b>Jurisdiction:</b>	Provincial	<b>Clearance to R.D. or N.W.L.:</b>	1 m
<b>Type of Structure:</b>	03 - Reinforced Concrete Beam/Slab	<b>Max Depth of N.W.L.:</b>	1 m
<b>Purpose of Structure:</b>	04 - Over Non-Navigable Waters	<b>Spans:</b>	
<b>Type of Handrail:</b>	02 - Concrete Rail	<u>Span No.:</u>	<u>Length</u>
<b>Roadway Surface:</b>	01 - Concrete	1	6
<b>Alignment Vertical:</b>	01 - Good	2	0

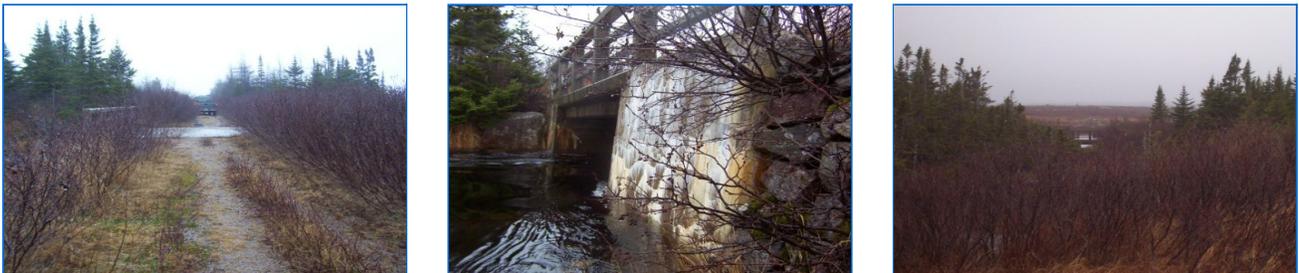
<b>SUBSTRUCTURE</b>			
<b>Condition:</b>	F2 - Fair	<b>Bearings:</b>	I - Inapplicable
		<b>Bearing Seat:</b>	F2 - Fair
<b>Comments:</b>	Concrete abutments and wingwalls, with alligator cracking and efflorescence staining throughout(Same as previous inspection). Some minor deterioration of abutments and wingwalls in some areas.		
<b>SUPERSTRUCTURE</b>			
<b>Condition:</b>	F2 - Fair	<b>Expansion Joints:</b>	I - Inapplicable
<b>Comments:</b>	Some minor cracking in the reinforced concrete deck(Same as previous inspection).		
<b>DECK</b>			
<b>Condition:</b>	F2 - Fair	<b>Curbs:</b>	I - Inapplicable
	P3 - Poor		F1 - Fair

<b>Hand Rail:</b>		<b>Roadway Condition:</b>	
<b>Approach Rail:</b>	I - Inapplicable		
<b>Comments:</b>	Previous Inspection - Exposed concrete deck with gravel approaches (noted during previous inspection). Cracking and disintegration of the deck surface, some vegetation growth (noted during previous inspection). Concrete hand rail is cracked, disintegrated and has exposed rebar in several areas. Roadway is grown in with alders. New inspection - All Concerns are persistent with the previous inspection and no new concerns were observed.		
<b>HYDROLOGY</b>			
<b>Water Velocity:</b>	1 m/s	<b>Ice Problem:</b>	N - No Problem
<b>Water Depth:</b>	2 m	<b>Scour Problem:</b>	N - No Problem
<b>Waterway:</b>	01 - Adequate	<b>Debris Problem:</b>	P - Possible Problem
<b>Comments:</b>	previous inspection was noted that there was a known debris problem. No debris problem was encountered, however streambed was inaccessible to inspect.

<b>REPLACEMENT/REHABILITATION</b>			
<b>Next Rehab. Date:</b>		<b>Replacement Year:</b>	
<b>Antic. Rehab. Cost:</b>	\$0	<b>Replacement Cost:</b>	\$Remove structure
<b>Recommendations:</b>	Structure is considered safe but should be posted with load limit until removal.		
<b>OBSERVATIONS</b>			
<b>Overall Condition:</b>	F1 - Fair	<b>Requires Further Inspection:</b>	No
<b>Additional Observations:</b>	Located on old R210 about 4.5km south of Sandy Harbor River Bridge. Bridge located on unmaintained road, bridge unmaintained, use at own risk.
