GOVERNMENT OF NEWFOUNDLAND AND LABRADOR Department of Transportation and Infrastructure	BRIDGE INSPECTION REPORT B07312023-5	
Date: 7/26/2023	Inspected By: Darrell Avery	Category: Eng. - Engineering	
BRIDGE INFORMATION			
Site:	TCH-030 - SOULIS BROOK BRIDGE		
Route:	1	Overall Length:	21 m
Year Built:	1990	Est: No	Overall Width: 13.4 m
Year Last Rehab.:		Est: No	Roadway Width: 12 m
Region:	CENTRAL EAST	Sidewalk Width:	0 m
Jurisdiction:	Provincial	Clearance to R.D. or N.W.L.:	2.5 m
Type of Structure:	04 - Rigid Frame	Max Depth of N.W.L.:	1 m
Purpose of Structure:	04 - Over Non-Navigable Waters		
Type of Handrail:	01 - Aluminum Rail	Spans:	
Roadway Surface:	02 - Asphalt	Span No.:	Length
Alignment Vertical:	01 - Good	1	19
Alignment Horizontal:	01 - Good	2	0
Restrictions:	No	3	0
		Span No.:	Length
		4	0
		5	0
		6	0
BRIDGE PHOTOS

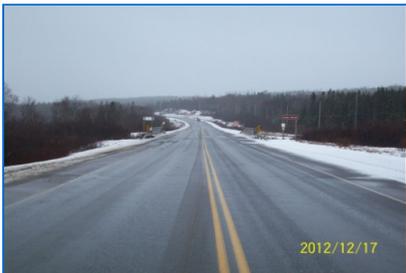
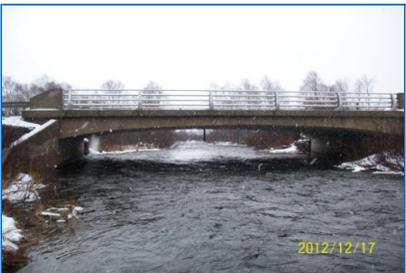
Comments:	Concrete abutments. Some erosion of abutment walls. Concrete wing walls right side only, not attached to structure. Abutment one wing wall leaning significantly (aprox. 40mm at top) due to the roadway/bridge water draining next to it.. Both wing walls severe scaling, some delamination and cracking. All Gabions are in poor condition due the ones at waterline being severely rusted and missing ballast. Longitudinal cracks are evident in several places connecting both abutments through the deck the worst appears to the center joint, all are minor.		
SUPERSTRUCTURE			
Condition:	F2 - Fair	Expansion Joints:	F2 - Fair
Comments:	Soffitt and fascia in fair condition with minor cracking.		
DECK

Condition:	F2 - Fair	Curbs:	F2 - Fair
Hand Rail:	F2 - Fair	Roadway Condition:	F2 - Fair
Approach Rail:	F2 - Fair		
Comments:	Asphalt wearing surface. Light cracking of curbs - larger cracks at curb ends. Cracks & deterioration in end blocks.		
HYDROLOGY			
Water Velocity:	1 m/s	Ice Problem:	N - No Problem
Water Depth:	1 m	Scour Problem:	N - No Problem
Waterway:	01 - Adequate	Debris Problem:	N - No Problem
Comments:			
REPLACEMENT/REHABILITATION			
Next Rehab. Date:		Replacement Year:	
Antic. Rehab. Cost:	\$200000	Replacement Cost:	\$0
Recommendations:	Install structural rail with new end blocks, repair wingwalls, replace gabions with armor stone.		
OBSERVATIONS			
Overall Condition:	F2 - Fair	Requires Further Inspection:	No
Additional Observations:	Structure widened on left side.
