GOVERNMENT OF NEWFOUNDLAND AND LABRADOR Department of Transportation and Infrastructure	BRIDGE INSPECTION REPORT B06282024-3	
Date: 6/27/2024	Inspected By: D. Burns/J. Rowe	Category: Eng. - Engineering	
BRIDGE INFORMATION			
Site:	2-064 - SOUTHEAST BROOK BRIDGE		
Route:	211-10	Overall Length:	20 m
Year Built:	1970	Est: No	Overall Width: 12 m
Year Last Rehab.:	2023	Est: No	Roadway Width: 11.5 m
Region:	CENTRAL EAST	Sidewalk Width:	0 m
Jurisdiction:	Provincial	Clearance to R.D. or N.W.L.:	4 m
Type of Structure:	03 - Reinforced Concrete Beam/Slab	Max Depth of N.W.L.:	0.5 m
Purpose of Structure:	04 - Over Non-Navigable Waters	Spans:	
Type of Handrail:	01 - Aluminum Rail	Span No.:	Length
Roadway Surface:	02 - Asphalt	1	6
Alignment Vertical:	01 - Good	2	0
Alignment Horizontal:	01 - Good	3	0
Restrictions:	No	6	0
BRIDGE PHOTOS

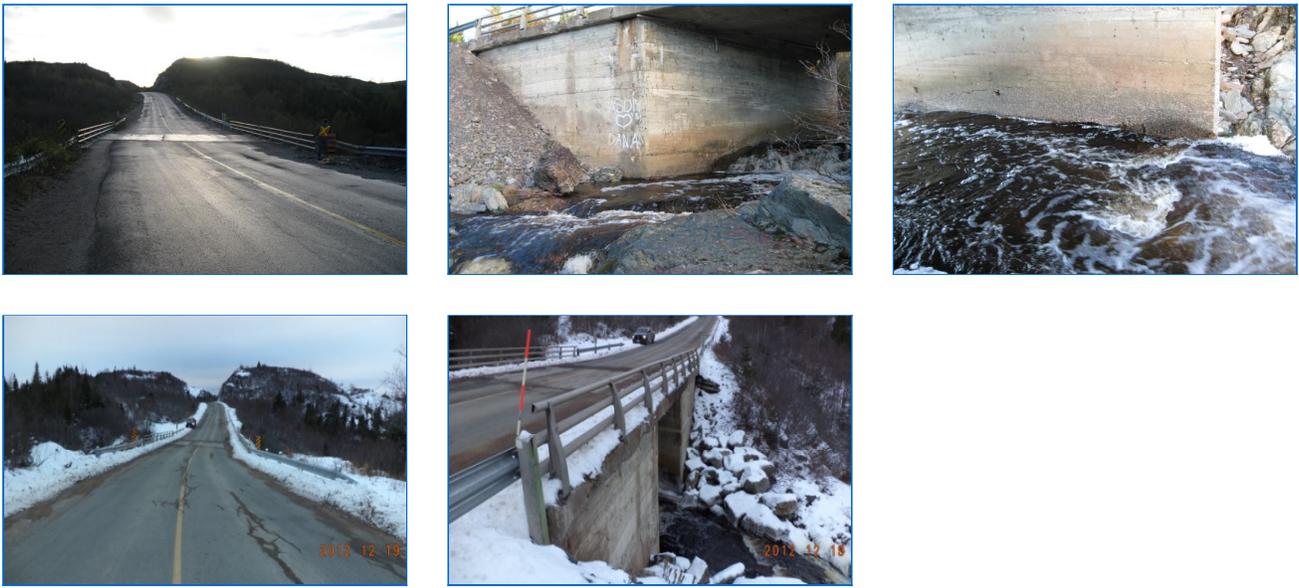
Comments:	Previous Inspection: Both abutment faces have visible cold joints from original construction. - Medium to wide

map cracks throughout. At the waterline, there is moderate erosion of the face. No visible signs of scour but a detailed inspection was not conducted due to fast moving water and a large waterfall downstream. Wingwalls have visible cold joints from original construction, narrow map cracks throughout with isolated efflorescence. New inspection - All errors seem to be persistent with previous inspection, although there are some areas that have been rehabbed on the wingwalls in 2023.

Condition:	F1 - Fair	Expansion Joints:	U - Uninspectable
Comments:	Visible formwork left from construction throughout the underside of deck. Formwork is causing efflorescence and rust staining in several areas, so it is evident that the formwork is causing leaking. Moderate crack running through the middle of the underside of the deck longitudinally. Cracking in middle of fascia on right side of bridge.

Condition:	F2 - Fair	Curbs:	I - Inapplicable
Hand Rail:	G - Good	Roadway Condition:	F2 - Fair
Approach Rail:	F2 - Fair		
Comments:	Erosion on shoulder of every roadway approach, on the right side it is affecting asphalt. Aluminum rail is in good condition with a few of the end caps broken or missing. Expansion joint seems to be causing cracking along the deck as it has been paved over. One minor pothole in middle of deck.

Next Rehab. Date:		Replacement Year:	
Antic. Rehab. Cost:	\$TBD	Replacement Cost:	\$TBD
Recommendations:	Structure is still missing end blocks after the 2023 rehabs, also needs to be complete with hazard markers./
