GOVERNMENT OF NEWFOUNDLAND AND LABRADOR Department of Transportation and Infrastructure	BRIDGE INSPECTION REPORT B08052024-5	
Date: 8/2/2024	Inspected By: D. Burns/B. Grandy	Category: Eng. - Engineering	
BRIDGE INFORMATION			
Site:	2-048 - SOUTHWEST ARM BROOK BRIDGE		
Route:	210	Overall Length:	44.2 m
Year Built:	1971	Est: No	Overall Width: 11.8 m
Year Last Rehab.:	2012	Est: No	Roadway Width: 10.4 m
Region:	CENTRAL EAST	Sidewalk Width:	0 m
Jurisdiction:	Provincial	Clearance to R.D. or N.W.L.:	2 m
Type of Structure:	01 - AASH to Girder	Max Depth of N.W.L.:	1 m
Purpose of Structure:	03 - Over Navigable Waters		
Type of Handrail:	04 - Steel Rail	Spans:	
Roadway Surface:	02 - Asphalt	Span No.:	Length
Alignment Vertical:	01 - Good	1	37.2
Alignment Horizontal:	01 - Good	2	0
Restrictions:	No	3	0
		4	0
		5	0
		6	0
BRIDGE PHOTOS

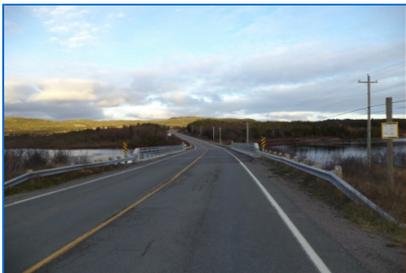
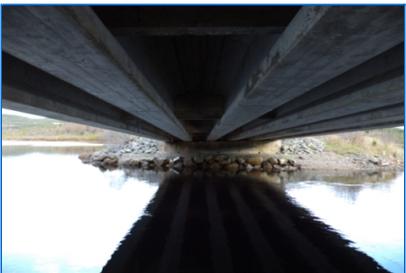
Comments:	Concrete abutments and wingwalls. Abutment 2 left corner has separation, all other corners were recently rehabbed. Minor cracking and honeycombing on both abutments. Some bearing pads look to be squat, with fallen debris on bearing seats due to poorly consolidated diaphragms.		
SUPERSTRUCTURE			
Condition:	F1 - Fair	Expansion Joints:	P3 - Poor
Comments:	6 AASHTO girders. All girders have spalling ends with girder 4, abutment 1 being the worst. Some girders ends now have exposed rebar. This may be due to expansion joints leaking. Expansion joints are plugged with sand. Multiple girders have exposed rebar with girder 2 abutment 2 showing roughly 250-400 mm. Diaphragms have poorly consolidated concrete and some are exposing rebar. Minor honeycombing on all girders. Right side fascia is rehabbed and showing leaking efflorescence.

DECK			
Condition:	F1 - Fair	Curbs:	F2 - Fair
Hand Rail:	G - Good	Roadway Condition:	F2 - Fair
Approach Rail:	F2 - Fair		
Comments:	Bridge identification sign missing. Underside of deck has leftover formwork and has signs of rust and effloresce deposits, indicating that these areas are leaking onto girders. Vegetation growing through drainage grates, with heavy sand build up on deck. 2 separate drip beads, 1 on fascia and 1 on soffit. Some cracking of curb around expansion joint section. Some minor cracking of end blocks.		
HYDROLOGY			
Water Velocity:	Tidal m/s	Ice Problem:	N - No Problem
Water Depth:	Tidal m	Scour Problem:	N - No Problem
Waterway:	01 - Adequate	Debris Problem:	N - No Problem
Comments:	Tidal-Depth and velocity fluctuate.		
REPLACEMENT/REHABILITATION			
Next Rehab. Date:		Replacement Year:	
Antic. Rehab. Cost:	\$TBD	Replacement Cost:	\$TBD
Recommendations:	Latex repairs on girders needed. Potential asphalt repairs required as well.

OBSERVATIONS			
Overall Condition:	F1 - Fair	Requires Further Inspection:	No
Additional Observations:	Poorly constructed, with leftover formwork in the deck and poorly consolidated concrete posing issues for the bridge's sustenance. Bridge missing identification sign.
