GOVERNMENT OF NEWFOUNDLAND AND LABRADOR Department of Transportation and Infrastructure	<b>BRIDGE INSPECTION REPORT</b> <b>B06192024-1</b>	
<b>Date:</b> 6/19/2024	<b>Inspected By:</b> Damien Burns	<b>Category:</b> Eng. - Engineering	
<b>BRIDGE INFORMATION</b>			
<b>Site:</b>	TCH-021 - SOUTHWEST RIVER BRIDGE		
<b>Route:</b>	1	<b>Overall Length:</b>	69.3 m
<b>Year Built:</b>	1964	<b>Est:</b> No	<b>Overall Width:</b> 10 m
<b>Year Last Rehab.:</b>	2014	<b>Est:</b> No	<b>Roadway Width:</b> 8.6 m
<b>Region:</b>	CENTRAL EAST	<b>Sidewalk Width:</b>	0 m
<b>Jurisdiction:</b>	Provincial	<b>Clearance to R.D. or N.W.L.:</b>	7 m
<b>Type of Structure:</b>	01 - AASH to Girder	<b>Max Depth of N.W.L.:</b>	1 m
<b>Purpose of Structure:</b>	03 - Over Navigable Waters	<b>Spans:</b>	
<b>Type of Handrail:</b>	01 - Aluminum Rail	<b>Span No.:</b>	<b>Length</b>
<b>Roadway Surface:</b>	02 - Asphalt	1	30.5
<b>Alignment Vertical:</b>	02 - Adequate	2	30.5

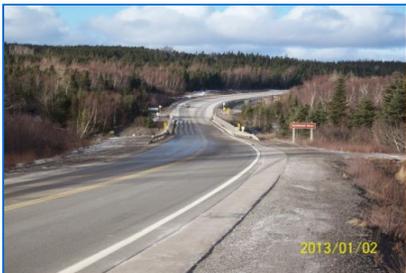
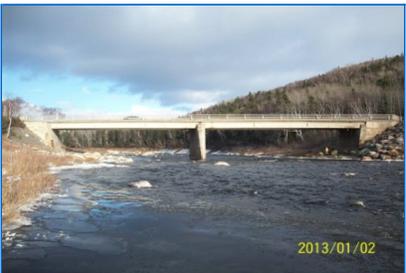
<b>SUBSTRUCTURE</b>			
<b>Condition:</b>	F2 - Fair	<b>Bearings:</b>	U - Uninspectable
		<b>Bearing Seat:</b>	U - Uninspectable
<b>Comments:</b>	Previous inspection #1 - Concrete abutments, wing walls and center pier. Abutments and wingwalls have scaling, cracking, delamination and disintegration in several areas. Centre pier has some disintegration of the upper sections with some sections of the upstream side repaired in 2014 and some erosion in the flow zone. Abutment 2 upstream has lose of concrete over icebreaker. Icebreaker missing from center pier, and now is on the shoreline downstream. Previous inspection #2 - continued concrete deterioration including at Abut. # 1 right and upper pier right/creep block. New inspection (DB) - Heavy build up of sand under rail, causing abutment #1 left to erode. Some visible chipping in center pier

exposed rebar due to cover issues. Delamination, disintegration and exposed rebar girder five, span one, near abutment one and girder one span two. Some staining of all girders due to cover issues. Expansion joints (three) replaced in 2014. Previous inspection #2 - continued girder concrete deterioration including horizontal cracking along bottom. New Inspection (DB) - Visible leaking of expansion joints.

**Comments:** Previous inspection #1 - Full concrete deck rehab and new asphalt wearing surface installed in 2014, good condition. Curb faces and top rehab in 2007 with several sections of the left soffit and fascia repaired in 2014, some minor cracking and disintegration remains on the fascia of both curbs. Four rail aluminum bridge rail with concrete end blocks repaired in 2014, good condition. Approach rail is too short at all corners to cover hazards. Approach #2 information sign requires replacement. Approach #2 right has a damaged rail post. There is a large settlement on Approach #1 right causing a hazard to traffic. Approach 2 potholed and there are old core holes from previously installed detour signs placed during re-hab. Deck Pavement is potholed. Facia on Abutment 1 left near the expansion joint is spalling. Previous inspection #2 - larger void in abut. #1 approach asphalt at expansion joint dam & missing asphalt at middle exp. joint dam. More curb deterioration along fascia. Missing hazard markers at abut. #1 left & right - Abut #2 right. Damaged guiderail at approach #2 right. New inspection (DB) - Missing all hazard markers. Post rail is cracked on Approach #1 right. Back of concrete curb is missing(around 3.75m in length). Some exposed rebar on left side bridge deck.

<b>Next Rehab. Date:</b>	2024	<b>Replacement Year:</b>	
<b>Antic. Rehab. Cost:</b>	\$0	<b>Replacement Cost:</b>	\$0
<b>Recommendations:</b>	Repair settlement on approach #1. Repair post on approach #2 right. Replace information sign. Place on Rehab schedule for substructure. Repair potholes, replace hazard markers, clean old bridge debris from river, repair facia, repair pavement on approach and fill in old core holes. Repair approach guiderail.
