GOVERNMENT OF NEWFOUNDLAND AND LABRADOR Department of Transportation and Infrastructure	<b>BRIDGE INSPECTION REPORT</b> <b>B07102024-8</b>	
<b>Date:</b> 7/8/2024	<b>Inspected By:</b> D. Burns/J. Rowe/B. Grandy	<b>Category:</b> Eng. - Engineering	
<b>BRIDGE INFORMATION</b>			
<b>Site:</b>	2-054 - SUGAR LOAF BROOK BRIDGE		
<b>Route:</b>	212	<b>Overall Length:</b>	27.4 m
<b>Year Built:</b>	1972	<b>Est:</b> No	<b>Overall Width:</b> 10 m
<b>Year Last Rehab.:</b>	2008	<b>Est:</b> No	<b>Roadway Width:</b> 8.6 m
<b>Region:</b>	CENTRAL EAST	<b>Sidewalk Width:</b>	0 m
<b>Jurisdiction:</b>	Provincial	<b>Clearance to R.D. or N.W.L.:</b>	3.6 m
<b>Type of Structure:</b>	01 - AASH to Girder	<b>Max Depth of N.W.L.:</b>	1.5 m
<b>Purpose of Structure:</b>	03 - Over Navigable Waters		
<b>Type of Handrail:</b>	02 - Concrete Rail	<b>Spans:</b>	
<b>Roadway Surface:</b>	01 - Concrete	<b>Span No.:</b>	<b>Length</b>
<b>Alignment Vertical:</b>	01 - Good	1	19

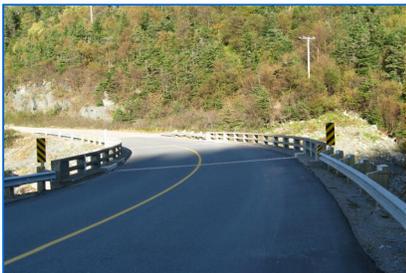
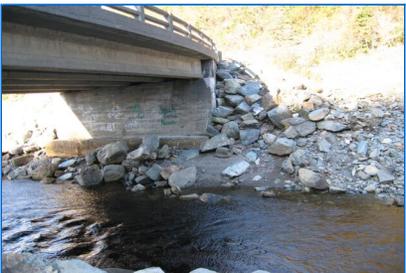
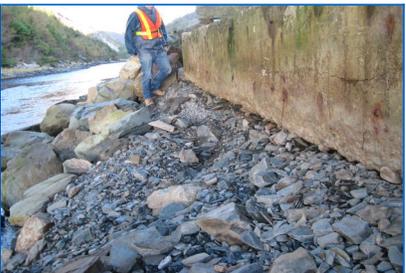
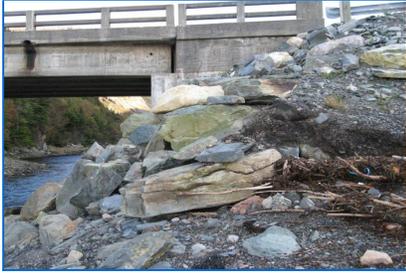
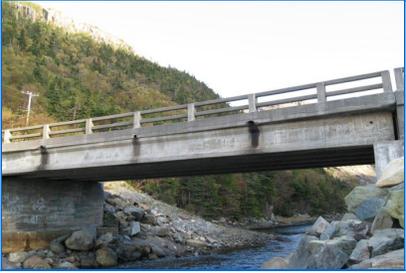
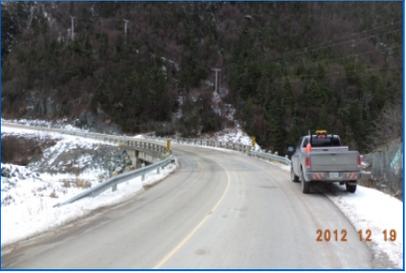
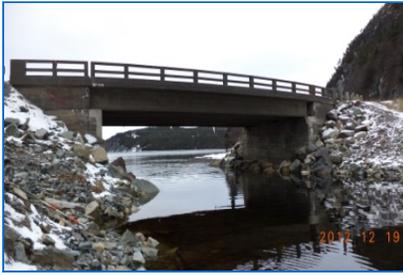
<b>Condition:</b>	F1 - Fair	<b>Bearings:</b>	F1 - Fair
		<b>Bearing Seat:</b>	P3 - Poor
<b>Comments:</b>	Abutments have moderate map cracking with efflorescence throughout. Spalling on abutment 1 right. Abutment corners are moderately deteriorated. Visible cold joint through the entire width of abutment 2. Previous inspection mentions that bearings are undersized. Spalling on wingwall 2 corner. Disintegration with exposed rebar on abutment 1 left wingwall corner.

<b>Condition:</b>	F1 - Fair	<b>Expansion Joints:</b>	P3 - Poor
<b>Comments:</b>	Visible erosion and rust/efflorescence staining on girder 1 (downstream) due to drainage running off deck, hairline map cracking observed on this girder as well. Exposed rebar on girders 1 and 3 near abutment 2. exposed rebar on girder 4 near abutment 1. Previous report mentions that expansion joints are suspected to be leaking.

<b>Condition:</b>	F1 - Fair	<b>Curbs:</b>	P3 - Poor
<b>Hand Rail:</b>	P1 - Poor	<b>Roadway Condition:</b>	F1 - Fair
<b>Approach Rail:</b>	P3 - Poor		
<b>Comments:</b>	Asphalt has alligator cracking throughout. left curb is in poor condition with moderate disintegration. Minor pothole on right side near approach 2. Hand rail concrete is dead in some areas, with some areas being deteriorated. Structural rail is rotting on abutment 2 left with erosion of asphalt near end block. Guide rail is not bolted to end blocks, terminal ends present at ends of guard rail.

<b>Overall Condition:</b>	F1 - Fair	<b>Requires Further Inspection:</b>	No
<b>Additional Observations:</b>	Biggest concern is the deck drains running on to girder 1.

<b>Next Rehab. Date:</b>	2026	<b>Replacement Year:</b>	2045
<b>Antic. Rehab. Cost:</b>	\$200,000	<b>Replacement Cost:</b>	\$3,500,000
<b>Recommendations:</b>	Previous inspection - Replace structure rail, end blocks, curbs, deck drains expansion joints and portions of the deck. - Concrete repairs as required. - Upgrade guiderail post spacing and connect to new end blocks. Remove all gravels from the bridge deck. - Time frames are estimates only.
