GOVERNMENT OF NEWFOUNDLAND AND LABRADOR Department of Transportation and Infrastructure	BRIDGE INSPECTION REPORT B01302020-17	
Date: 1/30/2020	Inspected By: Alex Ford	Category: Eng. - Engineering	
BRIDGE INFORMATION			
Site:	2-027 - TAYLOR'S BAY BROOK BRIDGE		
Route:	220	Overall Length:	17.5 m
Year Built:	1965	Est: No	Overall Width: 9 m
Year Last Rehab.:	1986	Est: No	Roadway Width: 7.4 m
Region:	CENTRAL EAST	Sidewalk Width:	0 m
Jurisdiction:	Provincial	Clearance to R.D. or N.W.L.:	2 m
Type of Structure:	03 - Reinforced Concrete Beam/Slab	Max Depth of N.W.L.:	0.5 m
Purpose of Structure:	04 - Over Non-Navigable Waters	Spans:	
Type of Handrail:	01 - Aluminum Rail	Span No.:	Length
Roadway Surface:	01 - Concrete	1	11.5
Alignment Vertical:	01 - Good	2	0
Alignment Horizontal:	02 - Adequate	3	0
Restrictions:	No	6	0
BRIDGE PHOTOS

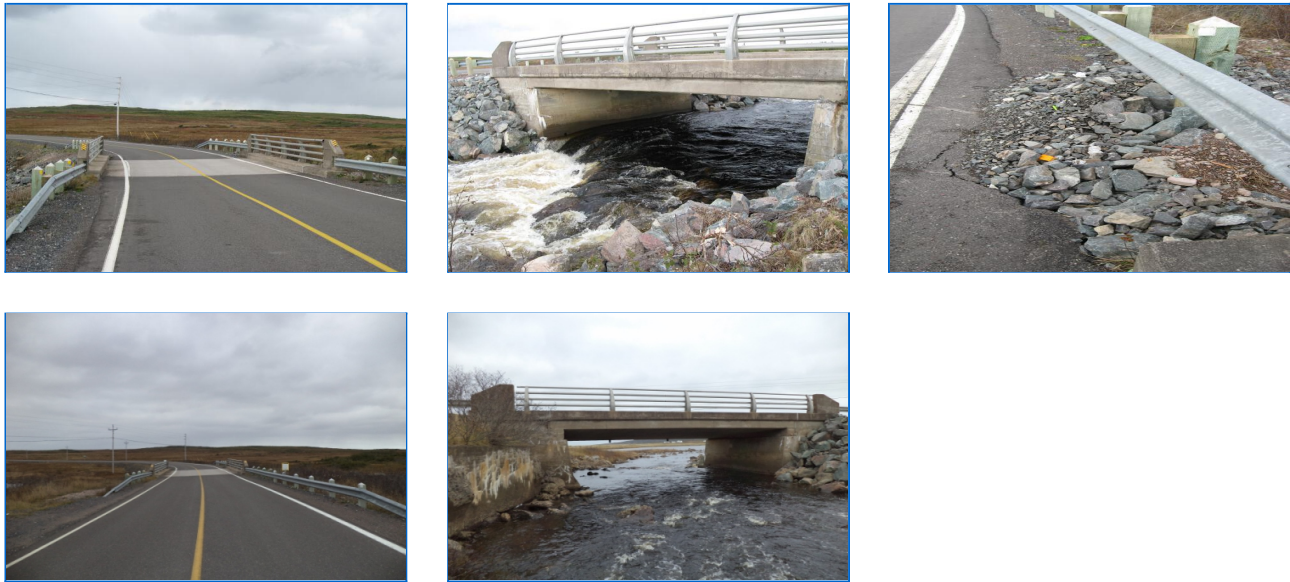
Comments:	Concrete abutments and wingwalls. Minor erosion of footings in water, some large cracking. Scour @ abutment two left corner, footing above cracked. Abutment upper corners deteriorated with efflorescence. Wingwalls near
