GOVERNMENT OF NEWFOUNDLAND AND LABRADOR Department of Transportation and Infrastructure	BRIDGE INSPECTION REPORT B02282023-2	
Date: 9/28/2022	Inspected By: M Button	Category: Office - Bridge Office	
BRIDGE INFORMATION			
Site:	2-027 - TAYLOR'S BAY BROOK BRIDGE		
Route:	220	Overall Length:	17.5 m
Year Built:	1965	Est: No	Overall Width: 9 m
Year Last Rehab.:	1986	Est: No	Roadway Width: 7.4 m
Region:	CENTRAL EAST	Sidewalk Width:	0 m
Jurisdiction:	Provincial	Clearance to R.D. or N.W.L.:	2 m
Type of Structure:	03 - Reinforced Concrete Beam/Slab	Max Depth of N.W.L.:	0.5 m
Purpose of Structure:	04 - Over Non-Navigable Waters	Spans:	
Type of Handrail:	01 - Aluminum Rail	Span No.:	Length
Roadway Surface:	01 - Concrete	1	11.5
Alignment Vertical:	01 - Good	2	0
Alignment Horizontal:	02 - Adequate	3	0
Restrictions:	No	4	0
		5	0
		6	0
BRIDGE PHOTOS

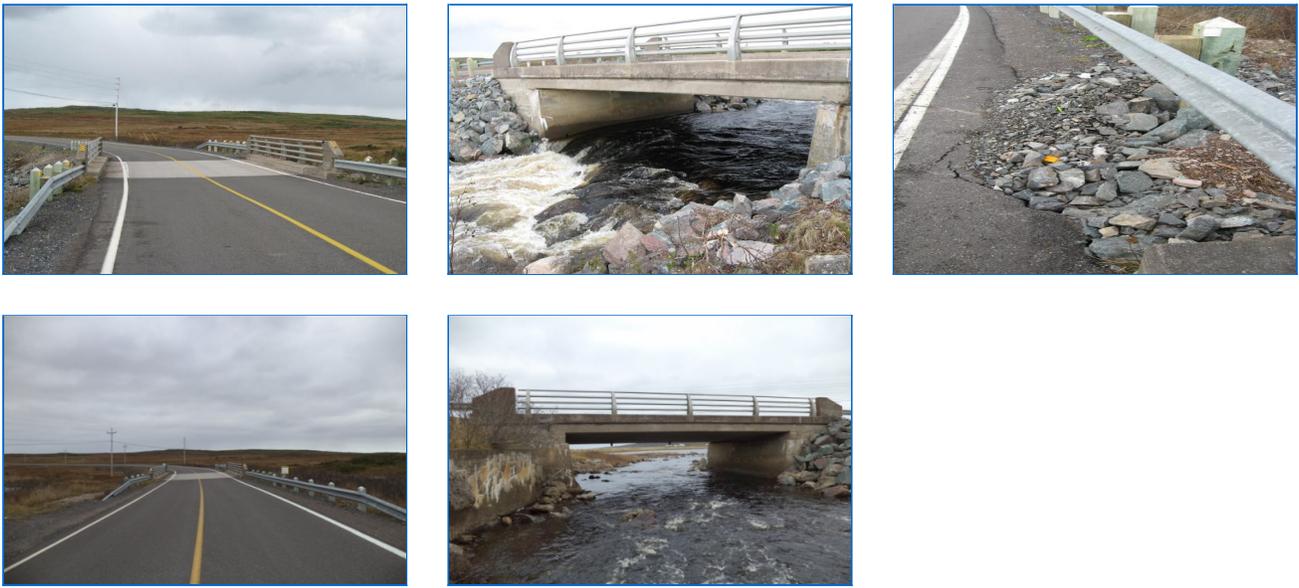
Bearing Seat:	F1 - Fair
Comments:	- Wingwall and abutment corners have moderate to severe map cracking and moderate efflorescence. One

wingwall has a large deep spall and is suspected to be leaking through from the gravel backfill, P3. - Abutment faces have narrow map cracks throughout (away from corners). Exposed concrete footings have severe erosion with wide cracks. - Bearing seat exterior edges have light to moderate spalling but are in fair condition under the bridge deck.

Comments: - Approach asphalt have moderate map cracking throughout. Potholes developing, F1. - Exposed concrete deck in fair condition. Light scaling/wear on surface exposing aggregate colors. - Curbs have narrow cracks in isolated locations and are in fair condition. - Structure rail in fair condition. - Guiderail in fair condition, connected to end blocks, does not have regulation post spacing and is missing hazard markers.

Recommendations: - Replace hazard markers and upgrade post layout. - Consider brush clearing approaches. - Repair spalls to wingwalls and abutment corners. Waterproof and pave structure if capacity is available.
