GOVERNMENT OF NEWFOUNDLAND AND LABRADOR Department of Transportation and Infrastructure	BRIDGE INSPECTION REPORT B10102023-13	
Date: 10/5/2023	Inspected By: Darrell Avery	Category: Eng. - Engineering	
BRIDGE INFORMATION			
Site:	TCH-116 - TCH-RT.230 UNDERPASS BONAVISTA HWY		
Route:	1	Overall Length:	60 m
Year Built:	1990	Est: No	Overall Width: 12.5 m
Year Last Rehab.:	2019	Est: No	Roadway Width: 10.5 m
Region:	CENTRAL EAST	Sidewalk Width:	0 m
Jurisdiction:	Provincial	Clearance to R.D. or N.W.L.:	6 m
Type of Structure:	05 - Pre-stressed Concrete Slab	Max Depth of N.W.L.:	0 m
Purpose of Structure:	01 - Highway Grade Separation	Spans:	
Type of Handrail:	01 - Aluminum Rail	<u>Span No.:</u>	<u>Length</u>
Roadway Surface:	02 - Asphalt	1	26
Alignment Vertical:	02 - Adequate	2	26
Alignment Horizontal:	02 - Adequate	3	0
Restrictions:	Yes	4	0
Describe Restrictions:	Clearance 6.0m posted. Not post for eastbound.

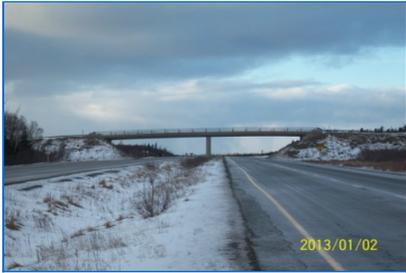
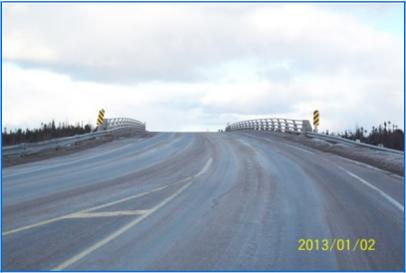
SUBSTRUCTURE			
Condition:	F2 - Fair	Bearings:	F2 - Fair
		Bearing Seat:	F2 - Fair
Comments:	Previous inspection - Concrete abutments, wing walls and pier. Pot bearings have rusting and some delamination of the top and bottom plates, worse at abutment one. Some light cracking and scaling of all concrete. Slope paving at abutment one is undermined and has shifted at the right corner. New inspection - Light cracking on surface of middle support columns(3).		
SUPERSTRUCTURE			
Condition:	F2 - Fair	Expansion Joints:	F2 - Fair
Comments:			
DECK

Condition:	F2 - Fair	Curbs:	F1 - Fair
Hand Rail:	F2 - Fair	Roadway Condition:	F1 - Fair
Approach Rail:	F2 - Fair		
Comments:	New inspection - there are sections of curbs with concrete deterioration/damage		
HYDROLOGY			
Water Velocity:	n/a m/s	Ice Problem:	NA - Not Applicable
Water Depth:	n/a m	Scour Problem:	NA - Not Applicable
Waterway:	03 - Not Applicable	Debris Problem:	NA - Not Applicable
Comments:	Clean debris from abutment seats		
REPLACEMENT/REHABILITATION			
Next Rehab. Date:	2025	Replacement Year:	
Antic. Rehab. Cost:	\$0	Replacement Cost:	\$0
Recommendations:	Repair curbs.		
OBSERVATIONS			
Overall Condition:	F2 - Fair	Requires Further Inspection:	No
Additional Observations:
