GOVERNMENT OF NEWFOUNDLAND AND LABRADOR Department of Transportation and Infrastructure	BRIDGE INSPECTION REPORT B08012023-4	
Date: 7/26/2023	Inspected By: Darrell Avery	Category: Eng. - Engineering	
BRIDGE INFORMATION			
Site:	TCH-111 - TCH-RT.320 UNDERPASS GAMBO INTERCH.		
Route:	1	Overall Length:	61 m
Year Built:	1989	Est: No	Overall Width: 12 m
Year Last Rehab.:		Est: No	Roadway Width: 10 m
Region:	CENTRAL EAST	Sidewalk Width:	0 m
Jurisdiction:	Provincial	Clearance to R.D. or N.W.L.:	5.9 m
Type of Structure:	05 - Pre-stressed Concrete Slab	Max Depth of N.W.L.:	0 m
Purpose of Structure:	01 - Highway Grade Separation	Spans:	
Type of Handrail:	01 - Aluminum Rail	Span No.:	Length
Roadway Surface:	02 - Asphalt	1	26
Alignment Vertical:	01 - Good	2	26
Alignment Horizontal:	01 - Good	3	0
Restrictions:	Yes	4	0
Describe Restrictions:	posted clearance 5.9m	5	0
		6	0
BRIDGE PHOTOS

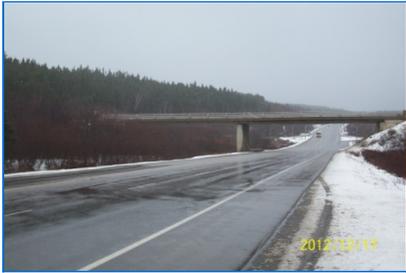
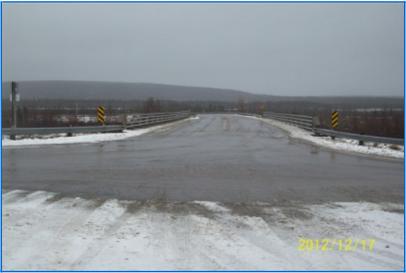
Bearing Seat:	U - Uninspectable
Comments:	Concrete abutments, wing walls and 3 column centre pier. Sixteen pot bearings at abutments and three on centre piers not inspected. Light cracking and scaling on wing walls. Pier columns have light cracking. Centre pier column has delamination and exposed rebar due to lack of cover.		
SUPERSTRUCTURE			
Condition:	F2 - Fair	Expansion Joints:	P3 - Poor
Comments:	Expansion joints leaking, some damage to dams and armour. Dymeric sealer at curb locations poor condition. Pavement and concrete at expansion joints is deteriorating. Abutment 2: • evidence of roadway settlement between curb and pavement. • guide rail attachment to end block requires repair.		
DECK

Condition:	F2 - Fair	Curbs:	F1 - Fair
Hand Rail:	F1 - Fair	Roadway Condition:	F2 - Fair
Approach Rail:	P1 - Poor		
Comments:	Asphalt wearing surface. Aluminum 4 rail system with concrete end blocks. Aluminum rail needs splice repair. End blocks have light scaling and map cracking. Curbs have light scaling and cracking that is more severe at expansion joints. No end shoes at end blocks, guide rail not structural.		
HYDROLOGY			
Water Velocity:	n/a m/s	Ice Problem:	NA - Not Applicable
Water Depth:	n/a m	Scour Problem:	NA - Not Applicable
Waterway:	03 - Not Applicable	Debris Problem:	NA - Not Applicable
Comments:			
REPLACEMENT/REHABILITATION			
Next Rehab. Date:		Replacement Year:	
Antic. Rehab. Cost:	\$80000	Replacement Cost:	\$0
Recommendations:	Replace expansion joints. Replace guide rail with structural guide rail and new end blocks. Clean the gutters. Repair bridge rail including splice. Replace and lengthen guiderail near pier columns.
