GOVERNMENT OF NEWFOUNDLAND AND LABRADOR Department of Transportation and Infrastructure	BRIDGE INSPECTION REPORT B08012023-7	
Date: 7/26/2023	Inspected By: Darrell Avery	Category: Eng. - Engineering	
BRIDGE INFORMATION			
Site:	2-090 - TERRA NOVA RIVER BRIDGE		
Route:	310	Overall Length:	74 m
Year Built:	1965	Est: No	Overall Width: 11.7 m
Year Last Rehab.:		Est: No	Roadway Width: 8.3 m
Region:	CENTRAL EAST	Sidewalk Width:	1.6 m
Jurisdiction:	Provincial	Clearance to R.D. or N.W.L.:	4 m
Type of Structure:	01 - AASH to Girder	Max Depth of N.W.L.:	2.5 m
Purpose of Structure:	03 - Over Navigable Waters	Spans:	
Type of Handrail:	01 - Aluminum Rail	<u>Span No.:</u>	<u>Length</u>
Roadway Surface:	02 - Asphalt	1	30
Alignment Vertical:	01 - Good	2	30
Alignment Horizontal:	01 - Good	3	0
Restrictions:	No	4	0
		5	0
		6	0
BRIDGE PHOTOS

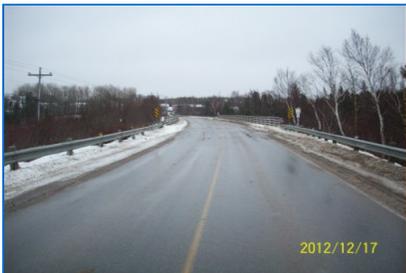
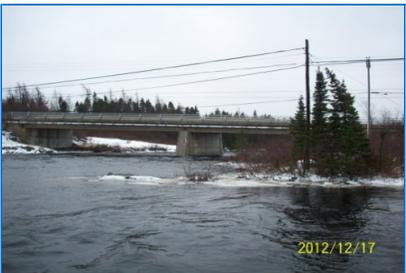
Comments:	Concrete abutments, center pier and wing walls. Medium cracking of abutments and wing walls with efflorescence, some large cracks and spalling on abutment one left side and right side near beam seat.. Staining of abutment walls from previously leaking joints. Erosion at waterline of center pier with a horizontal crack at the waterline. Elastomeric bearing pad are compressed and bulged. Abutment 2 Joint appears to be leaking. the top of center pier has a spall between Girders 5 and 6. There appears to be freshly spalled concrete beneath center pier icebreaker		
SUPERSTRUCTURE			
Condition:	F2 - Fair	Expansion Joints:	F2 - Fair
Comments:	6 AASHTO girders. Some light cracking. Three expansion joints with some minor abrasion damage. Medium cracking and efflorescence of soffit on span 1 and exposed rebar on soffit at left of span 2. Girder 1 has

longitudinal cracking and spalling on the lower flange. Pavement work is required adjacent to expansion joints to prevent further potholing.			
DECK			
Condition:	P3 - Poor	Curbs:	F1 - Fair
Hand Rail:	F2 - Fair	Roadway Condition:	F2 - Fair
Approach Rail:	F2 - Fair		
Comments:	Exposed concrete deck. Abrasion throughout, some delamination near curbs with 5-7 large pothole sections. Aluminum bridge rail with concrete endblocks. Cracking in curbs and sidewalks with some pop-outs from repairs. Asphalt approaches have cracking and pothole patching. The center of span 1 between girders 3 and 4 has signs of leakage through a web shape crack, efflorescence visible from beneath and a 30mm wide by 100mm long crack along the centerline is present on the driving surface. The concrete in the left side gutter is showing signs of concrete erosion.		
HYDROLOGY			
Water Velocity:	0.5 m/s	Ice Problem:	N - No Problem

Water Depth:	1-2.5 m	Scour Problem:	P - Possible Problem
Waterway:	01 - Adequate	Debris Problem:	N - No Problem
Comments:	Centre pier appears good from shoreline, but cannot be verified. Located on tidal area.		
REPLACEMENT/REHABILITATION			
Next Rehab. Date:		Replacement Year:	
Antic. Rehab. Cost:	\$70000	Replacement Cost:	\$0
Recommendations:	Repair approach asphalt, concrete deck and concrete surfaces.		
OBSERVATIONS			
Overall Condition:	F1 - Fair	Requires Further Inspection:	No
Additional Observations:
