| | GOVERNMENT OF NEWFOUNDLAND AND LABRADOR Department of Transportation and Infrastructure | BRIDGE INSPECTION REPORT B11202017-1 | |
| Date: 11/20/2017 | Inspected By: AB | Category: Eng. - Engineering | |
| Site: | TCH-020 - THORBURN LAKE CNR OVERPASS | | |

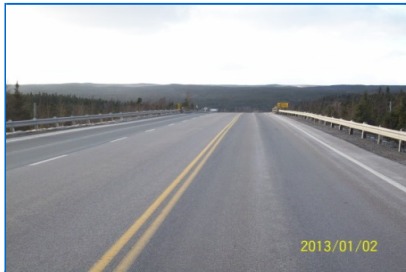
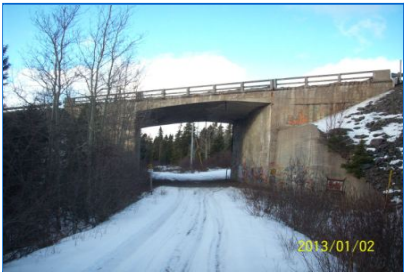
| Comments: | Abutments and wingwalls buried. were removed to at least 1000mm below subgrade depth. | | |

| Recommendations: | Bridge removed and replaced with 4140mm CS Multi-plate. Multi-plate installed and buried to within 3000mm of bridge in fall of 2016. Bridge removed, subgrade, granular and paving completed in mid November 2017. Project by J1 Contracting Ltd. | | |
