GOVERNMENT OF NEWFOUNDLAND AND LABRADOR Department of Transportation and Infrastructure	<b>BRIDGE INSPECTION REPORT</b> <b>B08082024-1</b>	
<b>Date:</b> 8/2/2024	<b>Inspected By:</b> D. Burns/B. Grandy	<b>Category:</b> Eng. - Engineering	
<b>BRIDGE INFORMATION</b>			
<b>Site:</b>	2-058 - TIDES BROOK BRIDGE		
<b>Route:</b>	222	<b>Overall Length:</b>	36 m
<b>Year Built:</b>	1975	<b>Est:</b> No	<b>Overall Width:</b> 10.5 m
<b>Year Last Rehab.:</b>		<b>Est:</b> No	<b>Roadway Width:</b> 9.5 m
<b>Region:</b>	CENTRAL EAST		<b>Sidewalk Width:</b> 0 m
<b>Jurisdiction:</b>	Provincial		<b>Clearance to R.D. or N.W.L.:</b> 2 m
<b>Type of Structure:</b>	01 - AASH to Girder		<b>Max Depth of N.W.L.:</b> 1.5 m
<b>Purpose of Structure:</b>	04 - Over Non-Navigable Waters	<b>Spans:</b>	
<b>Type of Handrail:</b>	01 - Aluminum Rail	<b>Span No.:</b>	<b>Length</b>
<b>Roadway Surface:</b>	01 - Concrete	1	25
<b>Alignment Vertical:</b>	01 - Good	2	0

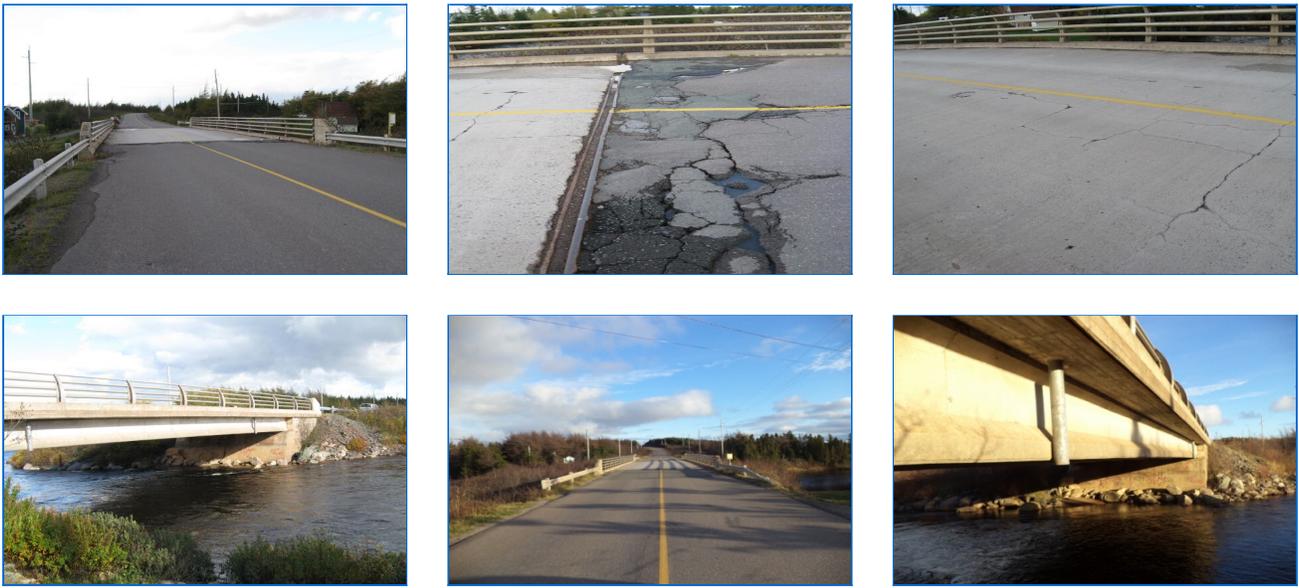
the southeast has wide cracking. - West abutment generally in fair condition. - Wingwalls generally in fair condition. - East bearing seat disintegrated on the northeast corner and has wide cracks on the southeast corner. - East bearings have severe cracks with expulsion of material, P3. West bearing too high for inspection. - All condition ratings for substructure based off east side. New inspection - All previous concerns persist. Wingwalls have visible cold joints.

<b>Condition:</b>	P3 - Poor	<b>Expansion Joints:</b>	P - Poor
<b>Comments:</b>	Previous inspection - Girders have isolated spalls to reinforcement, F1. - Deck soffit leaching efflorescence under and around the east side with large/severe spalls. Deck soffit also leaching efflorescence on the west side but has not visible spalling. Deck soffit otherwise in fair condition. - Expansion joints have broken seals and very severe damage to the armor plating. Several areas of the joint has been paved over. Joint no longer functioning as intended, Poor, P. Superstructure condition rating based on worst areas. New inspection - All previous concerns persist. Northeast girder ends are now spalling likely due to expansion joint condition.

<b>Condition:</b>	P1 - Poor	<b>Curbs:</b>	F1 - Fair
<b>Hand Rail:</b>	F1 - Fair	<b>Roadway Condition:</b>	P1 - Poor
<b>Approach Rail:</b>	F1 - Fair		
<b>Comments:</b>	Previous inspection - Approach asphalt has isolated severe alligator cracking with some small potholes near the expansion joints. - Exposed concrete deck has numerous wide cracks. On the east end, the deck is fractured into several loose square pieces, P1. - Curbs have severe disinsertion on the exteriors near the expansion joints. Roadway top and sides in fair condition. -Structure rail in fair condition. - Guiderail has several rotten posts. Rail is salvageable, connected to end blocks, but does not have regulation post spacing and is complete with hazard markers. - End blocks have moderate width map cracks throughout, P3. New inspection - All previous concerns persist. Approach potholes are now quite large and concrete wearing surface is cracking on west end as well. Expansion joints almost completely deteriorated.

<b>Overall Condition:</b>	P3 - Poor	<b>Requires Further Inspection:</b>	No
<b>Additional Observations:</b>	Bridge is in need of rehabilitation. Not much is new from previous inspection, although some concerns have become worse.

<b>Next Rehab. Date:</b>	2024	<b>Replacement Year:</b>	2040
<b>Antic. Rehab. Cost:</b>	\$250,000	<b>Replacement Cost:</b>	\$2,500,000
<b>Recommendations:</b>	- Seal all concrete cracks in the bridge deck and replace the east side (possibly full depth). - Consider end block replacement. - Repair curbs around the expansion joints. - Seal cracks in the abutments. - Repair spalls to girders. - Repair corners of abutments. - Remove overgrowth from guiderail area. Replace guiderail and install with new standards. - Replace expansion joints. - Waterproof and pave structure if capacity exists. - Remove all gravels from the bridge deck. - Consider bearing replacement.
