GOVERNMENT OF NEWFOUNDLAND AND LABRADOR Department of Transportation and Infrastructure	<b>BRIDGE INSPECTION REPORT</b> <b>B09052023-6</b>	
<b>Date:</b> 8/28/2023	<b>Inspected By:</b> Darrell Avery	<b>Category:</b> Eng. - Engineering	
<b>BRIDGE INFORMATION</b>			
<b>Site:</b>	2-095 - TROUT BROOK BRIDGE (BELLVUE)		
<b>Route:</b>	201	<b>Overall Length:</b>	27.5 m
<b>Year Built:</b>	1990	<b>Est:</b> No	<b>Overall Width:</b> 14 m
<b>Year Last Rehab.:</b>		<b>Est:</b> No	<b>Roadway Width:</b> 8 m
<b>Region:</b>	CENTRAL EAST		<b>Sidewalk Width:</b> 0 m
<b>Jurisdiction:</b>	Provincial		<b>Clearance to R.D. or N.W.L.:</b> 6 m
<b>Type of Structure:</b>	04 - Rigid Frame		<b>Max Depth of N.W.L.:</b> 1 m
<b>Purpose of Structure:</b>	04 - Over Non-Navigable Waters		<b>Spans:</b>
<b>Type of Handrail:</b>	06 - None	<b>Span No.:</b>	<b>Length</b>
<b>Roadway Surface:</b>	02 - Asphalt	1	12.4
<b>Alignment Vertical:</b>	01 - Good	2	0

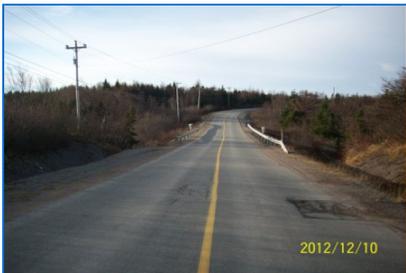
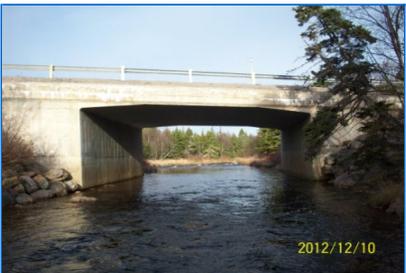
<b>SUBSTRUCTURE</b>			
<b>Condition:</b>	F2 - Fair	<b>Bearings:</b>	I - Inapplicable
		<b>Bearing Seat:</b>	I - Inapplicable
<b>Comments:</b>	Previous inspection - Concrete abutments and wing walls. Medium cracking with efflorescence throughout abutments and wing walls.		
<b>SUPERSTRUCTURE</b>			
<b>Condition:</b>	F2 - Fair	<b>Expansion Joints:</b>	I - Inapplicable
<b>Comments:</b>	Previous inspection - Light to medium cracking of the soffit with efflorescence and active wet areas. Medium map cracking and longitudinal cracking of parapet wall with significant efflorescence. Efflorescence also present on underside of deck. Soffit on Abutment 2, right is starting to chip away. New inspection - Continued efflorescence in U/S cracks on both sides of structure frame.		
<b>DECK</b>

<b>Condition:</b>	F2 - Fair	<b>Curbs:</b>	I - Inapplicable
<b>Hand Rail:</b>	I - Inapplicable	<b>Roadway Condition:</b>	F2 - Fair
<b>Approach Rail:</b>	F2 - Fair		
<b>Comments:</b>	Previous inspection - Rigid frame structure with approximately 1.5 metres of fill. Flex beam guide rail both sides with a few broken posts. Object markers abutment one and two, left are missing, and abutment 1 right. Shoulder washed out under guiderail on right side. New inspection - continued deterioration at end of parapet walls - thick spalling at approach right.		
<b>HYDROLOGY</b>			
<b>Water Velocity:</b>	0.5 m/s	<b>Ice Problem:</b>	N - No Problem
<b>Water Depth:</b>	1 m	<b>Scour Problem:</b>	N - No Problem
<b>Waterway:</b>	01 - Adequate	<b>Debris Problem:</b>	N - No Problem
<b>Comments:</b>	Previous inspection - Abutment one, left and right, slope protection adjacent to wing walls is undermined and fallen into brook.

<b>REPLACEMENT/REHABILITATION</b>			
<b>Next Rehab. Date:</b>		<b>Replacement Year:</b>	
<b>Antic. Rehab. Cost:</b>	\$tbd	<b>Replacement Cost:</b>	\$tbd
<b>Recommendations:</b>	Repair guide rail posts. Replace missing object markers. Place rip-rap at Abutment one. Repair washout under right side guiderail. Concrete repairs		
<b>OBSERVATIONS</b>			
<b>Overall Condition:</b>	F2 - Fair	<b>Requires Further Inspection:</b>	No
<b>Additional Observations:</b>
