GOVERNMENT OF NEWFOUNDLAND AND LABRADOR Department of Transportation and Infrastructure	BRIDGE INSPECTION REPORT B05292020-20	
Date: 5/29/2020	Inspected By: AB	Category: Eng. - Engineering	
BRIDGE INFORMATION			
Site:	2-095 - TROUT BROOK BRIDGE (BELLVUE)		
Route:	201	Overall Length:	27.5 m
Year Built:	1990	Est: No	Overall Width: 14 m
Year Last Rehab.:		Est: No	Roadway Width: 8 m
Region:	CENTRAL EAST	Sidewalk Width:	0 m
Jurisdiction:	Provincial	Clearance to R.D. or N.W.L.:	6 m
Type of Structure:	04 - Rigid Frame	Max Depth of N.W.L.:	1 m
Purpose of Structure:	04 - Over Non-Navigable Waters		
Type of Handrail:	06 - None	Spans:	
Roadway Surface:	02 - Asphalt	<u>Span No.:</u>	<u>Length</u>
Alignment Vertical:	01 - Good	1	12.4
Alignment Horizontal:	01 - Good	2	0
Restrictions:	No	3	0
		<u>Span No.:</u>	<u>Length</u>
		4	0
		5	0
		6	0
BRIDGE PHOTOS

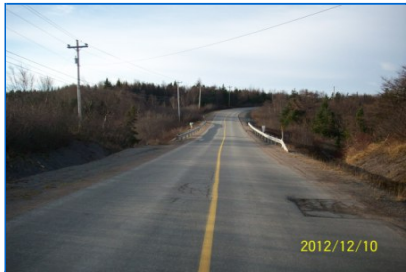
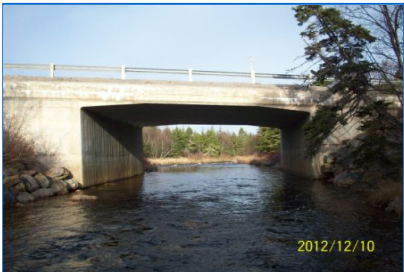
Bearing Seat:	I - Inapplicable
Comments:	Concrete abutments and wing walls. Medium cracking with efflorescence throughout abutments and wing walls. Scour checked in 2020. None present		
SUPERSTRUCTURE			
Condition:	F2 - Fair	Expansion Joints:	I - Inapplicable
Comments:	Light to medium cracking of the soffit with efflorescence and active wet areas. Medium map cracking and longitudinal cracking of parapet wall with significant efflorescence. Efflorescence also present on underside of deck. Soffit on Abutment 2, right is starting to chip away.		
DECK			
Condition:	F2 - Fair	Curbs:	I - Inapplicable

Hand Rail:	I - Inapplicable	Roadway Condition:	I - Inapplicable
Approach Rail:	F2 - Fair		
Comments:	Rigid frame structure with approximately 1.5 metres of fill. Flex beam guide rail both sides with a few broken posts. Object markers abutment one and two, left are missing. and abutment 1 right. Shoulder washed out under guiderail on right side.

Water Velocity:	0.5 m/s	Ice Problem:	N - No Problem
Water Depth:	1 m	Scour Problem:	N - No Problem
Waterway:	01 - Adequate	Debris Problem:	N - No Problem
Comments:	Abutment one, left and right, slope protection adjacent to wing walls is undermined and fallen into brook.

Next Rehab. Date:		Replacement Year:	
Antic. Rehab. Cost:	\$0	Replacement Cost:	\$0
Recommendations:	Repair guide rail posts. Replace missing object markers. Place rip-rap at Abutment one. Repair washout under right side guiderail.
