GOVERNMENT OF NEWFOUNDLAND AND LABRADOR Department of Transportation and Infrastructure	BRIDGE INSPECTION REPORT B12102021-2	
Date: 10/30/2021	Inspected By: Mike Button	Category: Office - Bridge Office	
BRIDGE INFORMATION			
Site:	5-028 - UPPER BROOK BRIDGE		
Route:	500	Overall Length:	29 m
Year Built:	1982	Est: No	Overall Width: 12.3 m
Year Last Rehab.:		Est: No	Roadway Width: 10.5 m
Region:	LABRADOR	Sidewalk Width:	0 m
Jurisdiction:	Provincial	Clearance to R.D. or N.W.L.:	2.7 m
Type of Structure:	01 - AASH to Girder	Max Depth of N.W.L.:	0.6 m
Purpose of Structure:	04 - Over Non-Navigable Waters		
Type of Handrail:	01 - Aluminum Rail	Spans:	
Roadway Surface:	01 - Concrete	<u>Span No.:</u>	<u>Length</u>
Alignment Vertical:	01 - Good	1	16
Alignment Horizontal:	01 - Good	2	0
Restrictions:	No	3	0
		<u>Span No.:</u>	<u>Length</u>
		4	0
		5	0
		6	0
BRIDGE PHOTOS

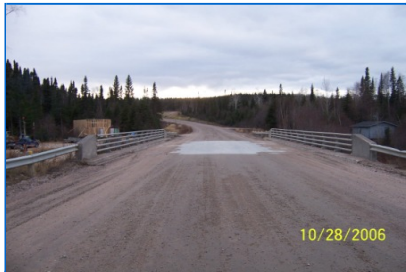
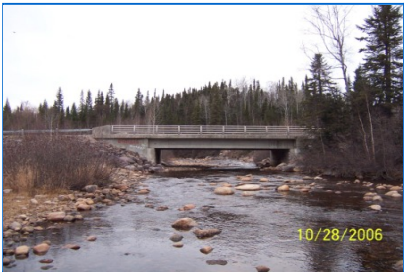
Bearing Seat:	G - Good
Comments:	- Abutments, and wingwalls in good condition overall. Some mild efflorescence on abutment exterior back wall corners under the curb expansion joint area due to concrete missing above. Bearings un-inspectable but assumed to be in fair condition. Bearing seat exterior edges in good condition, interior hidden by diaphragms.		
SUPERSTRUCTURE			
Condition:	G - Good	Expansion Joints:	P3 - Poor
Comments:	- Expansion joints are heavily damaged. Sections of the steel embed have been torn away, seals are torn and curb plates are exposed and bent. No chaulking on curb exteriors. - Girders, bottom of deck, soffit and fascia in good condition.		
DECK

Condition:	F2 - Fair	Curbs:	P3 - Poor
Hand Rail:	F2 - Fair	Roadway Condition:	F2 - Fair
Approach Rail:	F1 - Fair		
Comments:	- Approach/exit rails have some damage rail sections with several damaged/heavily spilt posts, are butt joined to the ends of the end blocks, complete with hazard markers and do not have collision dampening posts. - End blocks in fair condition. - Curbs have relatively large spalls around the expansion joint areas, P3. - Handrails have minor dents/scrapes throughout. Northwest corner is torn from the flyer, P3 - Deck not paved. Numerous sections of rust staining on the deck surface indicating rebar is just below or at the surface. Aggregate colors visible across the deck. - Approach asphalt is in good condition but is heavily patched at the tie in to the expansion joints. - No deck drains.

Next Rehab. Date:	2024	Replacement Year:	2050
Antic. Rehab. Cost:	\$45,000	Replacement Cost:	\$1,800,000
Recommendations:	- Replace guiderail and posts as required. Replace expansion joints. Repair curb concrete and re-chalk. Replace/reposition riprap on upstream corners.
