GOVERNMENT OF NEWFOUNDLAND AND LABRADOR Department of Transportation and Infrastructure	BRIDGE INSPECTION REPORT B12122022-3	
Date: 10/20/2022	Inspected By: M Button	Category: Office - Bridge Office	
BRIDGE INFORMATION			
Site:	5-025 - WABUSH NARROWS BRIDGE		
Route:		Overall Length:	41.6 m
Year Built:	1996	Est: No	Overall Width: 12.2 m
Year Last Rehab.:		Est: No	Roadway Width: 9.9 m
Region:	LABRADOR		Sidewalk Width: 1.1 m
Jurisdiction:	Provincial		Clearance to R.D. or N.W.L.: 6.6 m
Type of Structure:	08 - Steel Bridge		Max Depth of N.W.L.: 2.5 m
Purpose of Structure:	03 - Over Navigable Waters		Spans:
Type of Handrail:	01 - Aluminum Rail		Span No.: Length Span No.: Length
Roadway Surface:	01 - Concrete	1	28 4 0
Alignment Vertical:	01 - Good	2	0 5 0
Alignment Horizontal:	01 - Good	3	0 6 0
Restrictions:	No		
BRIDGE PHOTOS			
<div style="display: flex; justify-content: space-around;">

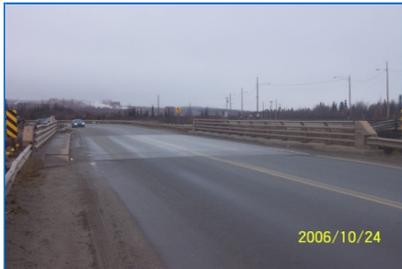
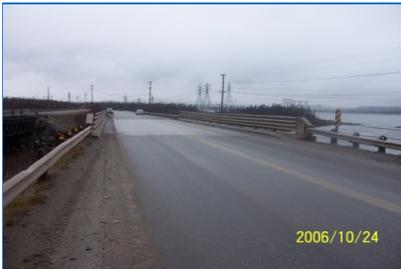
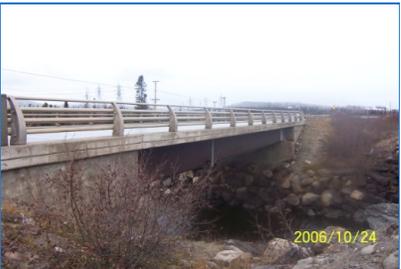
SUBSTRUCTURE			
Condition:	F2 - Fair	Bearings:	F1 - Fair
		Bearing Seat:	F1 - Fair
Comments:	- Thin surface repairs to abutments delaminated. Abutments covered in graffiti but no notable defects. - Wingwalls in fair condition. - Bearing seat in good condition with some rust staining from steel girders. - Bearings in fair condition with light cracking. Several bearings not in full contact with the bearing seat due to uneven concrete finish.		
SUPERSTRUCTURE			
Condition:	F1 - Fair	Expansion Joints:	P1 - Poor
Comments:	- Girders in good condition. Bearing plates have moderate corrosion. Patina formed over sections not painted. On the north side, steel delamination visible on the bottom flange of some girders. - Deck soffit in good condition. - Expansion joints visibly leaking and causing corrosion to the bearing plates on the bottom of the steel girders.		
DECK

Condition:	F1 - Fair	Curbs:	P3 - Poor
Hand Rail:	P3 - Poor	Roadway Condition:	P3 - Poor
Approach Rail:	F1 - Fair		
Comments:	- Asphalt is rutted on approaches with some isolated potholes. - Exposed concrete deck has potholes/spalls exposing reinforcement. Moderate surface (cover loss) expected from surface wear. All aggregates exposed and cover in areas of potholing/spalls is minimal. - Sidewalk on southwest corner has a large ridge causing a tripping hazard. Curb and sidewalk otherwise in fair condition. - Deck drains partially filled with gravels. - Structure rail has numerous damaged rails, P3. - Guiderail posts are undermining on southwest corner from slope erosion, flex rail in fair condition. Rail connected to end blocks but does not have regulation post spacing. - End blocks have hairline map cracks.

Next Rehab. Date:	2026	Replacement Year:	2050
Antic. Rehab. Cost:	\$225,000	Replacement Cost:	\$3,500,000
Recommendations:	- Replace 1 hazard marker. - Upgrade post spacing at end block connection. Repair erosion around guiderail posts. - Install run off ditches at structure corners. - Upgrade structure rail to steel rail system. - Repair potholes in exposed concrete deck. - Waterproof and pave structure if capacity exists. - Replace expansion joints. - Complete various concrete repairs. - Clean bridge deck from all gravels and clean deck drains. - Blast clean and re-paint girder bearing plates. - Remove tripping hazard/ridge from southwest side of sidewalk.
