GOVERNMENT OF NEWFOUNDLAND AND LABRADOR Department of Transportation and Infrastructure	<b>BRIDGE INSPECTION REPORT</b> <b>B01222021-2</b>	
<b>Date:</b> 1/21/2021	<b>Inspected By:</b> Mike Fleming	<b>Category:</b> Eng. - Engineering	
<b>BRIDGE INFORMATION</b>			
<b>Site:</b>	4-143 - BIGFALLS BRIDGE		
<b>Route:</b>	422	<b>Overall Length:</b>	52 m
<b>Year Built:</b>	1985	<b>Est: Yes</b>	<b>Overall Width:</b> 6 m
<b>Year Last Rehab.:</b>		<b>Est: No</b>	<b>Roadway Width:</b> 4.1 m
<b>Region:</b>	WEST COAST/NORTHERN		<b>Sidewalk Width:</b> 0 m
<b>Jurisdiction:</b>	Provincial	<b>Clearance to R.D. or N.W.L.:</b>	9.2 m
<b>Type of Structure:</b>	09 - Bailey Bridge	<b>Max Depth of N.W.L.:</b>	0.2 m
<b>Purpose of Structure:</b>	03 - Over Navigable Waters		
<b>Type of Handrail:</b>	04 - Steel Rail	<b>Spans:</b>	
<b>Roadway Surface:</b>	03 - Timber	<u>Span No.:</u>	<u>Length</u>
<b>Alignment Vertical:</b>	01 - Good	1	18.2

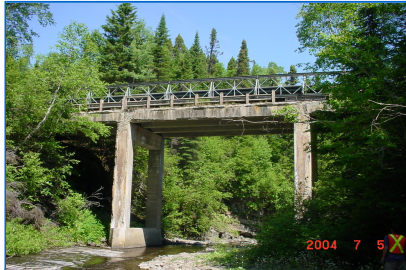
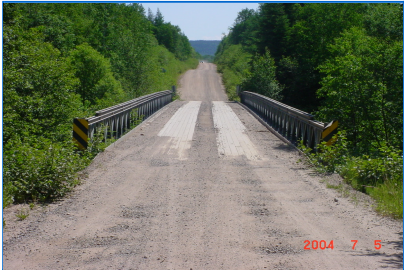
<b>SUBSTRUCTURE</b>			
<b>Condition:</b>	P3 - Poor	<b>Bearings:</b>	G - Good
		<b>Bearing Seat:</b>	G - Good
<b>Comments:</b>	Moderate to Heavy efflorescence deposits throughout substructure, columns starting to deteriorate, exposed and moderately corroded rebar.		
<b>SUPERSTRUCTURE</b>			
<b>Condition:</b>	G - Good	<b>Expansion Joints:</b>	I - Inapplicable
<b>Comments:</b>			
<b>DECK</b>			
<b>Condition:</b>	G - Good	<b>Curbs:</b>	G - Good
<b>Hand Rail:</b>	I - Inapplicable	<b>Roadway Condition:</b>	G - Good
