GOVERNMENT OF NEWFOUNDLAND AND LABRADOR Department of Transportation and Infrastructure	BRIDGE INSPECTION REPORT B01052021-5																	
Date: 4/23/2020	Inspected By: Terrance Coates	Category: Eng. - Engineering																	
BRIDGE INFORMATION																			
Site:	4-068 - BLACK DUCK BROOK BRIDGE																		
Route:		Overall Length:	18.8 m																
Year Built:	1966	Est: No	Overall Width: 9.1 m																
Year Last Rehab.:	1988	Est: No	Roadway Width: 8.1 m																
Region:	WEST COAST/NORTHERN		Sidewalk Width: 0 m																
Jurisdiction:	Provincial	Clearance to R.D. or N.W.L.:	1.9 m																
Type of Structure:	03 - Reinforced Concrete Beam/Slab		Max Depth of N.W.L.: 0.5 m																
Purpose of Structure:	03 - Over Navigable Waters		Spans:																
Type of Handrail:	01 - Aluminum Rail

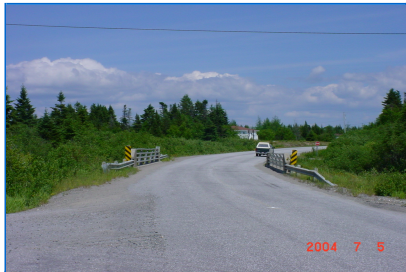
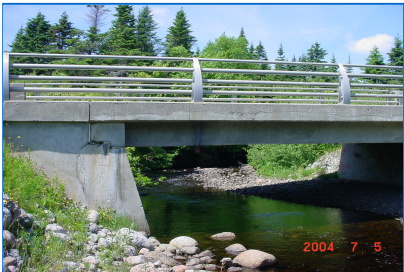
SUBSTRUCTURE																			
Condition:	G - Good	Bearings:	G - Good																
		Bearing Seat:	F2 - Fair																
Comments:	Minor scour and undermining on the west abutment footing. Abutment walls require some latex repairs. Bearing seats have some deterioration.																		
SUPERSTRUCTURE																			
Condition:	G - Good	Expansion Joints:	I - Inapplicable																
Comments:	No mechanical joint.																		
DECK																			
Condition:	F2 - Fair	Curbs:	G - Good																
Hand Rail:	F2 - Fair	Roadway Condition:	G - Good

Approach Rail:	P1 - Poor		
Comments:	Snow plow damage to aluminum handrail. Approach rail needs to be replaced. Deck drains are deteriorated and need to be replaced. Some minor deck repairs done in 2019 with a quikrete product that was not approved. Deck was then repaved.		
HYDROLOGY			
Water Velocity:	0 m/s	Ice Problem:	K - Known Problem
Water Depth:	0 m	Scour Problem:	K - Known Problem
Waterway:	01 - Adequate	Debris Problem:	K - Known Problem
Comments:			
REPLACEMENT/REHABILITATION			
Next Rehab. Date:	2021	Replacement Year:	2021
Antic. Rehab. Cost:	\$0	Replacement Cost:	\$0
Recommendations:	Replace approach rail. Repair aluminum handrail. Replace signage. Latex repairs to bearing seats.		
OBSERVATIONS			
Overall Condition:	F2 - Fair	Requires Further Inspection:	No
Additional Observations:			
LEGEND:			
Condition Definitions:		Problem Definitions:	
1 - *Good - [discontinued code].	F2 - Fair.	C - Unsafe (Closed to Public).	N - No Problem.
