GOVERNMENT OF NEWFOUNDLAND AND LABRADOR Department of Transportation and Infrastructure	BRIDGE INSPECTION REPORT B12042023-1	
Date: 11/3/2022	Inspected By: M Button	Category: Office - Bridge Office	
BRIDGE INFORMATION			
Site:	4-149 - BURNT POND BROOK BRIDGE		
Route:		Overall Length:	46.7 m
Year Built:	1978	Est: No	Overall Width: 10.5 m
Year Last Rehab.:		Est: No	Roadway Width: 9.3 m
Region:	WEST COAST/NORTHERN	Sidewalk Width:	0 m
Jurisdiction:	Provincial	Clearance to R.D. or N.W.L.:	4.3 m
Type of Structure:	01 - AASH to Girder	Max Depth of N.W.L.:	0.5 m
Purpose of Structure:	03 - Over Navigable Waters	Spans:	
Type of Handrail:	01 - Aluminum Rail	Span No.:	Length
Roadway Surface:	01 - Concrete	Span No.:	Length
Alignment Vertical:	01 - Good	1	31.1
Alignment Horizontal:	01 - Good	2	0
Restrictions:	No	3	0
		4	0
		5	0
		6	0
BRIDGE PHOTOS

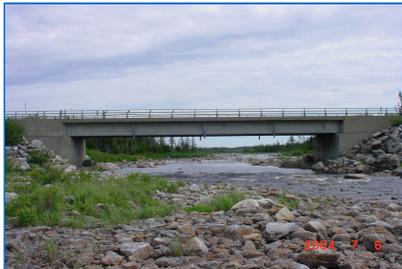
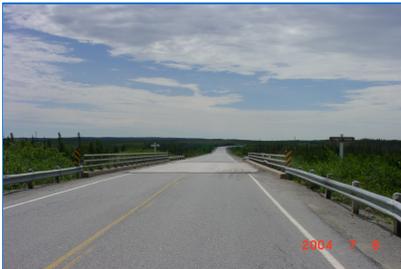
Additional Observations: - Bridge overall in fair condition with several P1 & P3 areas indicated above.
