GOVERNMENT OF NEWFOUNDLAND AND LABRADOR Department of Transportation and Infrastructure	<b>BRIDGE INSPECTION REPORT</b> <b>B09202024-1</b>	
<b>Date:</b> 9/20/2024	<b>Inspected By:</b> L Christensen	<b>Category:</b> Office - Bridge Office	
<b>BRIDGE INFORMATION</b>			
<b>Site:</b>	1-155 - BROAD COVE BROOK BRIDGE NO. 1		
<b>Route:</b>		<b>Overall Length:</b>	12 m
<b>Year Built:</b>	1965	<b>Est: Yes</b>	<b>Overall Width:</b> 7.9 m
<b>Year Last Rehab.:</b>		<b>Est: No</b>	<b>Roadway Width:</b> 7.3 m
<b>Region:</b>	AVALON PENINSULA	<b>Sidewalk Width:</b>	0 m
<b>Jurisdiction:</b>	Provincial	<b>Clearance to R.D. or N.W.L.:</b>	1.7 m
<b>Type of Structure:</b>	03 - Reinforced Concrete Beam/Slab	<b>Max Depth of N.W.L.:</b>	0.3 m
<b>Purpose of Structure:</b>	04 - Over Non-Navigable Waters	<b>Spans:</b>	
<b>Type of Handrail:</b>	02 - Concrete Rail	<u>Span No.:</u>	<u>Length</u>
<b>Roadway Surface:</b>	02 - Asphalt	1	8

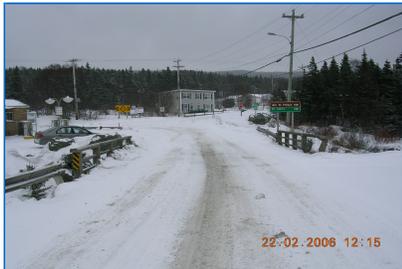
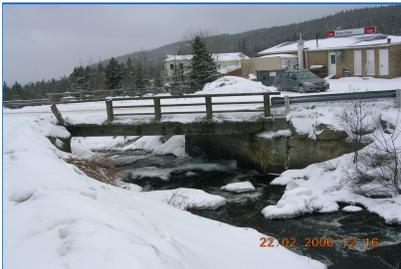
<b>SUBSTRUCTURE</b>			
<b>Condition:</b>	P1 - Poor	<b>Bearings:</b>	U - Uninspectable
		<b>Bearing Seat:</b>	U - Uninspectable
<b>Comments:</b>	Similar condition to 2023 inspection. Extreme scour under east abutment. Abutment seems to be resting on bedrock at either side of the deep scour, with a vertical crack in abutment above scour area. Minor scour on east abutment. Exposed bearing seat at ends has minor concrete deterioration. Exterior corners of both abutments and 3/4 wing walls have large areas of scaling exposing river rocks in concrete.		
<b>SUPERSTRUCTURE</b>			
<b>Condition:</b>	P1 - Poor	<b>Expansion Joints:</b>	I - Inapplicable
<b>Comments:</b>	Similar condition to 2023 inspection. Exterior soffit on both sides has severe concrete deterioration exposing reinforcement and hand rail J-bars. Interior deck soffit in F1 condition. Interior beams in F1 condition, exterior beam in P1/P3 condition. Large longitudinal cracking and exposed reinforcement on both exterior beams.

<b>Condition:</b>	P1 - Poor	<b>Curbs:</b>	I - Inapplicable
<b>Hand Rail:</b>	P1 - Poor	<b>Roadway Condition:</b>	P3 - Poor
<b>Approach Rail:</b>	P1 - Poor		
<b>Comments:</b>	Hand rail and approach rails in poor condition and have very limited impact force resistance. Rot in approach rail posts and some custom rail material used between approach rail and hand rail. Two potholes in the road are most likely from erosion undermining of road. Monitoring required for additional erosion undermining. Downstream side of road on west side has severe erosion next to the roadway with a large hole that is undermining the outside of the roadway. This causes a safety concern.

<b>Water Velocity:</b>	0 m/s	<b>Ice Problem:</b>	N - No Problem
<b>Water Depth:</b>	0 m	<b>Scour Problem:</b>	K - Known Problem
<b>Waterway:</b>	02 - InAdequate	<b>Debris Problem:</b>	N - No Problem
<b>Comments:</b>	Extreme scour under east abutment. Flow is not centered under bridge cause increased scour at east abutment.

<b>Overall Condition:</b>	P1 - Poor	<b>Requires Further Inspection:</b>	Yes
<b>Additional Observations:</b>	Replacement required. Monitor extreme scour, soffit facia deterioration and possible road undermining causing potholes.
