GOVERNMENT OF NEWFOUNDLAND AND LABRADOR Department of Transportation and Infrastructure	<b>BRIDGE INSPECTION REPORT</b> <b>B01192021-11</b>	
<b>Date:</b> 5/22/2020	<b>Inspected By:</b> Mike Fleming	<b>Category:</b> Eng. - Engineering	
<b>BRIDGE INFORMATION</b>			
<b>Site:</b>	TCH-068 - CORNER BROOK STREAM BRIDGE #1		
<b>Route:</b>		<b>Overall Length:</b>	26.6 m
<b>Year Built:</b>	1969	<b>Est:</b> No	<b>Overall Width:</b> 13.9 m
<b>Year Last Rehab.:</b>		<b>Est:</b> No	<b>Roadway Width:</b> 12.3 m
<b>Region:</b>	WEST COAST/NORTHERN	<b>Sidewalk Width:</b>	0 m
<b>Jurisdiction:</b>	Provincial	<b>Clearance to R.D. or N.W.L.:</b>	2.5 m
<b>Type of Structure:</b>	03 - Reinforced Concrete Beam/Slab	<b>Max Depth of N.W.L.:</b>	1.1 m
<b>Purpose of Structure:</b>	03 - Over Navigable Waters	<b>Spans:</b>	
<b>Type of Handrail:</b>	04 - Steel Rail	<u>Span No.:</u>	<u>Length</u>
<b>Roadway Surface:</b>	02 - Asphalt	1	22.3

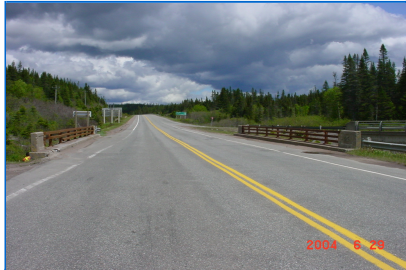
<b>SUBSTRUCTURE</b>			
<b>Condition:</b>	F2 - Fair	<b>Bearings:</b>	F2 - Fair
		<b>Bearing Seat:</b>	F2 - Fair
<b>Comments:</b>	Minor cracking throughout abutment walls and wingwalls.		
<b>SUPERSTRUCTURE</b>			
<b>Condition:</b>	F2 - Fair	<b>Expansion Joints:</b>	F2 - Fair
<b>Comments:</b>	Moderate delamination and staining on exterior girders; Moderate longitudinal cracking along original interior girders; Minor spalling and staining on fascia, minor corrosion to exposed reinforcement.		
<b>DECK</b>			
<b>Condition:</b>	G - Good	<b>Curbs:</b>	G - Good
<b>Hand Rail:</b>	G - Good	<b>Roadway Condition:</b>	G - Good
