GOVERNMENT OF NEWFOUNDLAND AND LABRADOR Department of Transportation and Infrastructure	<b>BRIDGE INSPECTION REPORT</b> <b>B08302022-1</b>	
<b>Date:</b> 7/28/2022	<b>Inspected By:</b> M Button	<b>Category:</b> Office - Bridge Office	
<b>BRIDGE INFORMATION</b>			
<b>Site:</b>	TCH-068 - CORNER BROOK STREAM BRIDGE EASTBOUND		
<b>Route:</b>	1	<b>Overall Length:</b>	26.6 m
<b>Year Built:</b>	1969	<b>Est: No</b>	<b>Overall Width:</b> 13.9 m
<b>Year Last Rehab.:</b>		<b>Est: No</b>	<b>Roadway Width:</b> 12.3 m
<b>Region:</b>	WEST COAST/NORTHERN	<b>Sidewalk Width:</b>	0 m
<b>Jurisdiction:</b>	Provincial	<b>Clearance to R.D. or N.W.L.:</b>	2.5 m
<b>Type of Structure:</b>	03 - Reinforced Concrete Beam/Slab	<b>Max Depth of N.W.L.:</b>	1.1 m
<b>Purpose of Structure:</b>	03 - Over Navigable Waters	<b>Spans:</b>	
<b>Type of Handrail:</b>	04 - Steel Rail	<u>Span No.:</u>	<u>Length</u>
<b>Roadway Surface:</b>	02 - Asphalt	1	22.3

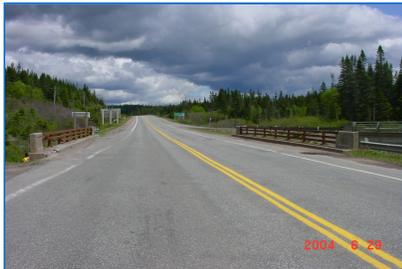
<b>SUPERSTRUCTURE</b>			
<b>Condition:</b>	F1 - Fair	<b>Expansion Joints:</b>	F1 - Fair
<b>Comments:</b>	- Upstream exterior post tensioned girder has a large spall to the bottom flange exposing reinforcement, P3. - Downstream exterior post tension girder has moderate weather with various rust stains from deck fascia spalls

above. - Newer concrete deck soffit in good condition. Downstream exterior deck fascia has various spalls to reinforcement causing staining to exterior girder below, P3. - Exterior original rectangular concrete beams near total disintegration with numerous layers of reinforcing steel exposed, P. Newer post tensioned girders appear to have be deliberately placed directly adjacent to the poor condition original beams. New girders suspected to be taking all load. - Original concrete deck soffit has various areas of delaminations and spalls but otherwise in fair condition. - Deck soffit joint between old and new deck (extension) not visible due to lost formwork. - Expansion joints paved over. No chaulking on curb expansion gaps.

<b>Next Rehab. Date:</b>	2026	<b>Replacement Year:</b>	2040
<b>Antic. Rehab. Cost:</b>	\$100,000	<b>Replacement Cost:</b>	\$0
<b>Recommendations:</b>	- Complete various concrete repairs. - Bridge covered in gravels, clean the bridge. - Clean bearing beats on extension. - Install hazard markers. - Chaulk curb expansion gaps.

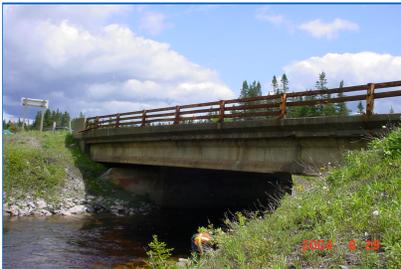
<b>SUBSTRUCTURE</b>			
<b>Condition:</b>	F1 - Fair	<b>Bearings:</b>	U - Uninspectable
		<b>Bearing Seat:</b>	U - Uninspectable
<b>Comments:</b>	- Original abutments in fair condition with various full length cold joints. - Original wingwall have tops demolished to allow for post tension concrete girders. Faces have moderate to severe disintegration and cold joints. Northwest original wingwall has separated from original abutment. - Original structure does not have a visible bearing seat or bearings. - New abutments not inspected as the area is very difficult to access (must climb over top of old wingwalls and between girders). Concrete viewed from a distance only. Some narrow cracking with efflorescence was observed. - Bearing or bearing seat not inspectable. A lot of gravel build up on exterior upstream and downstream bearing seats. - New exterior wingwalls in fair condition.
