GOVERNMENT OF NEWFOUNDLAND AND LABRADOR Department of Transportation and Infrastructure	<b>BRIDGE INSPECTION REPORT</b> <b>B01192021-1</b>	
<b>Date:</b> 5/19/2020	<b>Inspected By:</b> Terrance Coates	<b>Category:</b> Eng. - Engineering	
<b>BRIDGE INFORMATION</b>			
<b>Site:</b>	TCH-057 - CROOKED FEEDER BRIDGE		
<b>Route:</b>		<b>Overall Length:</b>	18.7 m
<b>Year Built:</b>	1965	<b>Est:</b> No	<b>Overall Width:</b> 14.3 m
<b>Year Last Rehab.:</b>	1990	<b>Est:</b> No	<b>Roadway Width:</b> 12.5 m
<b>Region:</b>	WEST COAST/NORTHERN		<b>Sidewalk Width:</b> 0 m
<b>Jurisdiction:</b>	Federal	<b>Clearance to R.D. or N.W.L.:</b>	2.1 m
<b>Type of Structure:</b>	02 - Double Tee	<b>Max Depth of N.W.L.:</b>	0.4 m
<b>Purpose of Structure:</b>	03 - Over Navigable Waters	<b>Spans:</b>	
<b>Type of Handrail:</b>	01 - Aluminum Rail	<u>Span No.:</u>	<u>Length</u>
<b>Roadway Surface:</b>	02 - Asphalt	<u>Span No.:</u>	<u>Length</u>

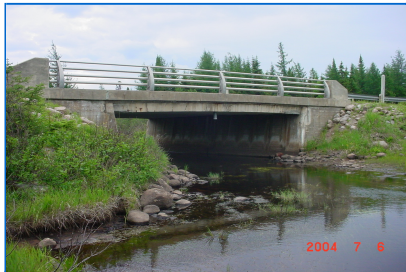
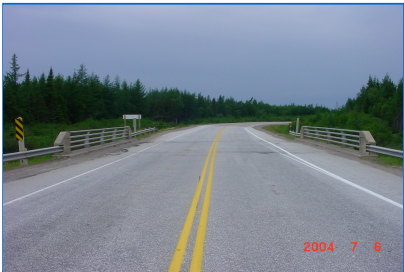
<b>SUBSTRUCTURE</b>			
<b>Condition:</b>	P1 - Poor	<b>Bearings:</b>	I - Inapplicable
		<b>Bearing Seat:</b>	F2 - Fair
<b>Comments:</b>	Abutment and wing wall concrete deteriorated. Corners severely deteriorated with exposed rebar corroding. Efflorescence on abutment and wing walls.		
<b>SUPERSTRUCTURE</b>			
<b>Condition:</b>	P3 - Poor	<b>Expansion Joints:</b>	I - Inapplicable
<b>Comments:</b>	Exterior double-T girders on upstream and downstream have deterioration with bottom cable exposed and strands of the cable rusted through.		
<b>DECK</b>			
<b>Condition:</b>	G - Good	<b>Curbs:</b>	G - Good

<b>Hand Rail:</b>	G - Good	<b>Roadway Condition:</b>	G - Good
<b>Approach Rail:</b>	G - Good		
<b>Comments:</b>	Old deck drains that were plugged have leaked causing spalling, deterioration, and exposed rebar on underside of double-T girders. Asphalt is cracking at each end of the deck with more extensive deterioration on the west end of the deck (large potholes).

<b>Next Rehab. Date:</b>	2021	<b>Replacement Year:</b>	2021
<b>Antic. Rehab. Cost:</b>	\$0	<b>Replacement Cost:</b>	\$0
<b>Recommendations:</b>	Remove winter sand build-up along curbs. Latex concrete repairs to abutments, wing walls, and double-T girders. Minor curb resurfacing repairs. Repave deck and approaches. Remove beaver dam on upstream side of bridge.
