GOVERNMENT OF NEWFOUNDLAND AND LABRADOR Department of Transportation and Infrastructure	BRIDGE INSPECTION REPORT B02132023-8	
Date: 5/9/2022	Inspected By: Mike Fleming	Category: Eng. - Engineering	
BRIDGE INFORMATION			
Site:	TCH-060 - DEER LAKE TAILRACE BRIDGE (HINTON)		
Route:		Overall Length:	108.1 m
Year Built:	1955	Est: No	Overall Width: 9.9 m
Year Last Rehab.:	1987	Est: No	Roadway Width: 7.3 m
Region:	WEST COAST/NORTHERN		Sidewalk Width: 1.26 m
Jurisdiction:	Provincial		Clearance to R.D. or N.W.L.: 5 m
Type of Structure:	01 - AASH to Girder		Max Depth of N.W.L.: 4 m
Purpose of Structure:	04 - Over Non-Navigable Waters		Spans:
Type of Handrail:	01 - Aluminum Rail		<u>Span No.:</u> <u>Length</u> <u>Span No.:</u> <u>Length</u>
Roadway Surface:	02 - Asphalt		1 31.43 4 0
Alignment Vertical:	01 - Good		2 31.58 5 0
Alignment Horizontal:	01 - Good		3 31.52 6 0
Restrictions:	No		
BRIDGE PHOTOS

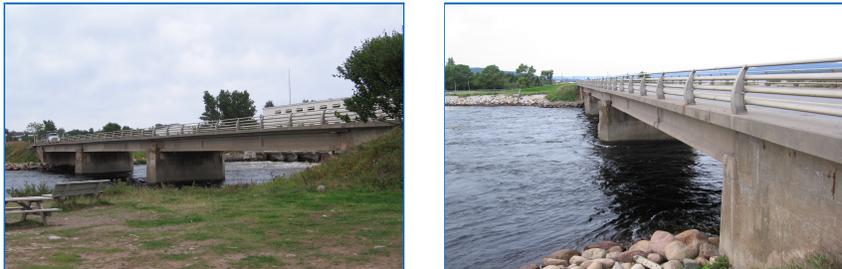
Condition:	P3 - Poor	Bearings:	F1 - Fair
		Bearing Seat:	F1 - Fair
Comments:	Moderate to severe cracking and deterioration in abutments and piers. One large downstream section of pier is severely fractured and has separated.		
SUPERSTRUCTURE			
Condition:	F1 - Fair	Expansion Joints:	P3 - Poor
Comments:	Deterioration of expansion joints with two expansion joints damaged and leaking. Moderate spalling on bottom of center girder and upstream fascia girder.		
DECK			
Condition:	F1 - Fair	Curbs:	F1 - Fair

Hand Rail:	F1 - Fair	Roadway Condition:	F1 - Fair
Approach Rail:	F1 - Fair		
Comments:	Potholes in asphalt and deterioration of curb noted.		
HYDROLOGY			
Water Velocity:	0 m/s	Ice Problem:	P - Possible Problem
Water Depth:	0 m	Scour Problem:	P - Possible Problem
Waterway:	01 - Adequate	Debris Problem:	P - Possible Problem
Comments:			
REPLACEMENT/REHABILITATION			
Next Rehab. Date:	2023	Replacement Year:	
Antic. Rehab. Cost:	\$0	Replacement Cost:	\$0
Recommendations:	Repair curbs, deck, abutments, piers and girders. Replace expansion joints		
OBSERVATIONS			
Overall Condition:	P3 - Poor	Requires Further Inspection:	No
Additional Observations:	Pics on file		
LEGEND:			
Condition Definitions:		Problem Definitions:	
1 - *Good - [discontinued code].	F2 - Fair.	C - Unsafe (Closed to Public).	N - No Problem.
2 - *Fair - [discontinued code].	F1 - Fair.	U - Uninspectable.	P - Possible Problem.
3 - *Poor - [discontinued code].	P3 - Poor.	I - Inapplicable.	K - Known Problem.
