GOVERNMENT OF NEWFOUNDLAND AND LABRADOR Department of Transportation and Infrastructure	BRIDGE INSPECTION REPORT B01142021-2																	
Date: 5/7/2020	Inspected By: Terrance Coates	Category: Eng. - Engineering																	
BRIDGE INFORMATION																			
Site:	4-148 - DRY POND BROOK BRIDGE																		
Route:		Overall Length:	42.8 m																
Year Built:	1978	Est: No	Overall Width: 10.9 m																
Year Last Rehab.:		Est: No	Roadway Width: 9.9 m																
Region:	WEST COAST/NORTHERN		Sidewalk Width: 0 m																
Jurisdiction:	Provincial		Clearance to R.D. or N.W.L.: 4.5 m																
Type of Structure:	01 - AASH to Girder		Max Depth of N.W.L.: 0.5 m																
Purpose of Structure:	03 - Over Navigable Waters		Spans:																
Type of Handrail:	01 - Aluminum Rail

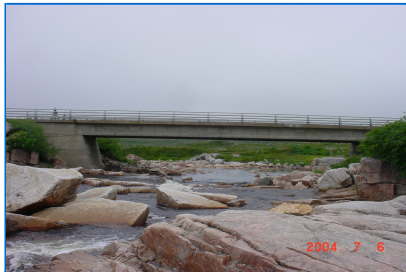
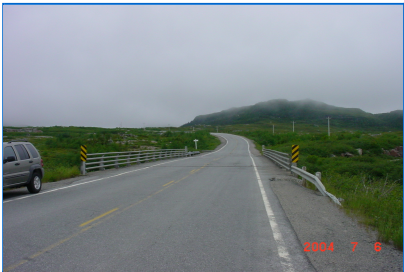
</div>																			
SUBSTRUCTURE																			
Condition:	F2 - Fair	Bearings:	G - Good																
		Bearing Seat:	P1 - Poor																
Comments:	Moderate to severe spalling on southwest bearing seat. Minor scour damage on south abutment wall.																		
SUPERSTRUCTURE																			
Condition:	F2 - Fair	Expansion Joints:	P1 - Poor																
Comments:	Expansion joints are paved over and there is evidence on the abutment and bearing seats that they're leaking.																		
DECK																			
Condition:	P1 - Poor	Curbs:	P1 - Poor																
Hand Rail:	F2 - Fair	Roadway Condition:	P1 - Poor

Comments: Deck fascia is deteriorated with moderated corrosion to exposed rebar. Moderate spalling of deck soffit. Asphalt on deck is very deteriorated with many potholes leading me to believe some concrete deck repair would be needed. No end curbs on deck. No end blocks. Bridge approaches have guide (not structural) and bridge exits have no rail.

Recommendations: Replace expansion joints. Latex concrete repairs to bearing seats and wingwalls. Install curbs and end blocks. Install structural approach rail. Repair concrete deck. Pave deck and approaches. Install hazard markers.
