GOVERNMENT OF NEWFOUNDLAND AND LABRADOR Department of Transportation and Infrastructure	BRIDGE INSPECTION REPORT B09162022-5	
Date: 7/29/2022	Inspected By: M Button	Category: Office - Bridge Office	
BRIDGE INFORMATION			
Site:	4-220 - FEEDER BROOK BRIDGE (NORTH)		
Route:		Overall Length:	12.3 m
Year Built:	1994	Est: No	Overall Width: 6.1 m
Year Last Rehab.:		Est: No	Roadway Width: 4.5 m
Region:	WEST COAST/NORTHERN	Sidewalk Width:	2.2 m
Jurisdiction:	Provincial	Clearance to R.D. or N.W.L.:	1.6 m
Type of Structure:	09 - Bailey Bridge	Max Depth of N.W.L.:	0 m
Purpose of Structure:	03 - Over Navigable Waters	Spans:	
Type of Handrail:	03 - Timber Rail	<u>Span No.:</u>	<u>Length</u>
Roadway Surface:	03 - Timber	1	12.3
Alignment Vertical:	01 - Good	2	0
Alignment Horizontal:	02 - Adequate	3	0
Restrictions:	No	<u>Span No.:</u>	<u>Length</u>
		4	0
		5	0
		6	0
BRIDGE PHOTOS

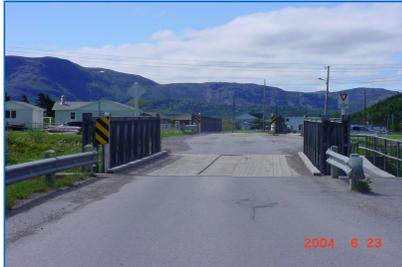
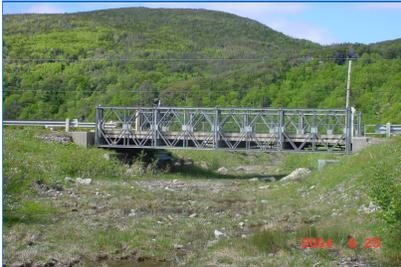
Bearing Seat:	U - Uninspectable
Comments:	- Abutment concrete in fair condition. Shallow footing likely undermined on north side due to bund wall perforations. Bund walls in front of both abutments need replacement. - No wingwalls. - Bearing seat and bearings covered in gravel, not inspected. Substructure placed as P1 due to bund wall.		
SUPERSTRUCTURE			
Condition:	P3 - Poor	Expansion Joints:	I - Inapplicable
Comments:	- Deck chesses have various longitudinal splits. No visible signs of rot, F2. - Floor beams and stringers have moderate to severe corrosion in various locations, P3. - Pins connecting truss sections have light corrosion, pins should be galvanized. - Through truss members in fair to good condition. - No expansion joints. Superstructure placed as P3 due to floor beams stingers.		
DECK

Condition:	F2 - Fair	Curbs:	P1 - Poor
Hand Rail:	I - Inapplicable	Roadway Condition:	P - Poor
Approach Rail:	P3 - Poor		
Comments:	- Approach asphalt in fair condition. - Deck raceway worn through in several locations with various splits throughout, P. - Timber curbs are mostly disintegrated, P1. - Structure rail are the truss elements. - Guiderail in tipped and has very old posts, P3. Replace.

Next Rehab. Date:	2023	Replacement Year:	2050
Antic. Rehab. Cost:	\$50,000	Replacement Cost:	\$1,000,000
Recommendations:	- Replace raceway, guiderail and curbs. Replace several hazard markers. - Replace various stringers and floor beams. - Replace both abutment bund walls. - Clean all sand and vegetation from bearing seats and atop bund walls.
