GOVERNMENT OF NEWFOUNDLAND AND LABRADOR Department of Transportation and Infrastructure	BRIDGE INSPECTION REPORT B06132022-3	
Date: 5/2/2022	Inspected By: Colby Spencer	Category: Eng. - Engineering	
BRIDGE INFORMATION			
Site:	4-042 - GILES' BROOK BRIDGE		
Route:	420	Overall Length:	36.1 m
Year Built:	1962	Est: No	Overall Width: 8.8 m
Year Last Rehab.:		Est: Yes	Roadway Width: 7.3 m
Region:	WEST COAST/NORTHERN		Sidewalk Width: 0 m
Jurisdiction:	Provincial	Clearance to R.D. or N.W.L.:	7.2 m
Type of Structure:	01 - AASH to Girder	Max Depth of N.W.L.:	0 m
Purpose of Structure:	03 - Over Navigable Waters	Spans:	
Type of Handrail:	01 - Aluminum Rail	<u>Span No.:</u>	<u>Length</u>
Roadway Surface:	02 - Asphalt	<u>Span No.:</u>	<u>Length</u>
Alignment Vertical:	01 - Good	1	23.7
Alignment Horizontal:	01 - Good	2	0
Restrictions:	No	3	0
		4	0
		5	0
		6	0
BRIDGE PHOTOS

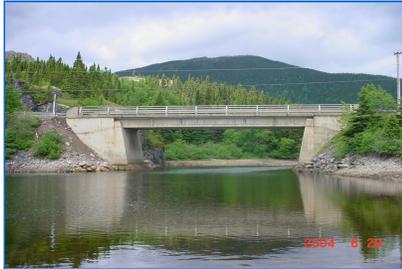
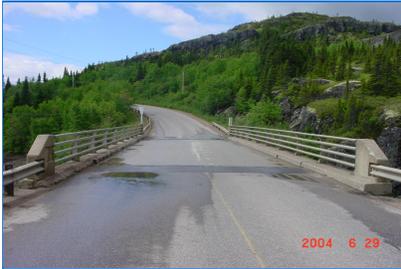
Bearing Seat:	U - Uninspectable
Comments:	Abutments eroding near water mark. Efflor. along walls. Erosion behind wing wall.		
SUPERSTRUCTURE			
Condition:	P3 - Poor	Expansion Joints:	P1 - Poor
Comments:	Joints are leaking, concrete cracked off outside of joint. Damage to expansion joints visible on road surface.		
DECK			
Condition:	P3 - Poor	Curbs:	P3 - Poor
Hand Rail:	P3 - Poor	Roadway Condition:	P3 - Poor

Approach Rail:	F1 - Fair		
Comments:	Curbs have spalling with rebar visible. Longitudinal crack visible on deck. Standing water on deck. Approach rail damaged and detached from end block. Plow damage to rail. Outside fascia has spalling with exposed rebar at rail posts.		
HYDROLOGY			
Water Velocity:	0 m/s	Ice Problem:	N - No Problem
Water Depth:	0 m	Scour Problem:	N - No Problem
Waterway:	01 - Adequate	Debris Problem:	N - No Problem
Comments:			
REPLACEMENT/REHABILITATION			
Next Rehab. Date:		Replacement Year:	
Antic. Rehab. Cost:	\$0	Replacement Cost:	\$0
Recommendations:	Install new curb and bridge rail. Complete deck repair and build out slopes.		
OBSERVATIONS			
Overall Condition:	F1 - Fair	Requires Further Inspection:	No
Additional Observations:			
LEGEND:			
Condition Definitions:		Problem Definitions:	
1 - *Good - [discontinued code].	F2 - Fair.	C - Unsafe (Closed to Public).	N - No Problem.
2 - *Fair - [discontinued code].	F1 - Fair.	U - Uninspectable.	P - Possible Problem.
