GOVERNMENT OF NEWFOUNDLAND AND LABRADOR Department of Transportation and Infrastructure	BRIDGE INSPECTION REPORT B01042021-13																	
Date: 4/23/2020	Inspected By: Terrance Coates	Category: Eng. - Engineering																	
BRIDGE INFORMATION																			
Site:	4-005 - HARRY'S RIVER BRIDGE																		
Route:		Overall Length:	58.9 m																
Year Built:	1972	Est: No	Overall Width: 10.6 m																
Year Last Rehab.:	2005	Est: No	Roadway Width: 9 m																
Region:	WEST COAST/NORTHERN		Sidewalk Width: 0 m																
Jurisdiction:	Provincial		Clearance to R.D. or N.W.L.: 2.7 m																
Type of Structure:	01 - AASH to Girder		Max Depth of N.W.L.: 3.4 m																
Purpose of Structure:	03 - Over Navigable Waters		Spans:																
Type of Handrail:	01 - Aluminum Rail

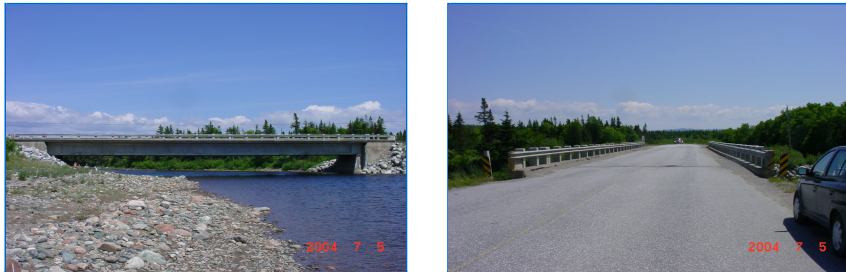
SUBSTRUCTURE																			
Condition:	G - Good	Bearings:	G - Good																
		Bearing Seat:	G - Good																
Comments:	Minor cracking and efflorescence deposits on headwalls.																		
SUPERSTRUCTURE																			
Condition:	G - Good	Expansion Joints:	F2 - Fair																
Comments:	Damage to expansion joint as a result of some settling in the approach slabs.																		
DECK																			
Condition:	F2 - Fair	Curbs:	G - Good																
Hand Rail:	G - Good	Roadway Condition:	G - Good

Approach Rail:	G - Good		
Comments:	Approach slabs have settled and require repairs. Potholes in asphalt on deck.		
HYDROLOGY			
Water Velocity:	0 m/s	Ice Problem:	K - Known Problem
Water Depth:	0 m	Scour Problem:	P - Possible Problem
Waterway:	01 - Adequate	Debris Problem:	P - Possible Problem
Comments:			
REPLACEMENT/REHABILITATION			
Next Rehab. Date:	2021	Replacement Year:	2021
Antic. Rehab. Cost:	\$0	Replacement Cost:	\$0
Recommendations:	Repair approach slabs. Patch potholes in asphalt. Install bridge signage.		
OBSERVATIONS			
Overall Condition:	G - Good	Requires Further Inspection:	No
Additional Observations:			
LEGEND:			
Condition Definitions:			
1 - *Good - [discontinued code].	F2 - Fair.	C - Unsafe (Closed to Public).	Problem Definitions:
2 - *Fair - [discontinued code].	F1 - Fair.	U - Uninspectable.	N - No Problem.
3 - *Poor - [discontinued code].	P3 - Poor.	I - Inapplicable.	P - Possible Problem.
