GOVERNMENT OF NEWFOUNDLAND AND LABRADOR Department of Transportation and Infrastructure	BRIDGE INSPECTION REPORT B02062023-2																	
Date: 5/2/2022	Inspected By: Mike Fleming	Category: Eng. - Engineering																	
BRIDGE INFORMATION																			
Site:	4-005 - HARRY'S RIVER BRIDGE																		
Route:		Overall Length:	58.9 m																
Year Built:	1972	Est: No	Overall Width: 10.6 m																
Year Last Rehab.:	2005	Est: No	Roadway Width: 9 m																
Region:	WEST COAST/NORTHERN		Sidewalk Width: 0 m																
Jurisdiction:	Provincial		Clearance to R.D. or N.W.L.: 2.7 m																
Type of Structure:	01 - AASH to Girder		Max Depth of N.W.L.: 3.4 m																
Purpose of Structure:	03 - Over Navigable Waters		Spans:																
Type of Handrail:	01 - Aluminum Rail

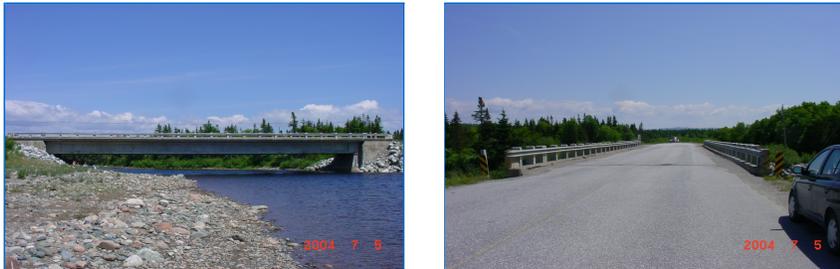
SUBSTRUCTURE																			
Condition:	F1 - Fair	Bearings:	G - Good																
		Bearing Seat:	G - Good																
Comments:	Light/minor efflorescence deposits and light to moderate deterioration with spalling and cracking on abutments.																		
SUPERSTRUCTURE																			
Condition:	G - Good	Expansion Joints:	F1 - Fair																
Comments:	Light damage noted on one expansion joint steel.																		
DECK																			
Condition:	F2 - Fair	Curbs:	G - Good																
Hand Rail:	F2 - Fair	Roadway Condition:	F2 - Fair

Approach Rail:	F1 - Fair		
Comments:	Moderate settlement and deteriorated asphalt noted on approach slabs. Approach rail is damaged		
HYDROLOGY			
Water Velocity:	0 m/s	Ice Problem:	K - Known Problem
Water Depth:	0 m	Scour Problem:	P - Possible Problem
Waterway:	01 - Adequate	Debris Problem:	P - Possible Problem
Comments:			
REPLACEMENT/REHABILITATION			
Next Rehab. Date:	2023	Replacement Year:	
Antic. Rehab. Cost:	\$0	Replacement Cost:	\$0
Recommendations:	Repair approach slabs and resurface; repair abutments and replace sections of approach rail. Install bridge signage.		
OBSERVATIONS			
Overall Condition:	F1 - Fair	Requires Further Inspection:	No
Additional Observations:	Significant amount of winter sand along curbs. Pics on file.		
LEGEND:			
Condition Definitions:		Problem Definitions:	
1 - *Good - [discontinued code].	F2 - Fair.	C - Unsafe (Closed to Public).	N - No Problem.
2 - *Fair - [discontinued code].	F1 - Fair.	U - Uninspectable.	P - Possible Problem.
