GOVERNMENT OF NEWFOUNDLAND AND LABRADOR Department of Transportation and Infrastructure	BRIDGE INSPECTION REPORT B08232019-1	
Date: 7/10/2019	Inspected By: Terrance Coates	Category: Eng. - Engineering	
BRIDGE INFORMATION			
Site:	4-165 - HARRYMAN'S BROOK BRIDGE		
Route:	422	Overall Length:	6.1 m
Year Built:	1956	Est: No	Overall Width: 9.5 m
Year Last Rehab.:		Est: No	Roadway Width: 9 m
Region:	WEST COAST/NORTHERN		Sidewalk Width: 0 m
Jurisdiction:	Provincial	Clearance to R.D. or N.W.L.:	1.1 m
Type of Structure:	03 - Reinforced Concrete Beam/Slab		Max Depth of N.W.L.: 1 m
Purpose of Structure:	03 - Over Navigable Waters		Spans:
Type of Handrail:	02 - Concrete Rail		<u>Span No.:</u> <u>Length</u> <u>Span No.:</u> <u>Length</u>
Roadway Surface:	01 - Concrete	1	5.5 4 0
Alignment Vertical:	01 - Good	2	0 5 0
Alignment Horizontal:	01 - Good	3	0 6 0
Restrictions:	No		
BRIDGE PHOTOS

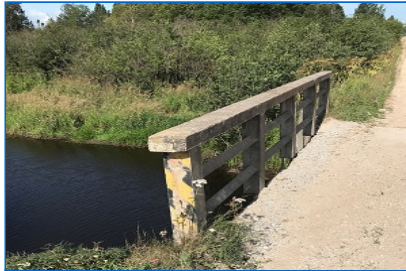
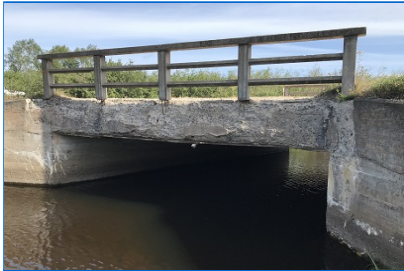
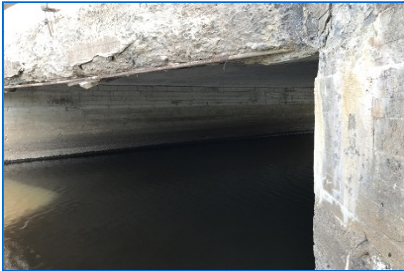
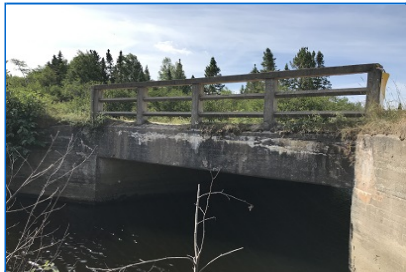
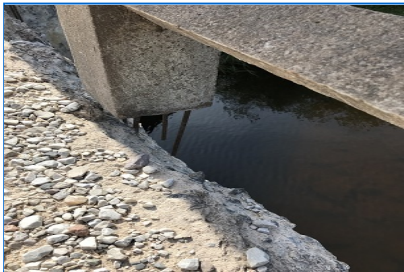
Bearing Seat:	I - Inapplicable
Comments:	Exposed reinforcement underside of deck		
SUPERSTRUCTURE			
Condition:	F1 - Fair	Expansion Joints:	I - Inapplicable
Comments:	Efflorescence deposits on side of slab		
DECK			
Condition:	F1 - Fair	Curbs:	I - Inapplicable
Hand Rail:	P1 - Poor	Roadway Condition:	I - Inapplicable

Approach Rail:	I - Inapplicable		
Comments:	Rails in poor condition, no approach rail, deteriorated concrete below rail - rebar exposed		
HYDROLOGY			
Water Velocity:	0 m/s	Ice Problem:	N - No Problem
Water Depth:	0 m	Scour Problem:	N - No Problem
Waterway:	01 - Adequate	Debris Problem:	N - No Problem
Comments:			
REPLACEMENT/REHABILITATION			
Next Rehab. Date:	2019	Replacement Year:	2019
Antic. Rehab. Cost:	\$0	Replacement Cost:	\$0
Recommendations:	Consider replacement with 40 foot steel panel bridge		
OBSERVATIONS			
Overall Condition:	F1 - Fair	Requires Further Inspection:	No
Additional Observations:	Bridge requires annual inspection		
LEGEND:			
Condition Definitions:			
1 - *Good - [discontinued code].	F2 - Fair.	C - Unsafe (Closed to Public).	Problem Definitions:
2 - *Fair - [discontinued code].	F1 - Fair.	U - Uninspectable.	N - No Problem.
3 - *Poor - [discontinued code].	P3 - Poor.	I - Inapplicable.	P - Possible Problem.
