GOVERNMENT OF NEWFOUNDLAND AND LABRADOR Department of Transportation and Infrastructure	BRIDGE INSPECTION REPORT B06132022-5																	
Date: 5/2/2022	Inspected By: Colby Spencer	Category: Eng. - Engineering																	
BRIDGE INFORMATION																			
Site:	TCH-055 - MCISAAC'S BROOK BRIDGE																		
Route:		Overall Length:	17.5 m																
Year Built:	1965	Est: No	Overall Width: 14.4 m																
Year Last Rehab.:	2000	Est: No	Roadway Width: 12.9 m																
Region:	WEST COAST/NORTHERN		Sidewalk Width: 0 m																
Jurisdiction:	Provincial		Clearance to R.D. or N.W.L.: 2.5 m																
Type of Structure:	03 - Reinforced Concrete Beam/Slab		Max Depth of N.W.L.: 0.2 m																
Purpose of Structure:	03 - Over Navigable Waters		Spans:																
Type of Handrail:	01 - Aluminum Rail

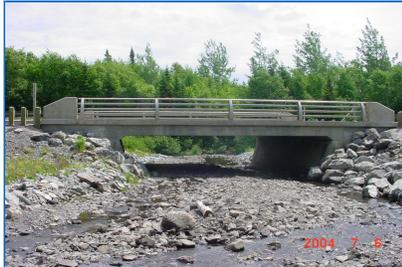
</div>																			
SUBSTRUCTURE																			
Condition:	G - Good	Bearings:	G - Good																
		Bearing Seat:	G - Good																
Comments:																			
SUPERSTRUCTURE																			
Condition:	G - Good	Expansion Joints:	I - Inapplicable																
Comments:	Horizontal crack in abutment wall.																		
DECK																			
Condition:	G - Good	Curbs:	G - Good																
Hand Rail:	G - Good	Roadway Condition:	G - Good

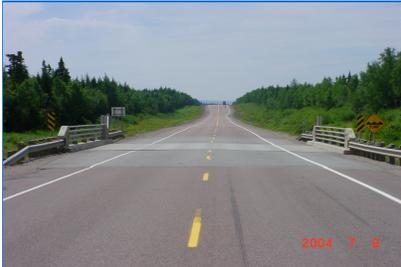
Approach Rail:	G - Good		
Comments:	Pothole in asphalt at join with concrete deck.		
HYDROLOGY			
Water Velocity:	0 m/s	Ice Problem:	P - Possible Problem
Water Depth:	0 m	Scour Problem:	P - Possible Problem
Waterway:	01 - Adequate	Debris Problem:	P - Possible Problem
Comments:			
REPLACEMENT/REHABILITATION			
Next Rehab. Date:		Replacement Year:	
Antic. Rehab. Cost:	\$0	Replacement Cost:	\$0
Recommendations:	Remove winter sand build-up along curbs. Repair asphalt next to concrete deck		
OBSERVATIONS			
Overall Condition:	G - Good	Requires Further Inspection:	No
Additional Observations:			
LEGEND:			
Condition Definitions:			
1 - *Good - [discontinued code].	F2 - Fair.	C - Unsafe (Closed to Public).	Problem Definitions:
2 - *Fair - [discontinued code].	F1 - Fair.	U - Uninspectable.	N - No Problem.
3 - *Poor - [discontinued code].	P3 - Poor.	I - Inapplicable.	P - Possible Problem.
4 - *Unsafe - [discontinued code].	P1 - Poor.		K - Known Problem.
