GOVERNMENT OF NEWFOUNDLAND AND LABRADOR Department of Transportation and Infrastructure	BRIDGE INSPECTION REPORT B01222021-6	
Date: 5/20/2020	Inspected By: Terrance Coates	Category: Eng. - Engineering	
BRIDGE INFORMATION			
Site:	4-103 - MIDDLE BROOK BRIDGE		
Route:	431	Overall Length:	32.2 m
Year Built:	1978	Overall Width:	11.5 m
Year Last Rehab.:		Roadway Width:	10.7 m
Region:	WEST COAST/NORTHERN	Sidewalk Width:	0 m
Jurisdiction:	Provincial	Clearance to R.D. or N.W.L.:	3.8 m
Type of Structure:	01 - AASH to Girder	Max Depth of N.W.L.:	0 m
Purpose of Structure:	03 - Over Navigable Waters	Spans:	
Type of Handrail:	01 - Aluminum Rail	<u>Span No.:</u>	<u>Length</u>
Roadway Surface:	02 - Asphalt	1	23.8
Alignment Vertical:	01 - Good	2	0
Alignment Horizontal:	01 - Good	3	0
Restrictions:	No	<u>Span No.:</u>	<u>Length</u>
		4	0
		5	0
		6	0
BRIDGE PHOTOS

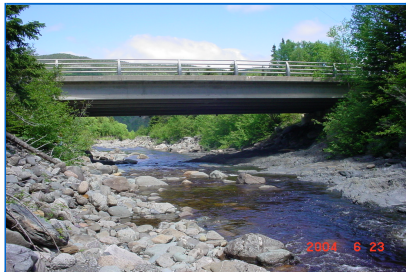
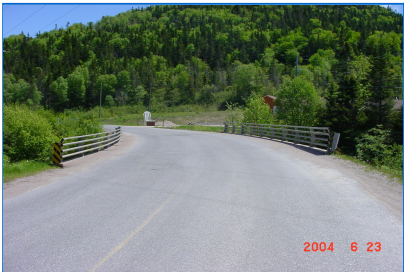
SUBSTRUCTURE			
Condition:	F2 - Fair	Bearings:	F2 - Fair

Bearing Seat:	G - Good
Comments:	Backwall on one abutment is deteriorating on downstream corner with exposed rebar corroding. Bearing pads are cracking.		
SUPERSTRUCTURE			
Condition:	P3 - Poor	Expansion Joints:	P1 - Poor
Comments:	Expansion joints are paved over. Older style angle iron expansion joints are leaking. No end blocks.		
DECK			
Condition:	F2 - Fair	Curbs:	P1 - Poor
Hand Rail:	G - Good	Roadway Condition:	P1 - Poor

Approach Rail:	U - Uninspectable		
Comments:	No approach guide rail installed. Curb is too low allowing all winter sand/salt run-off to go over the side of the deck causing concrete deterioration. Asphalt is deteriorated around paved over expansion joints causing potholes. Downstream side soffit and deck fascia severely deteriorated with exposed rebar corroded.		
HYDROLOGY			
Water Velocity:	0 m/s	Ice Problem:	N - No Problem
Water Depth:	0 m	Scour Problem:	N - No Problem
Waterway:	01 - Adequate	Debris Problem:	N - No Problem
Comments:			
REPLACEMENT/REHABILITATION			
Next Rehab. Date:	2021	Replacement Year:	2021
Antic. Rehab. Cost:	\$0	Replacement Cost:	\$0
Recommendations:	Remove winter sand build-up. Install new expansion joints. Construct curbs with end blocks. Repair deteriorated concrete on fascia, soffit and backwalls. Install structural guide rail on approaches. Install hazard markers.		
OBSERVATIONS
