GOVERNMENT OF NEWFOUNDLAND AND LABRADOR Department of Transportation and Infrastructure	BRIDGE INSPECTION REPORT B06132022-6																	
Date: 5/2/2022	Inspected By: Colby Spencer	Category: Eng. - Engineering																	
BRIDGE INFORMATION																			
Site:	4-051 - SANDY LAKE NARROWS BRIDGE																		
Route:	401	Overall Length:	89.4 m																
Year Built:	1968	Est: No	Overall Width: 9 m																
Year Last Rehab.:	1993	Est: No	Roadway Width: 7.4 m																
Region:	WEST COAST/NORTHERN		Sidewalk Width: 0 m																
Jurisdiction:	Provincial	Clearance to R.D. or N.W.L.:	6.2 m																
Type of Structure:	03 - Reinforced Concrete Beam/Slab		Max Depth of N.W.L.: 0 m																
Purpose of Structure:	03 - Over Navigable Waters		Spans:																
Type of Handrail:	01 - Aluminum Rail

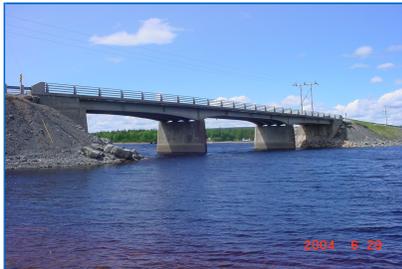
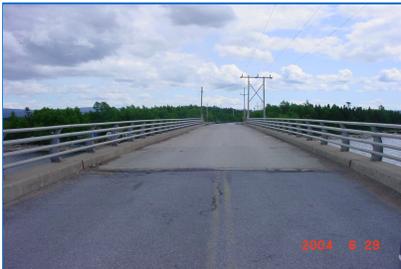
SUBSTRUCTURE																			
Condition:	G - Good	Bearings:	G - Good																
		Bearing Seat:	G - Good																
Comments:																			
SUPERSTRUCTURE																			
Condition:	G - Good	Expansion Joints:	F2 - Fair																
Comments:	Sleeper block side of expansion joint at the end of the approach slab is settling/overturning exposing the steel plate on one side of the expansion joint causing a hazard for snow plows.																		
DECK																			
Condition:	G - Good	Curbs:	G - Good																
Hand Rail:	I - Inapplicable	Roadway Condition:	G - Good
