GOVERNMENT OF NEWFOUNDLAND AND LABRADOR Department of Transportation and Infrastructure	BRIDGE INSPECTION REPORT B01142021-18																	
Date: 5/11/2020	Inspected By: Terrance Coates	Category: Eng. - Engineering																	
BRIDGE INFORMATION																			
Site:	4-112 - SOUTH WEST BROOK BRIDGE																		
Route:		Overall Length:	39.5 m																
Year Built:	1976	Est: Yes	Overall Width: 11.4 m																
Year Last Rehab.:		Est: No	Roadway Width: 10.6 m																
Region:	WEST COAST/NORTHERN		Sidewalk Width: 0 m																
Jurisdiction:	Provincial		Clearance to R.D. or N.W.L.: 3 m																
Type of Structure:	01 - AASH to Girder		Max Depth of N.W.L.: 0.5 m																
Purpose of Structure:	03 - Over Navigable Waters		Spans:																
Type of Handrail:	01 - Aluminum Rail

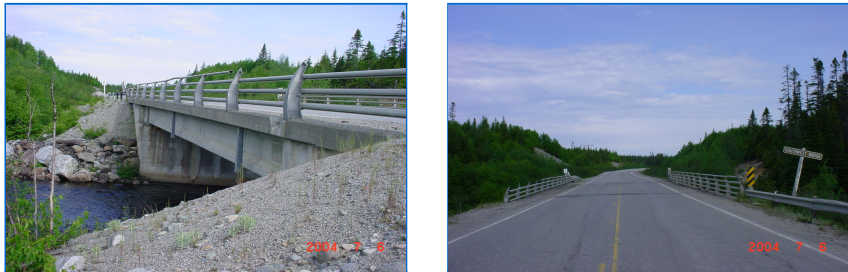
SUBSTRUCTURE																			
Condition:	G - Good	Bearings:	G - Good																
		Bearing Seat:	G - Good																
Comments:	Rehab done in 2017.																		
SUPERSTRUCTURE																			
Condition:	G - Good	Expansion Joints:	G - Good																
Comments:																			
DECK																			
Condition:	G - Good	Curbs:	G - Good																
Hand Rail:	G - Good	Roadway Condition:	G - Good

Approach Rail:	G - Good		
Comments:	Asphalt near expansion joints on approaches deteriorating.		
HYDROLOGY			
Water Velocity:	0 m/s	Ice Problem:	N - No Problem
Water Depth:	0 m	Scour Problem:	N - No Problem
Waterway:	01 - Adequate	Debris Problem:	P - Possible Problem
Comments:			
REPLACEMENT/REHABILITATION			
Next Rehab. Date:	2021	Replacement Year:	2021
Antic. Rehab. Cost:	\$0	Replacement Cost:	\$0
Recommendations:	Remove winter sand build-up along curbs. Replace one missing hazard marker. Repave approaches.		
OBSERVATIONS			
Overall Condition:	G - Good	Requires Further Inspection:	No
Additional Observations:			
LEGEND:			
Condition Definitions:		Problem Definitions:	
1 - *Good - [discontinued code].	F2 - Fair.	C - Unsafe (Closed to Public).	N - No Problem.
2 - *Fair - [discontinued code].	F1 - Fair.	U - Uninspectable.	P - Possible Problem.
3 - *Poor - [discontinued code].	P3 - Poor.	I - Inapplicable.	K - Known Problem.
