GOVERNMENT OF NEWFOUNDLAND AND LABRADOR Department of Transportation and Infrastructure	BRIDGE INSPECTION REPORT B01222021-7	
Date: 5/20/2020	Inspected By: Terrance Coates	Category: Eng. - Engineering	
BRIDGE INFORMATION			
Site:	4-131 - THREE TON BROOK BRIDGE		
Route:	431	Overall Length:	23.9 m
Year Built:	1982	Est: No	Overall Width: 10.1 m
Year Last Rehab.:		Est: No	Roadway Width: 9.1 m
Region:	WEST COAST/NORTHERN	Sidewalk Width:	0 m
Jurisdiction:	Provincial	Clearance to R.D. or N.W.L.:	5.5 m
Type of Structure:	03 - Reinforced Concrete Beam/Slab	Max Depth of N.W.L.:	0.5 m
Purpose of Structure:	03 - Over Navigable Waters	Spans:	
Type of Handrail:	01 - Aluminum Rail	<u>Span No.:</u>	<u>Length</u>
Roadway Surface:	02 - Asphalt	1	12
Alignment Vertical:	01 - Good	2	0
Alignment Horizontal:	02 - Adequate	3	0
Restrictions:	No	<u>Span No.:</u>	<u>Length</u>
		4	0
		5	0
		6	0
BRIDGE PHOTOS

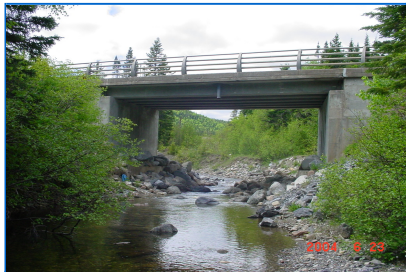
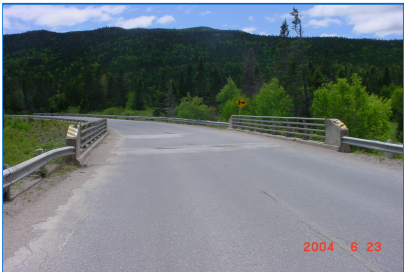
Condition:	F2 - Fair	Bearings:	G - Good
		Bearing Seat:	G - Good
Comments:	Efflorescence deposits on the abutments, wing walls and backwalls.		
SUPERSTRUCTURE			
Condition:	F2 - Fair	Expansion Joints:	P3 - Poor
Comments:	End blocks are deteriorated with exposed rebar corroded. No Michigan shoe connection on end blocks. Spalling of concrete on the bottom of some girders near bearing pads. Spalling on soffits. Expansion joints are paved over.		
DECK			
Condition:	F2 - Fair	Curbs:	P1 - Poor
Hand Rail:	P3 - Poor	Roadway Condition:	P1 - Poor

Approach Rail:	G - Good		
Comments:	Aluminum handrail is damaged by snow plow blade. Top handrail is detached from 3 posts. Curb face is deteriorated. Asphalt is deteriorated near the expansion joints that are paved over.		
HYDROLOGY			
Water Velocity:	0 m/s	Ice Problem:	P - Possible Problem
Water Depth:	0 m	Scour Problem:	P - Possible Problem
Waterway:	01 - Adequate	Debris Problem:	P - Possible Problem
Comments:			
REPLACEMENT/REHABILITATION			
Next Rehab. Date:	2021	Replacement Year:	2021
Antic. Rehab. Cost:	\$0	Replacement Cost:	\$0
Recommendations:	Remove winter sand build-up along curbs. Resurface curbs. Replace end blocks. Replace expansion joints. Install new handrail. Latex concrete repairs to soffit and spalled areas on underside of some girders. Minor latex concrete repairs to backwalls, wing walls and abutments. Latex		
OBSERVATIONS			
Overall Condition:	F2 - Fair	Requires Further Inspection:	No
