GOVERNMENT OF NEWFOUNDLAND AND LABRADOR Department of Transportation and Infrastructure	<b>BRIDGE INSPECTION REPORT</b> <b>B01142021-6</b>	
<b>Date:</b> 5/7/2020	<b>Inspected By:</b> Terrance Coates	<b>Category:</b> Eng. - Engineering	
<b>BRIDGE INFORMATION</b>			
<b>Site:</b>	4-147 - TOP POND BROOK BRIDGE		
<b>Route:</b>		<b>Overall Length:</b>	44.8 m
<b>Year Built:</b>	1976	<b>Est: No</b>	<b>Overall Width:</b> 10.9 m
<b>Year Last Rehab.:</b>		<b>Est: No</b>	<b>Roadway Width:</b> 9.9 m
<b>Region:</b>	WEST COAST/NORTHERN	<b>Sidewalk Width:</b>	0 m
<b>Jurisdiction:</b>	Provincial	<b>Clearance to R.D. or N.W.L.:</b>	5.2 m
<b>Type of Structure:</b>	01 - AASH to Girder	<b>Max Depth of N.W.L.:</b>	0.4 m
<b>Purpose of Structure:</b>	03 - Over Navigable Waters	<b>Spans:</b>	
<b>Type of Handrail:</b>	01 - Aluminum Rail	<u>Span No.:</u>	<u>Length</u>
<b>Roadway Surface:</b>	02 - Asphalt	1	31.2
<b>Alignment Vertical:</b>	01 - Good	2	0

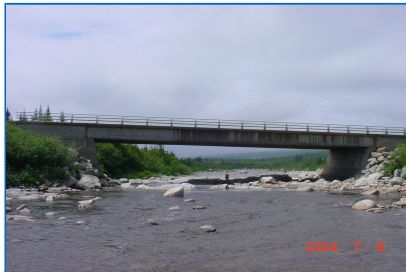
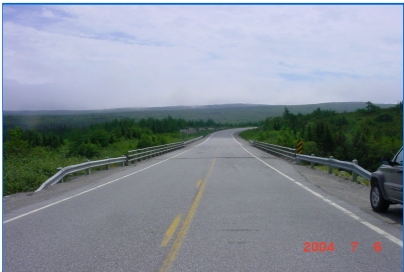
<b>SUBSTRUCTURE</b>			
<b>Condition:</b>	G - Good	<b>Bearings:</b>	G - Good
		<b>Bearing Seat:</b>	G - Good
<b>Comments:</b>	Rehab done in 2016. Minor spalling on underside of 1 girder exposing rebar.		
<b>SUPERSTRUCTURE</b>			
<b>Condition:</b>	G - Good	<b>Expansion Joints:</b>	G - Good
<b>Comments:</b>			
<b>DECK</b>			
<b>Condition:</b>	G - Good	<b>Curbs:</b>	G - Good
<b>Hand Rail:</b>	G - Good	<b>Roadway Condition:</b>	G - Good

<b>Approach Rail:</b>	G - Good		
<b>Comments:</b>	North bound lane approach rail damage to buried end.		
<b>HYDROLOGY</b>			
<b>Water Velocity:</b>	0 m/s	<b>Ice Problem:</b>	P - Possible Problem
<b>Water Depth:</b>	0 m	<b>Scour Problem:</b>	P - Possible Problem
<b>Waterway:</b>	01 - Adequate	<b>Debris Problem:</b>	P - Possible Problem
<b>Comments:</b>			
<b>REPLACEMENT/REHABILITATION</b>			
<b>Next Rehab. Date:</b>	2021	<b>Replacement Year:</b>	2021
<b>Antic. Rehab. Cost:</b>	\$0	<b>Replacement Cost:</b>	\$0
<b>Recommendations:</b>	Remove winter sand build-up along curbs. Replace damaged buried end on north bound lane approach rail.		
<b>OBSERVATIONS</b>			
<b>Overall Condition:</b>	G - Good	<b>Requires Further Inspection:</b>	No
<b>Additional Observations:</b>			
<b>LEGEND:</b>			
<b>Condition Definitions:</b>			
1 - *Good - [discontinued code].	F2 - Fair.	C - Unsafe (Closed to Public).	<b>Problem Definitions:</b>
