TECHNICAL MEMORANDUM

Date: 2024-Aug-14 **File No.:** 241207
Lisa Reid, P.Eng.
To: Director, Building Design and Construction **From:** Doug Power, P.Eng.
Jared Johnston, C.E.T.
Subject: Inspection of NL DTI Wharf at Red Bay

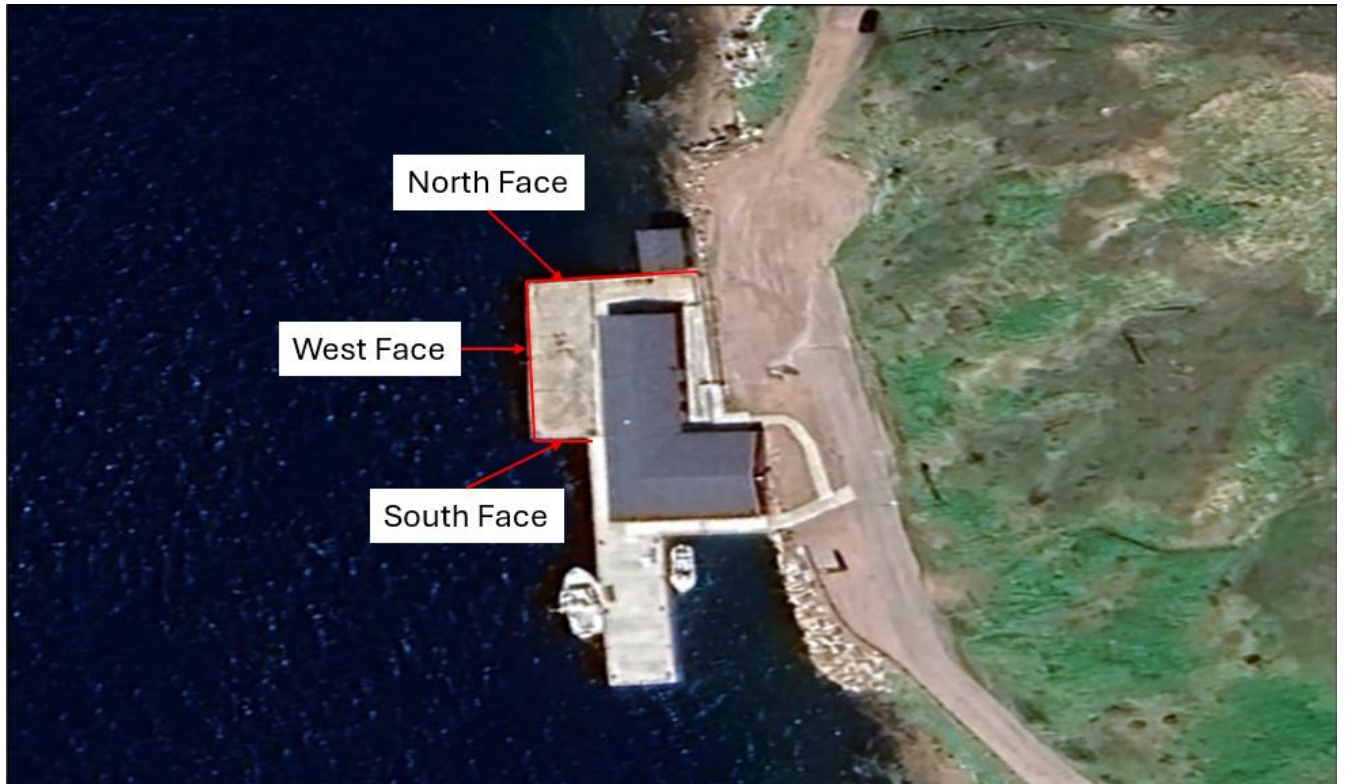
Figure 1- NL DTI Wharf at Red Bay

Overall, the wharf is in very poor condition. The southwest and northwest corners of the wharf have clearly dropped likely resulting from broken/missing piles in these areas. The concrete wharf slab at the southwest corner has a large crack likely caused by overstress due to the broken/missing piles.

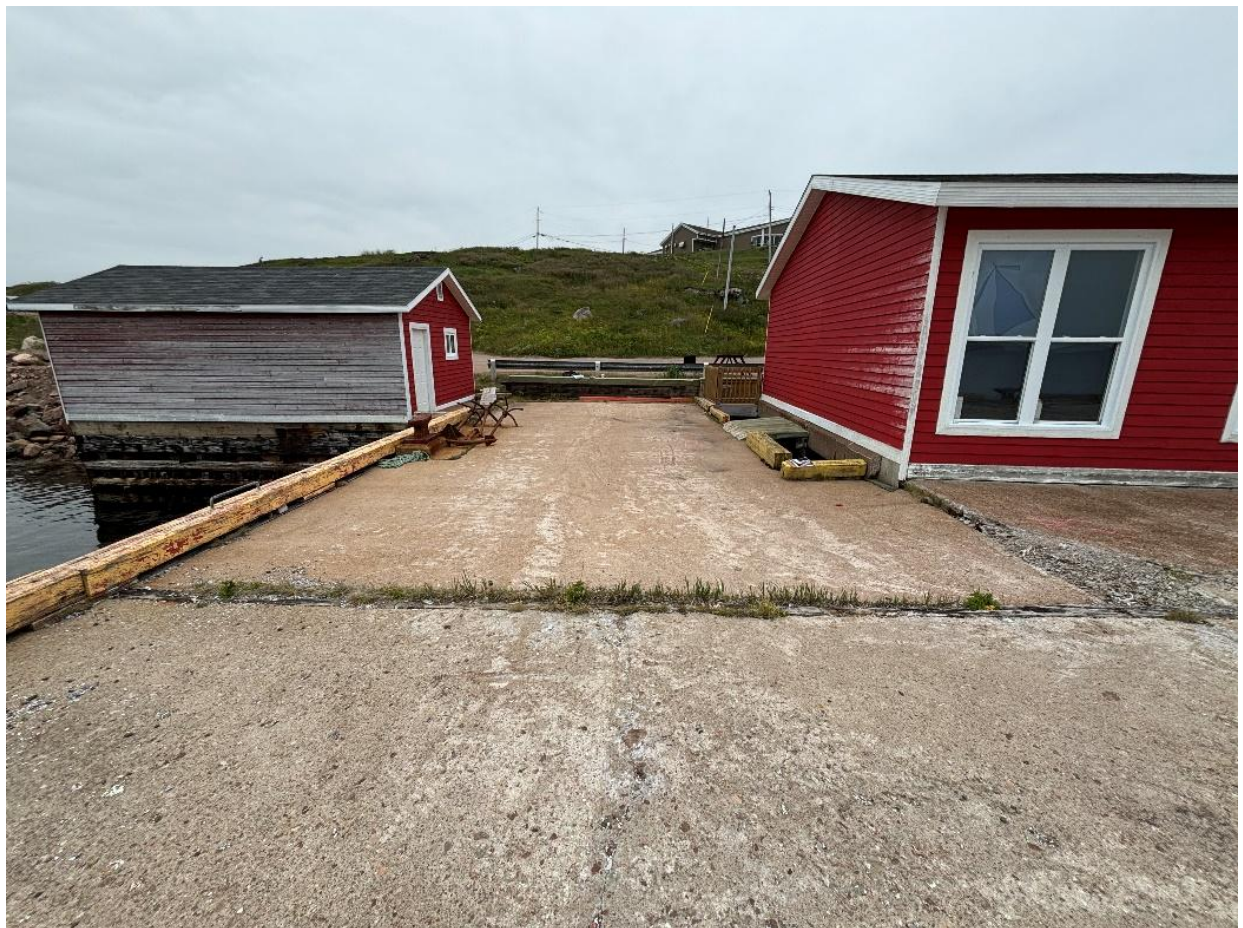
Figure 2 – Standing on northwest corner looking east (approach).

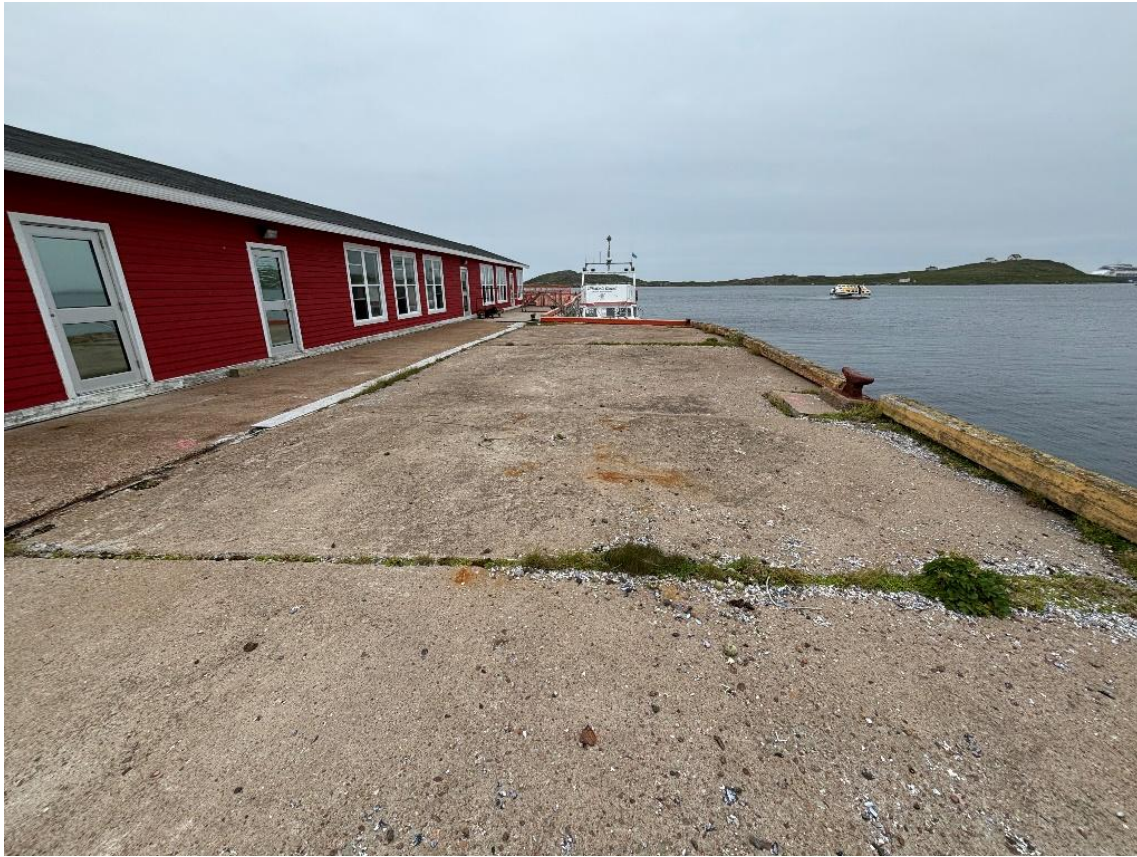
Figure 3 - Standing on northwest corner looking south.

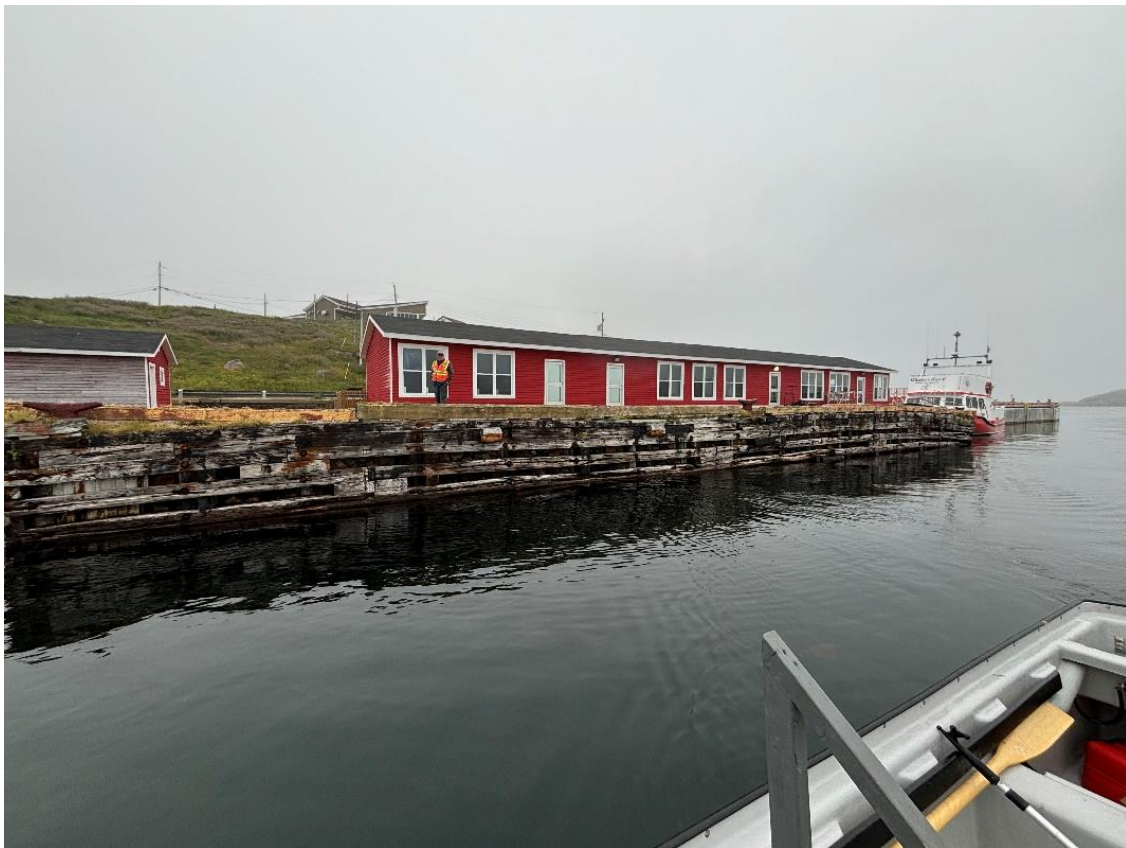
The mooring cleats on the northwest and southwest corners of the wharf have dropped with the deck slab in these areas. The cleat in the middle of the main west berthing face has significant tilt outward.

Figure 4 – West berthing face.

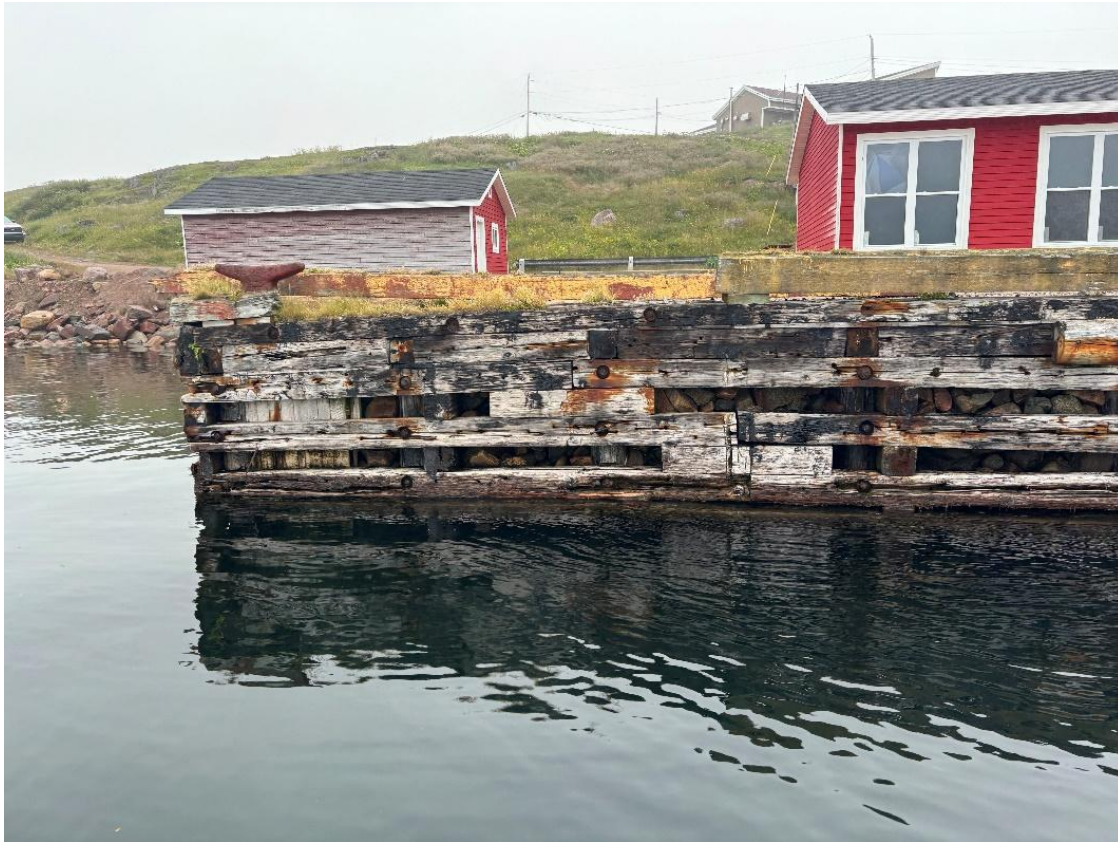
Figure 5 - Dropped northwest corner on west berthing face.

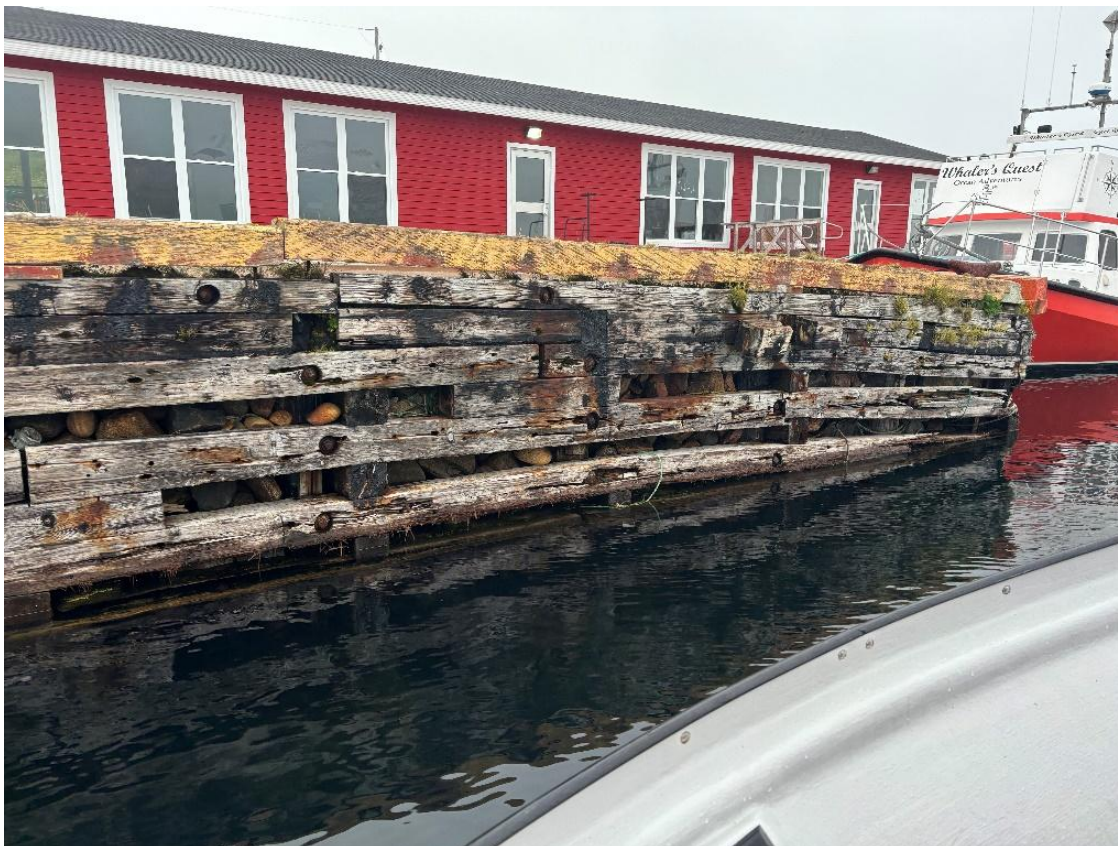
Figure 6 – Dropped southwest corner on west berthing face.

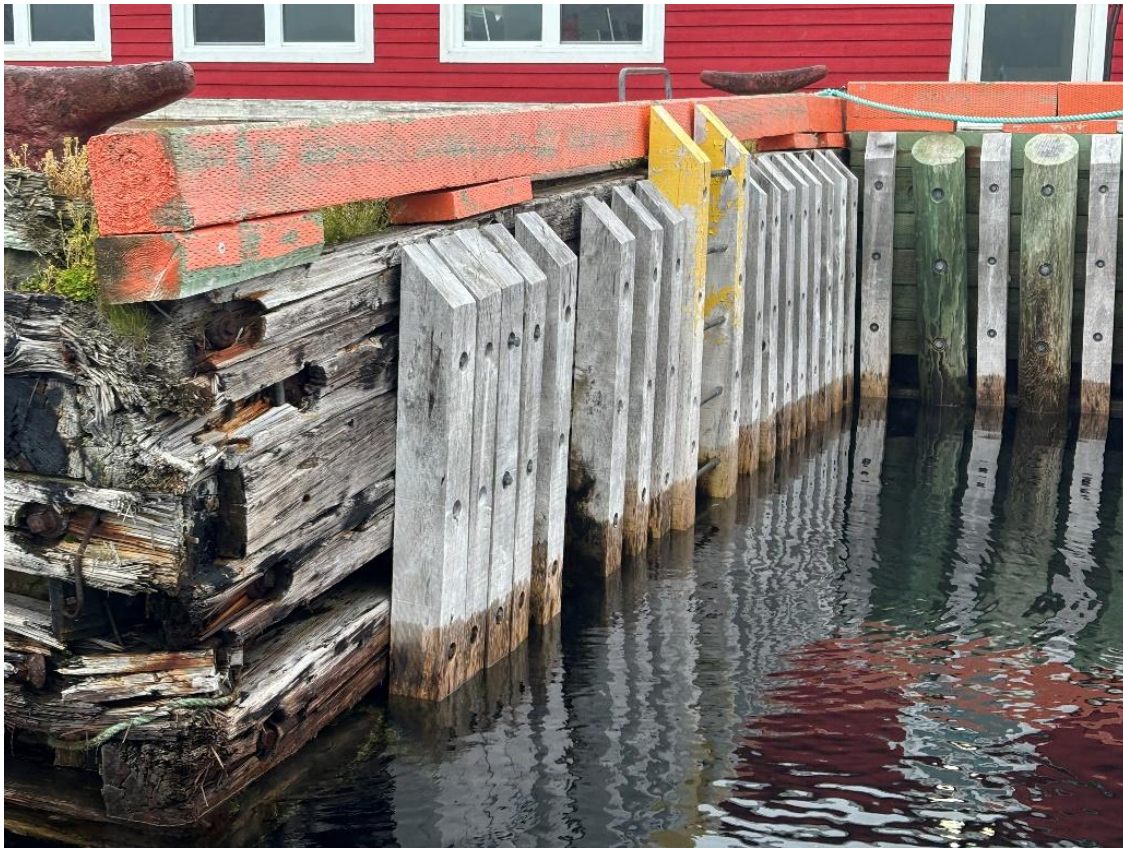
All timber fendering is either missing or severely damaged on the north and west faces of the structure. There is a ladder and some fendering present on the south face of the wharf with local people advising this work was completed by the Town.

Figure 7 – Damaged timber on southwest corner of west face.

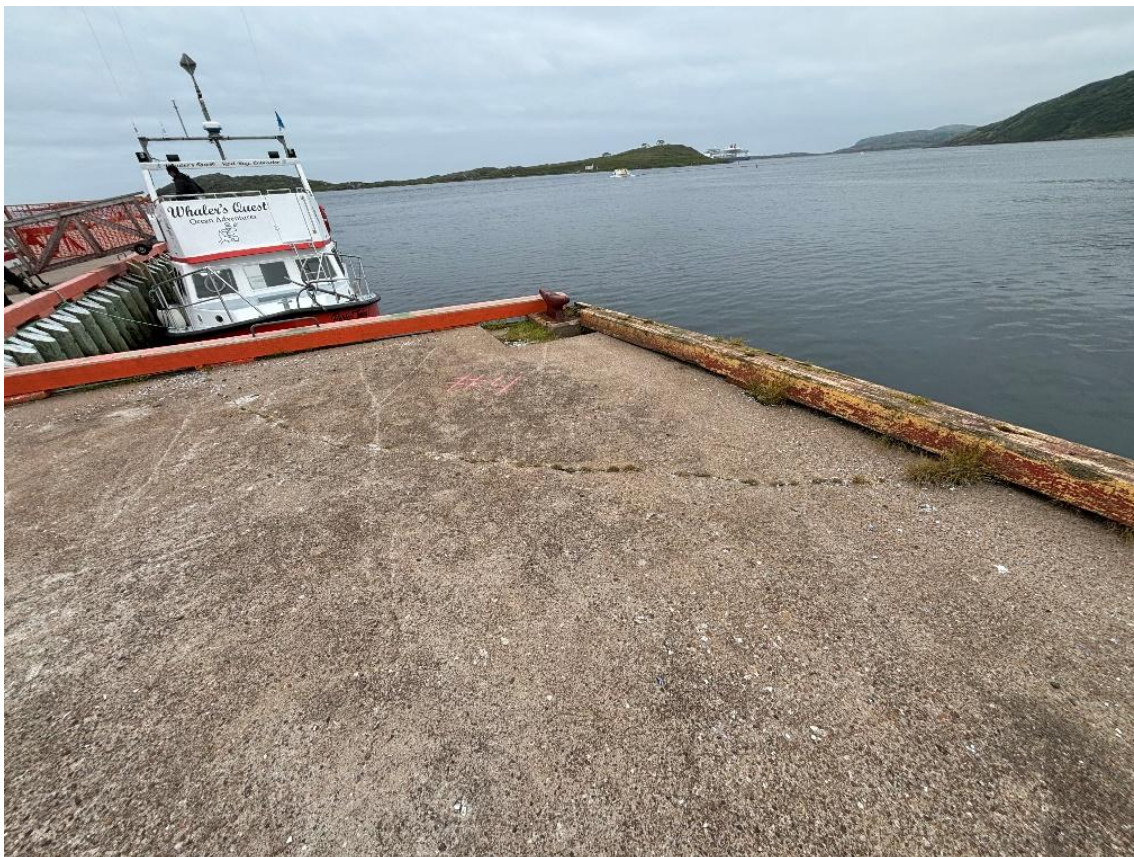
Figure 8 – Wide crack in slab at the dropped southwest corner.

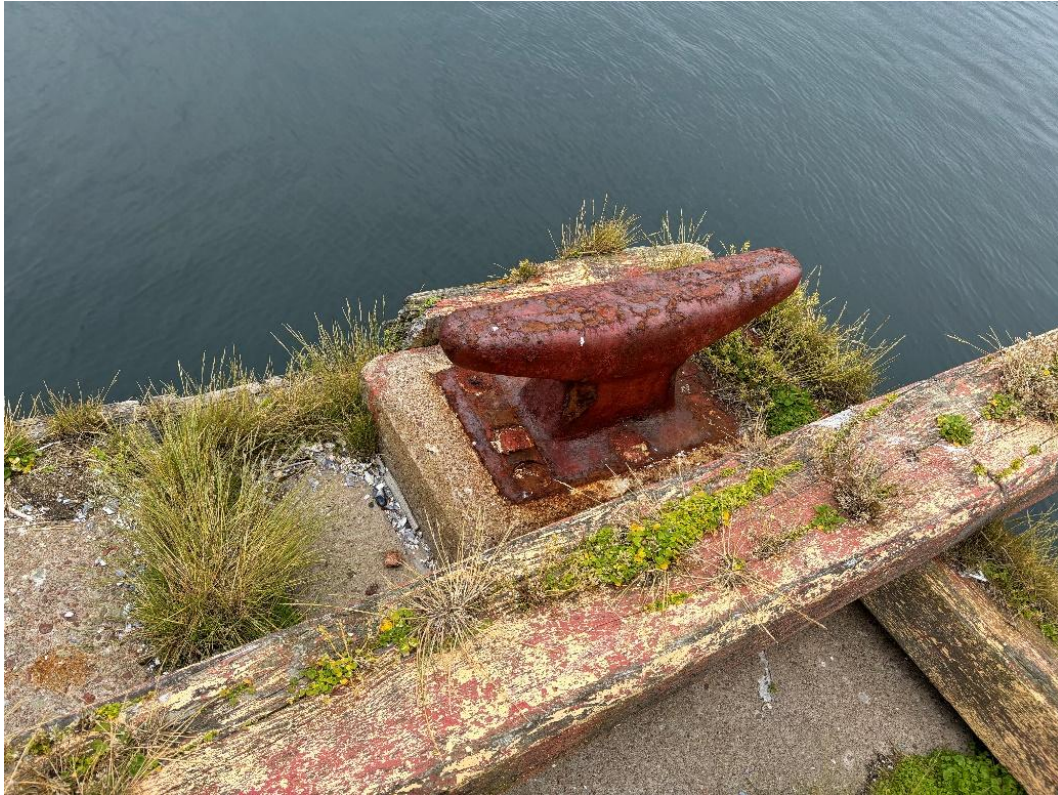
All existing wheel guard along the perimeter of the wharf (approximately 53m) is either deteriorated or detached entirely.

Figure 9 – Cleat on northwest corner with wheel guard detached in area.

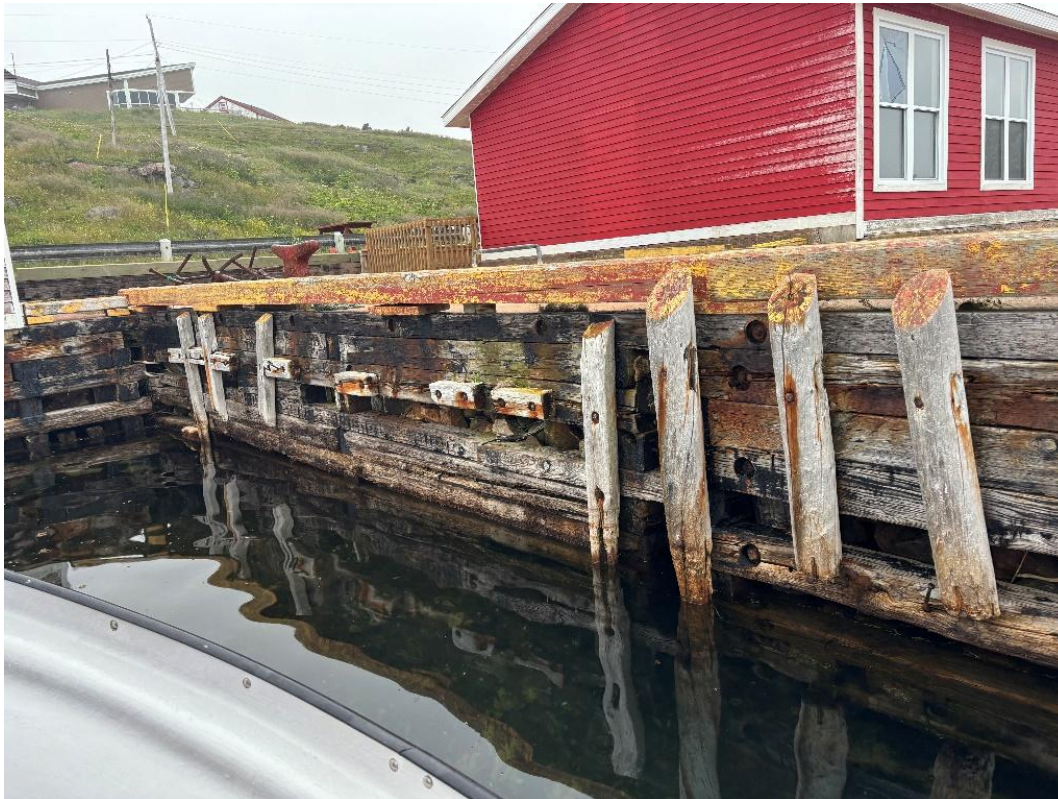
There are no ladders present on the north and west faces of the wharf.

Figure 10 - North face of wharf.

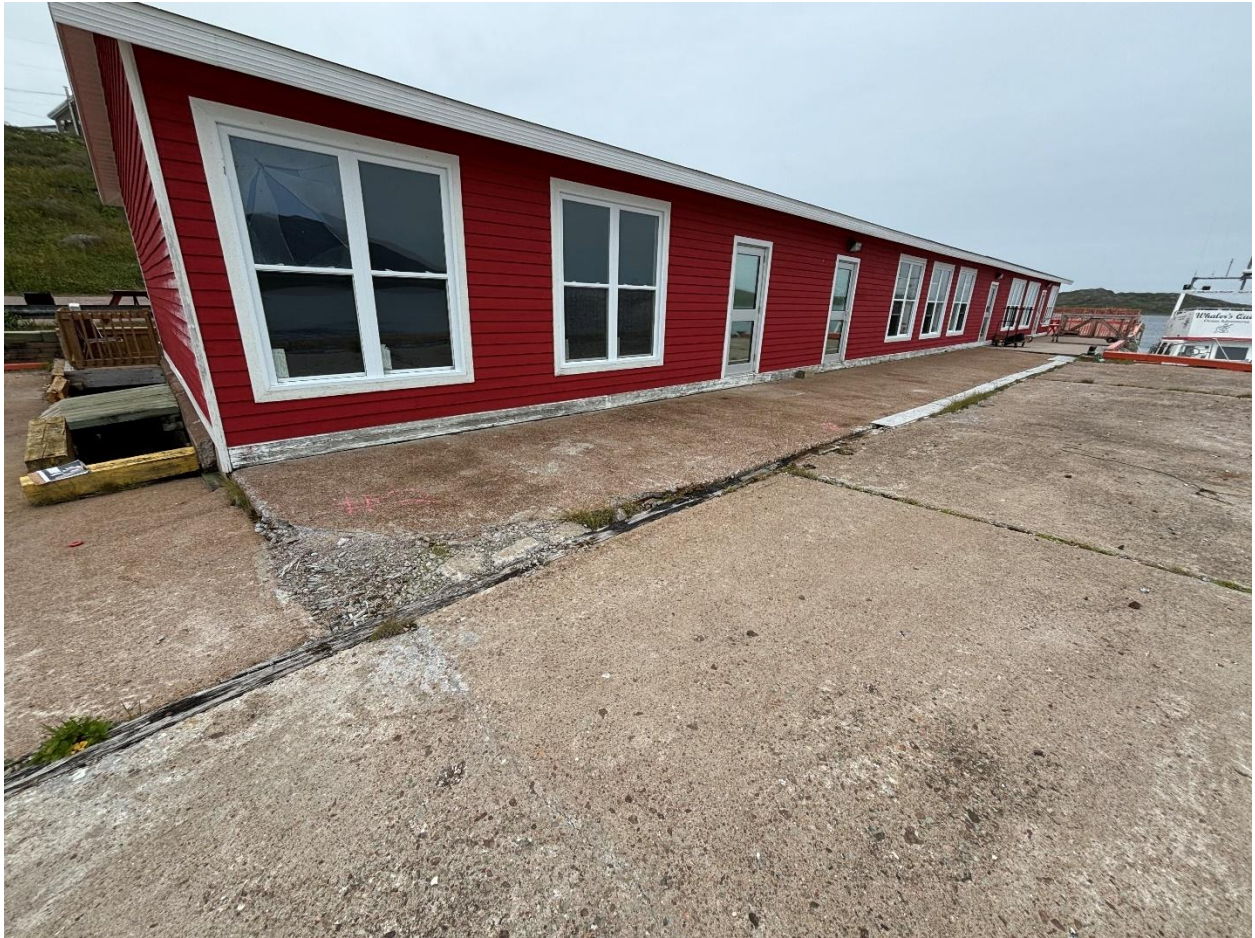
Some local residents advised that occasionally visitors to the Town via boat tie up to the NL DTI wharf, but it is a rare occurrence. The wharf is barricaded at the south end to prevent access with some fencing and with a patio rail on the north end of the building deterring access to the north approach.

Figure 11 – Building on adjacent wharf with snow fence barrier to prevent access at south end of NL DTI wharf and patio rail to deter access at north end.
