# **Building Condition Assessment - Breakwater Books Building and Former Roebothan-McKay-Marshall Law Building**

96-100 Water Street and 205-211 Duckworth Street, St. John's NL

**Government of Newfoundland and  
Labrador, Department of  
Transportation and Infrastructure  
Building Condition Report  
Client Reference no. 102405008**

June 2026  
02501045.000-0100-BS-R-0001-01

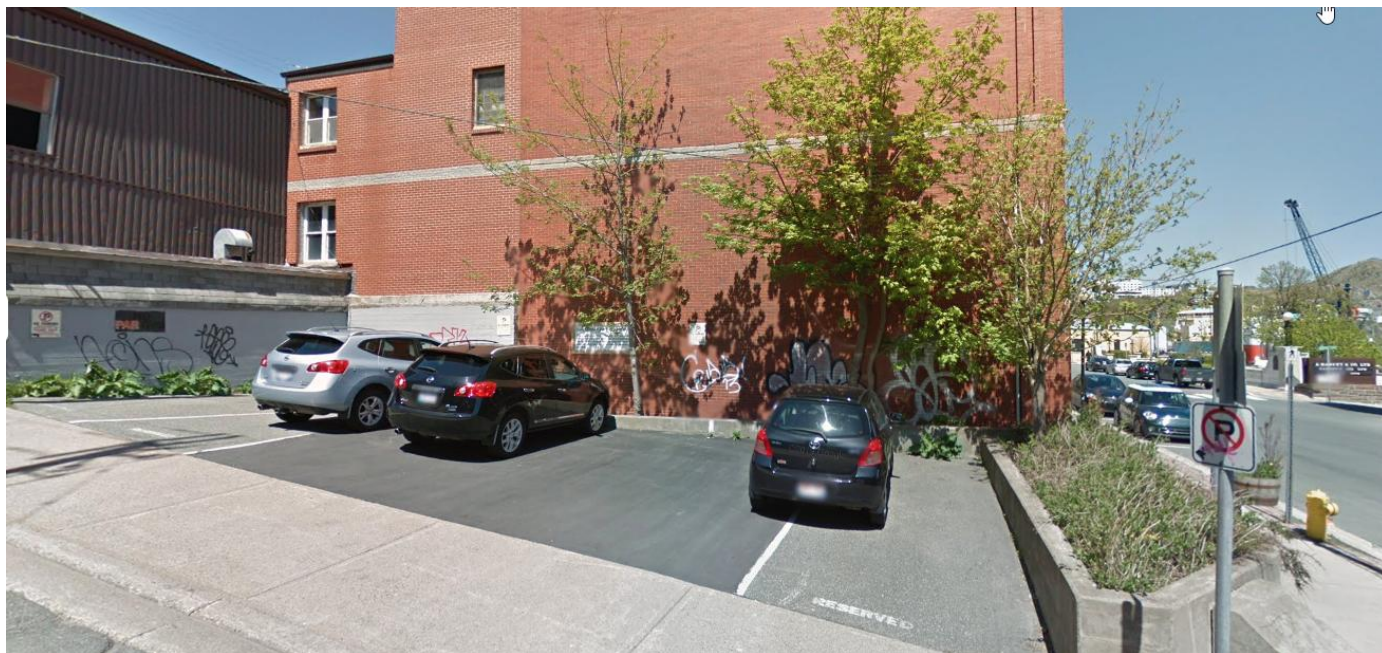
Asphalt covering of west parking area is in **fair** condition. Historical imagery indicates partial asphalt resurfacing of three (3) of the six (6) available parking spaces around 2013. Images prior to 2013 capture low spots and multiple potholes. Line painting appears to have been last completed in the summer of 2013. Lines are no longer usefully visible in this area. No subsurface stormwater management infrastructure is present, and depressions visible within the area resurfaced in 2013.

Photo 1: West parking area Showing asphalt repairs (Google, 2013)

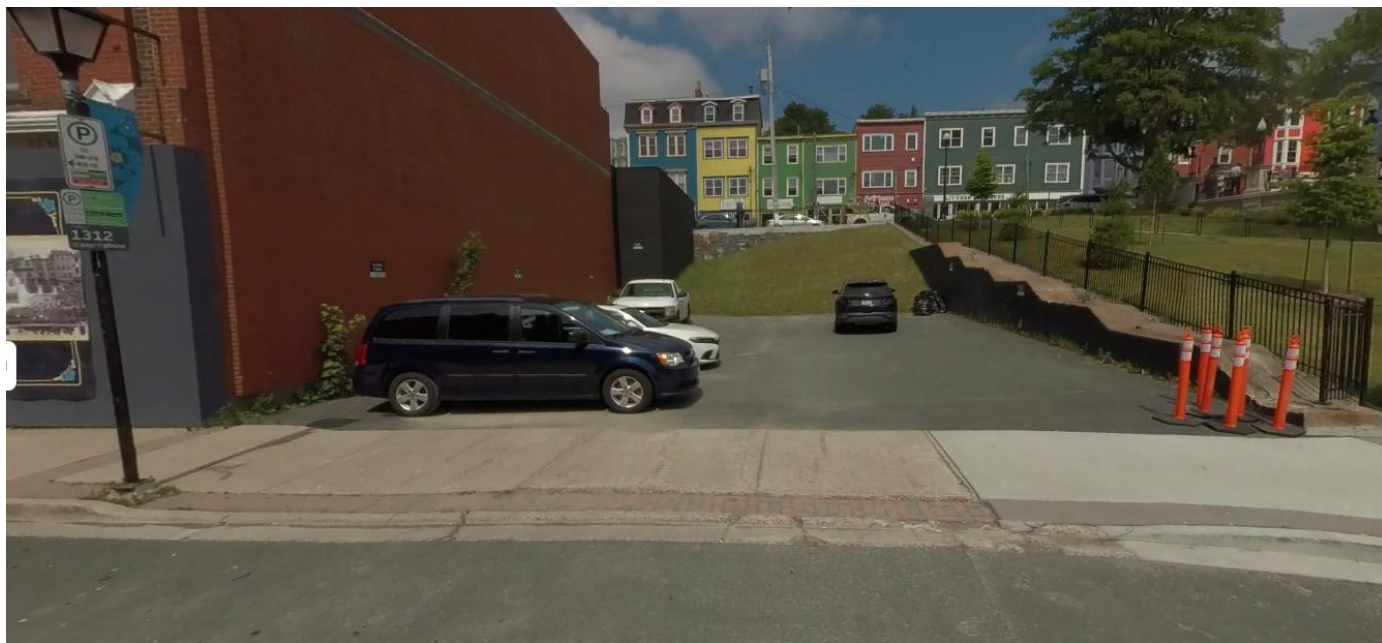
The asphalt parking area to the east of the building adjacent the War Memorial site is newly constructed as of 2024 as part of the National War Memorial Centennial Project. Similar to the west parking area, subsurface stormwater management infrastructure is not present in the area. The condition of the surface asphalt is **good**, with considerable remaining useful life. It should be noted a full-width asphalt patch is present along the edge of the newly reinstated public sidewalk. It is believed the asphalt surface was cut to accommodate widening and realignment of the sidewalk and deliberately oversized to accommodate construction. A localized depression was observed on the west end of the patch deep enough to retain surface water. This patch is an area of increased vulnerability to water infiltration and will likely see deterioration at an increased rate.

Photo 2: East parking area (Google, 2025)

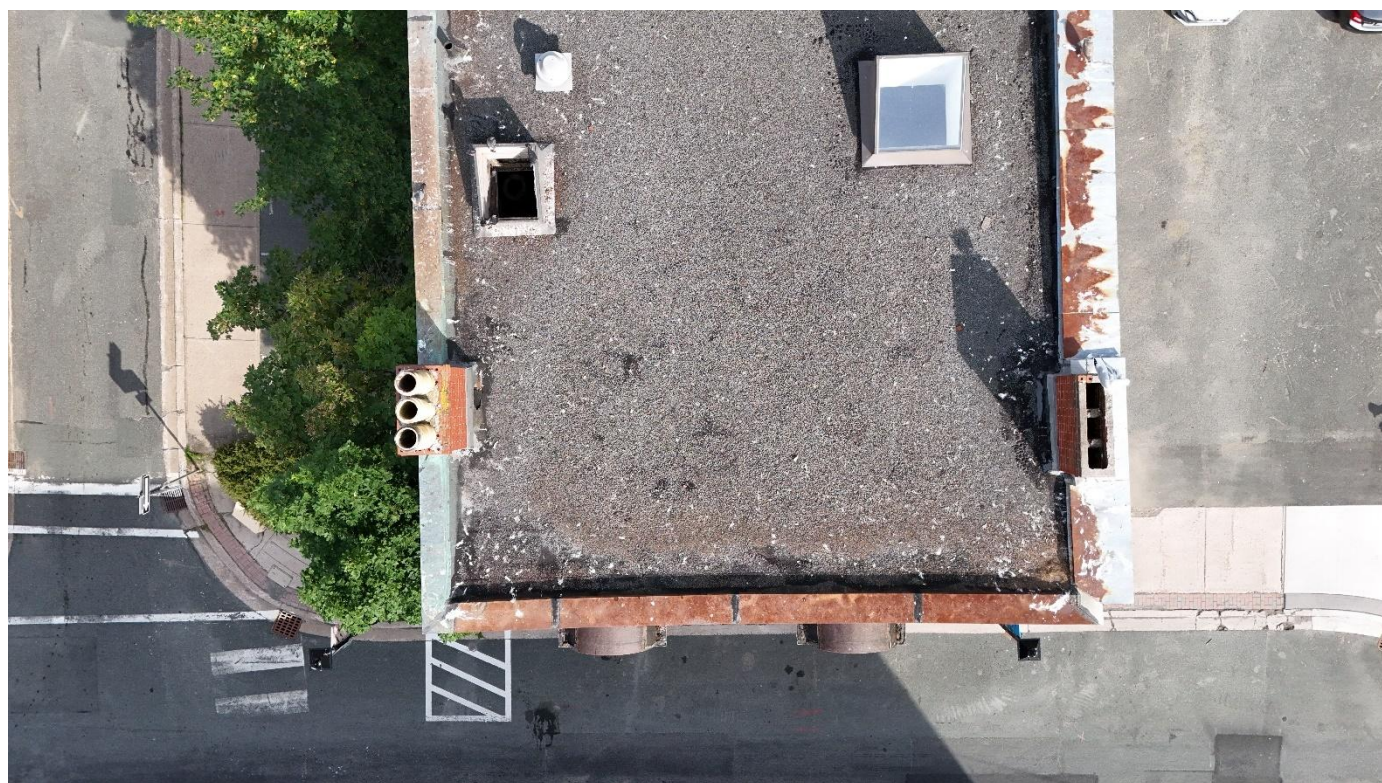
Aerial photographs suggest that this was most recently renovated around 1989 with the change in ownership to Clyde Rose of Breakwater Books, so it has likely been nearly 30 years since this was last done, which explains the roof's [poor](#) condition. The roof structure is wood framed, possibly being original above the front of house and being from as early as the 1950's for the addition. It is difficult to tell if there have been repairs or replacements in the system, but based on the internal condition of the ceiling, and water damage due in large part to an unprotected skylight, the roof will need to be replaced. The acrylic skylight pane has been missing for some time in the skylight above the bathroom Photo 3. This skylight and one above the South stairwell appear to have been added in the 1989 renovation. The roof above the addition was also clearly re-done in the 1989 renovation, as internal pictures show a second layer of roof joists that have been placed a foot or two above the original. This was likely done to increase the roof height above the addition so it could act more easily as a rooftop patio.

Photo 3: Aerial view of roof showing open skylight

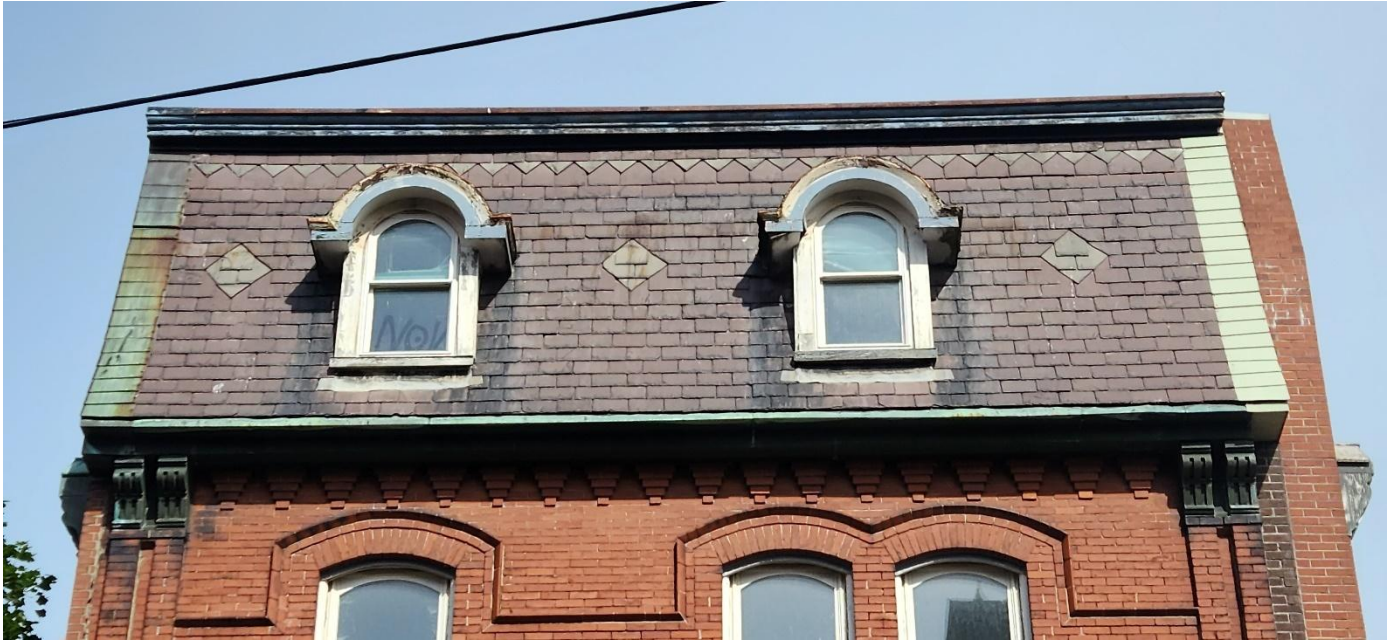
The mansard roof hosts 2 hooded dormer windows. Their trim is mostly original, but water damaged and will need to be replaced. It should be noted that the windows themselves are vinyl and sit behind exterior wooden trim to imitate the appearance of the original arched windows. These are of **poor** quality and should be replaced. The edges of this roof to the east and west feature metal siding and eaves that align materially with the parapet caps and are likely from these corresponding renovations (Photo 4). The corbels just below this roof are in remarkably good condition and appear to be original. These are likely painted metal as wood would have lost its sharpness of form due to age.

Photo 4: Mansard roof and hooded dormers

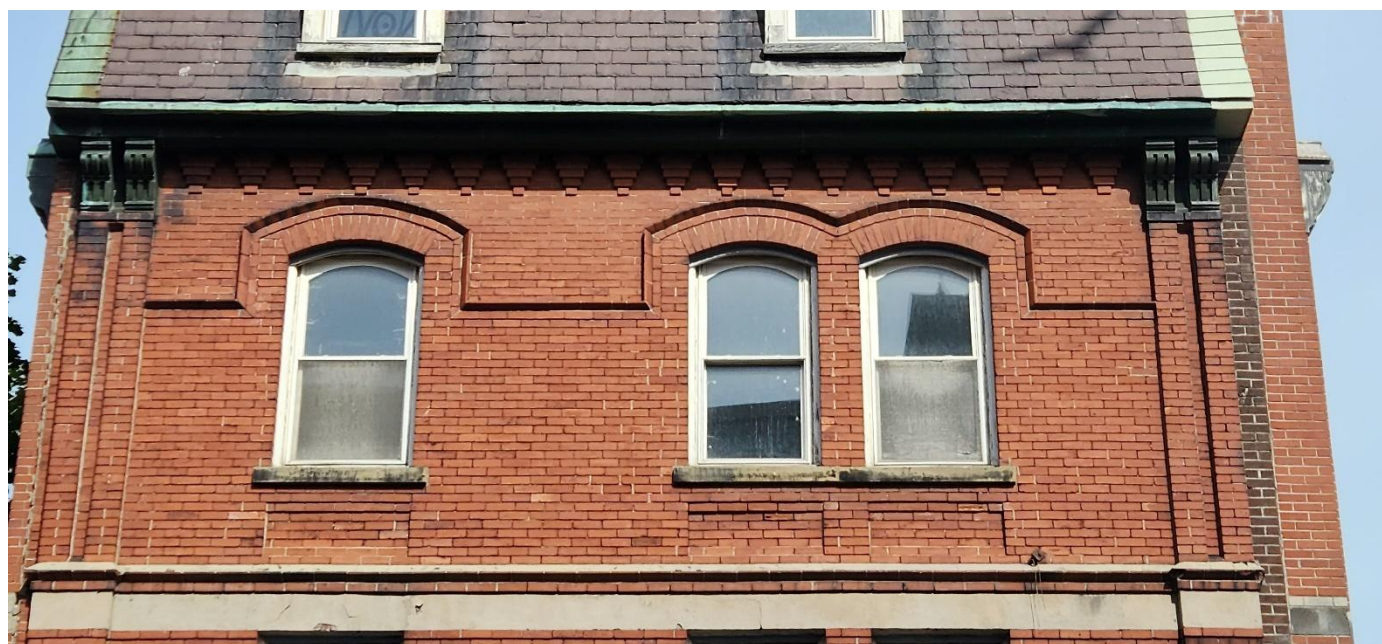
Photo 5: Cladding and ornamentation

The ground level of the building is fully below grade along the perimeter. Based on interior and exterior site photography these foundation walls are a mixture of concrete and layered concrete block and brick. Like the brick walls above these are a product of many additions and repairs over the building's long life, so it is difficult to determine their exact composition and thickness per section. Based on a visual inspection and from the stability of the above structure the walls are in **good** condition.

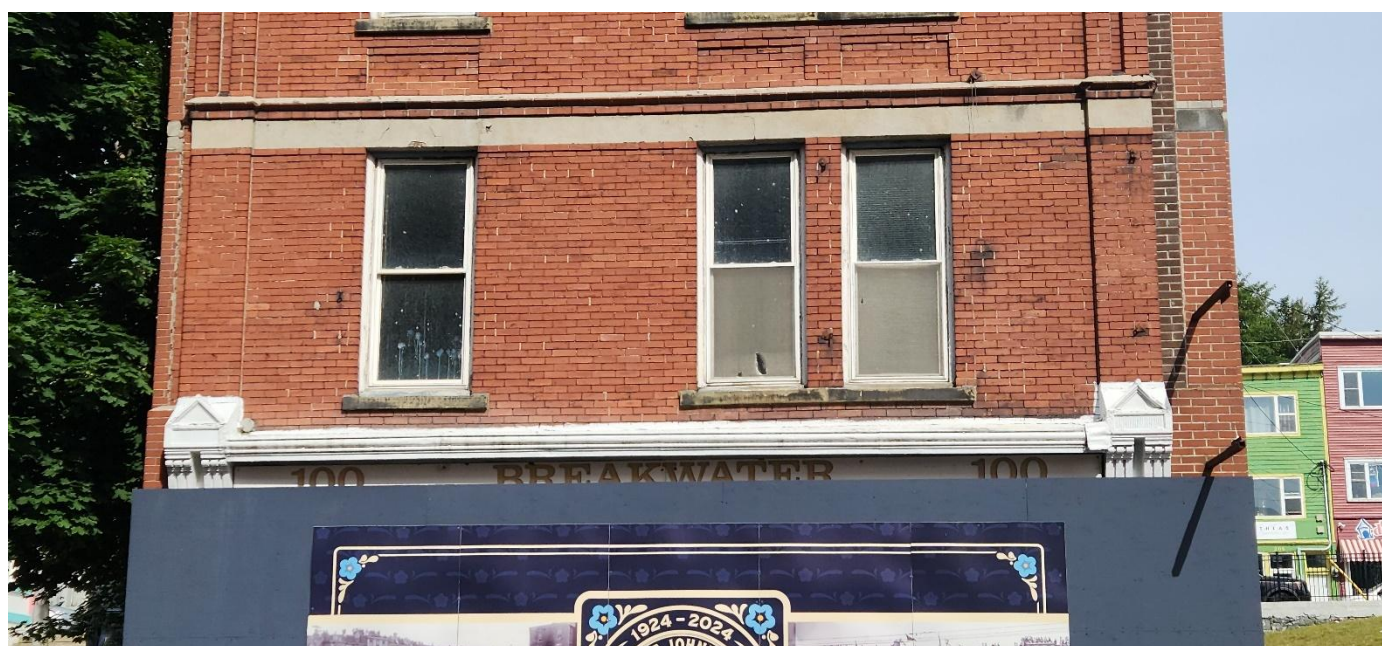
Photo 6: Partial south elevation at level 2

The front façade is largely original and in **good** condition. From top to bottom it is the slate shingled roof previously discussed, two floors of brick cladding featuring ornate brickwork, and a storefront off the street composed of ornate wood, metal, and stone finishes. The brickwork of the third storey includes entablature, bracket details, coping insets, and arched brickwork around the windows. The second storey is simpler in design, and these two floors are separated by a stone belt course. The brick is in **good** condition considering it is original to the building but shows staining in some areas. It has significant remaining useful life.

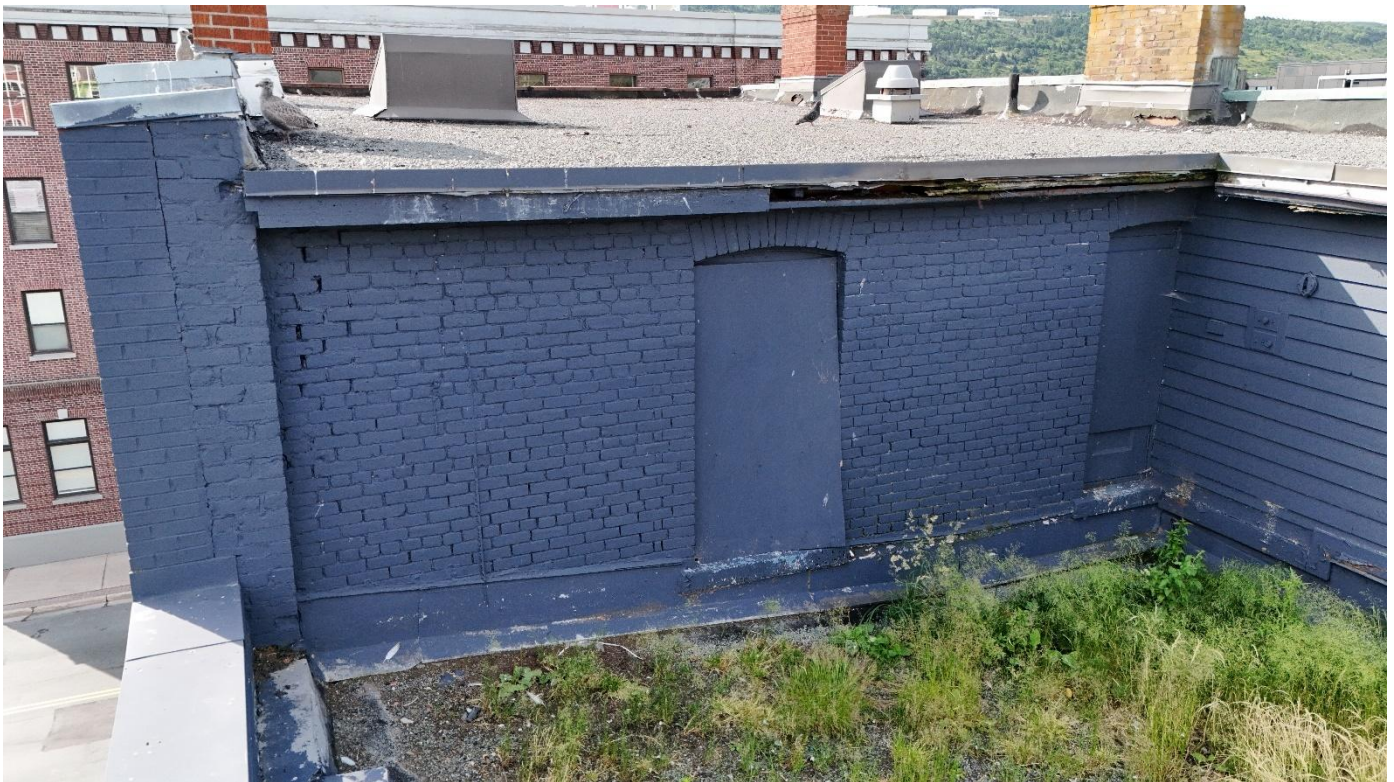
Photo 7: Partial north elevation at level 4

The north elevation has all been painted a dark blue in recent years and is mostly brick. However, there is a more recent wooden siding visible on the top floor enclosing the north stairwell. The visible brick is mostly part of the old exterior wall of the law building that burnt down and is in **poor** condition due to damage from the fire.

The brick of Breakwater Books is visible on fourth floor and is constructed in an English bond masonry style, as well as hosting arched brick doorways, this style continues down now internal parts of this exterior wall on previous floors but is not seen on other elevations. This portion of the wall is likely original and is in **fair** condition, as there appears to be settlement issues on its east end on the fourth floor. The stair on this elevation is in **very poor** condition and should be demolished (Room).

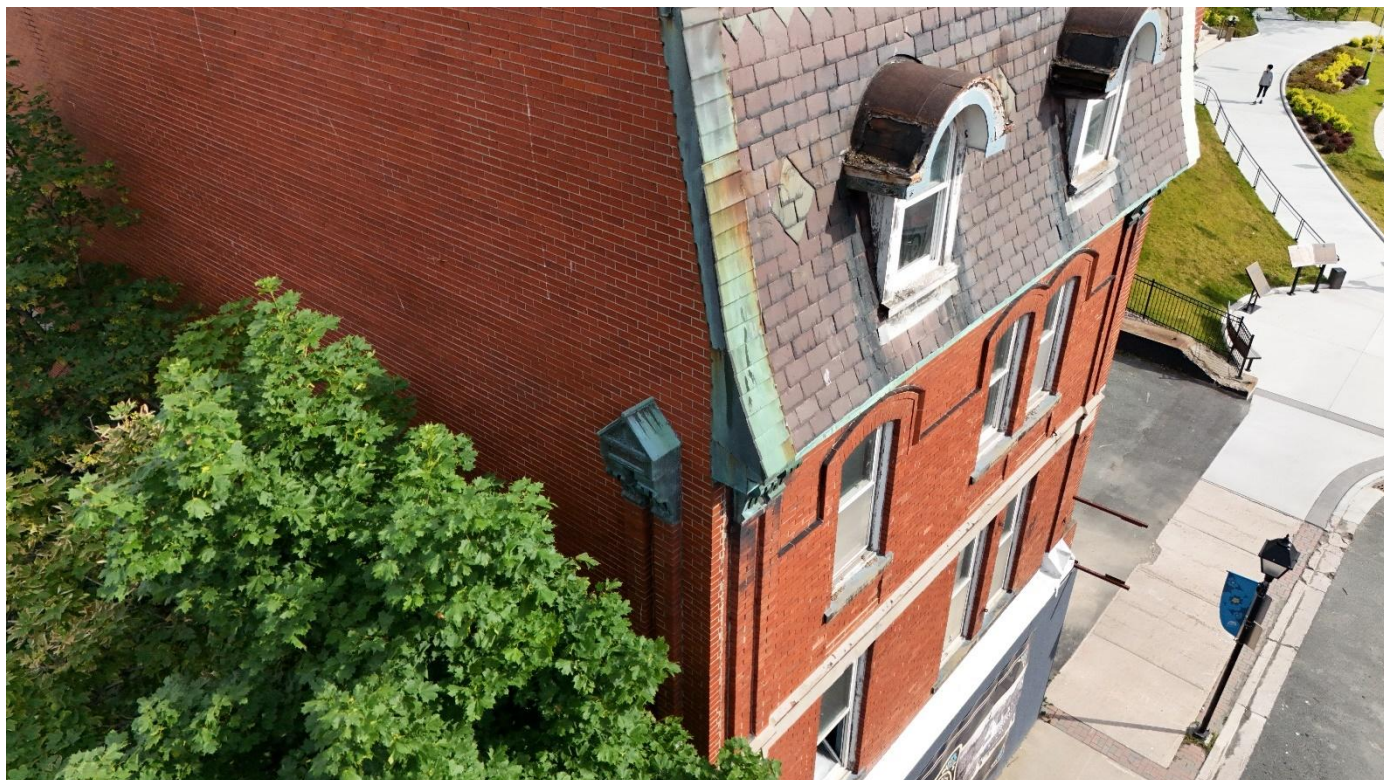
This elevation mimics the stone belt separating the second and third storey of the front in two different ways: first in the newer section with what appears to be four layers of concrete split face brick; and second in the older front section with two layers of larger stone blocks. To the south end of the wall there is a brick pilaster that is capped at just over third storey height that is capped by a decorative pilaster capital. It is unclear whether this is purely decorative or aides in concealment of electrical of some nature, as there is evidence of electrical of in this region on the interior. This would have been added in the 1960s when the adjacent building was demolished. All these features are in **good** condition.

Photo 10: Aerial photo of southwest corner showing pilaster capital

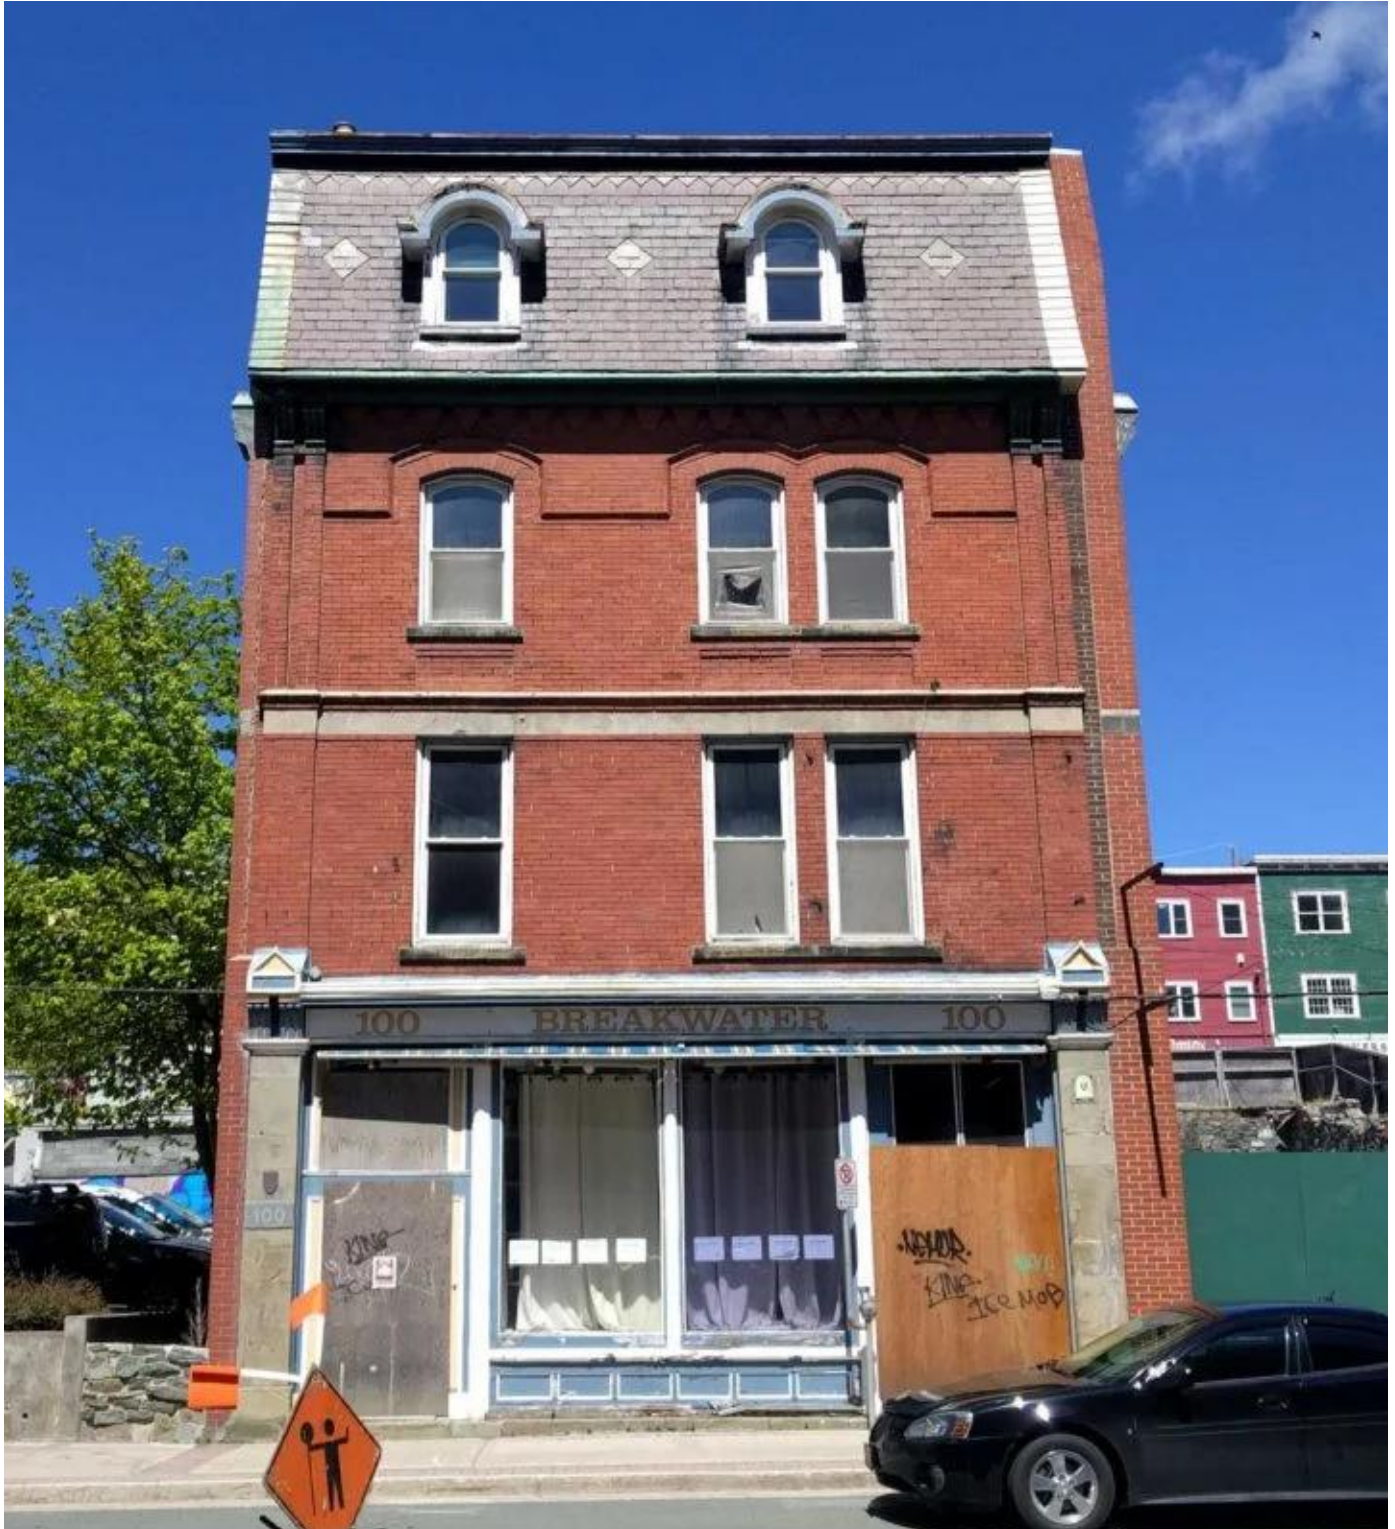
Photo 12: South elevation depicting windows and doors, and uncovered storefront, date unknown (NL Heritage)

The hooded dormers in the mansard roof have been subject to water damage and are in **poor** condition and would need replacement. The rest of the window trim appears ok and has been layered overtop of the square vinyl windows in attempt to mimic the appearance of the original arched windows. The windowsills for all windows in the front brick wall are stone and in **good** condition.

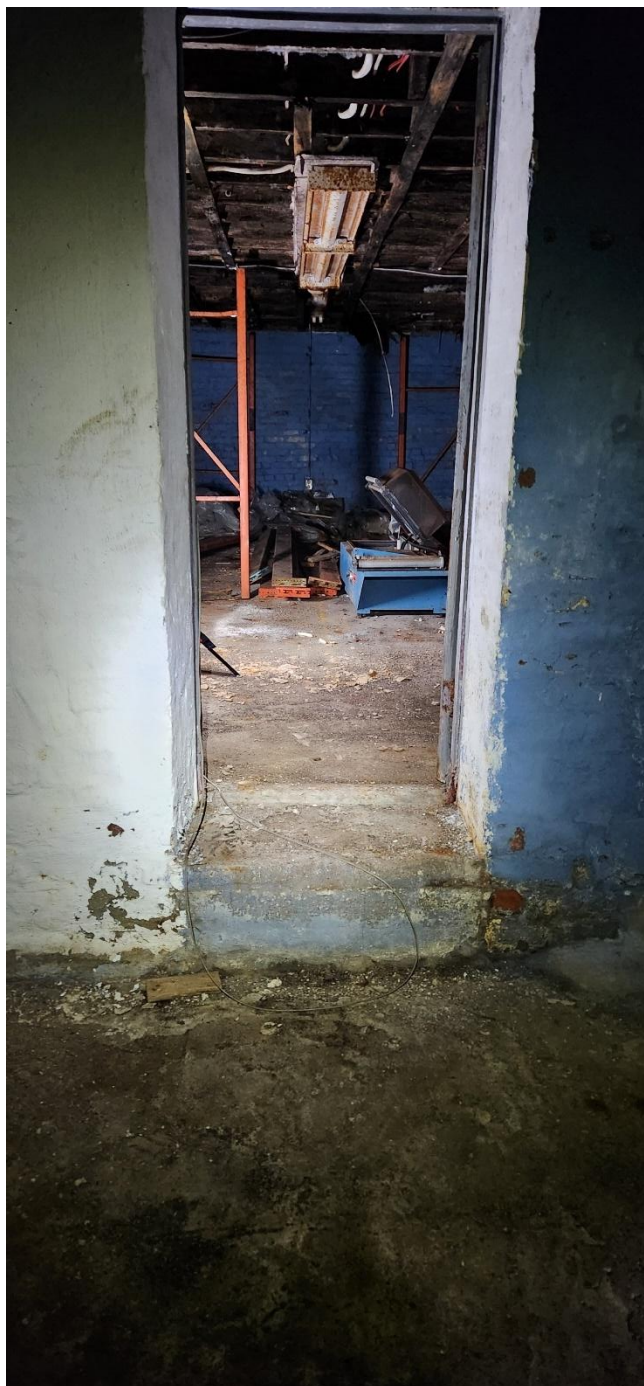
The floor under the addition is also concrete and steps up 200mm from the front. It is hard to gauge its condition due to accumulated debris, but visible portions are in **fair** condition. This concrete is newer and would have likely been added with the addition of the freight elevator around the 1960s.

Photo 15: View into basement storage B03 looking north

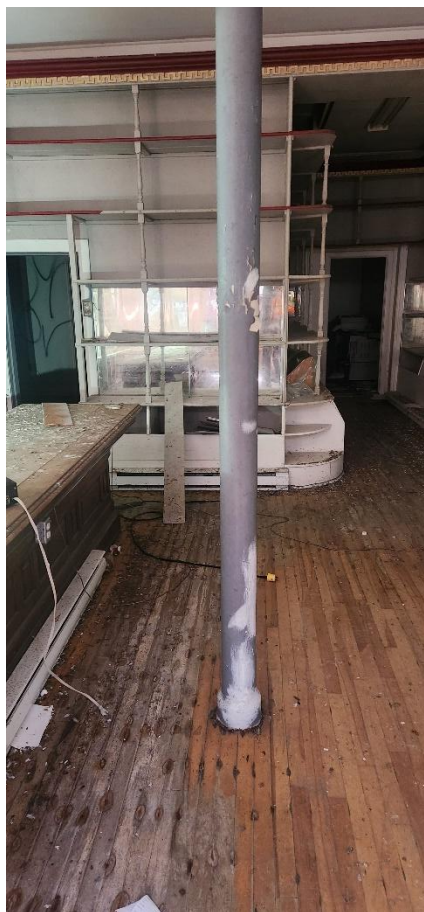
Toward the front of the house, the walls are wood framed finished with a white painted plaster over lath and are generally in **fair** condition and should be restored to extend their useful life. They show no significant damage but are vandalised in room 103 and the south stairwell and peeling along the east wall of the storefront and near the base of the stairwell. The storefront walls include mirrors installed behind the first two layers of shelving; these remain intact and undamaged. There is also a metal post that stands in the center of the storefront space.

Photo 19: Round column in 102 Storefront

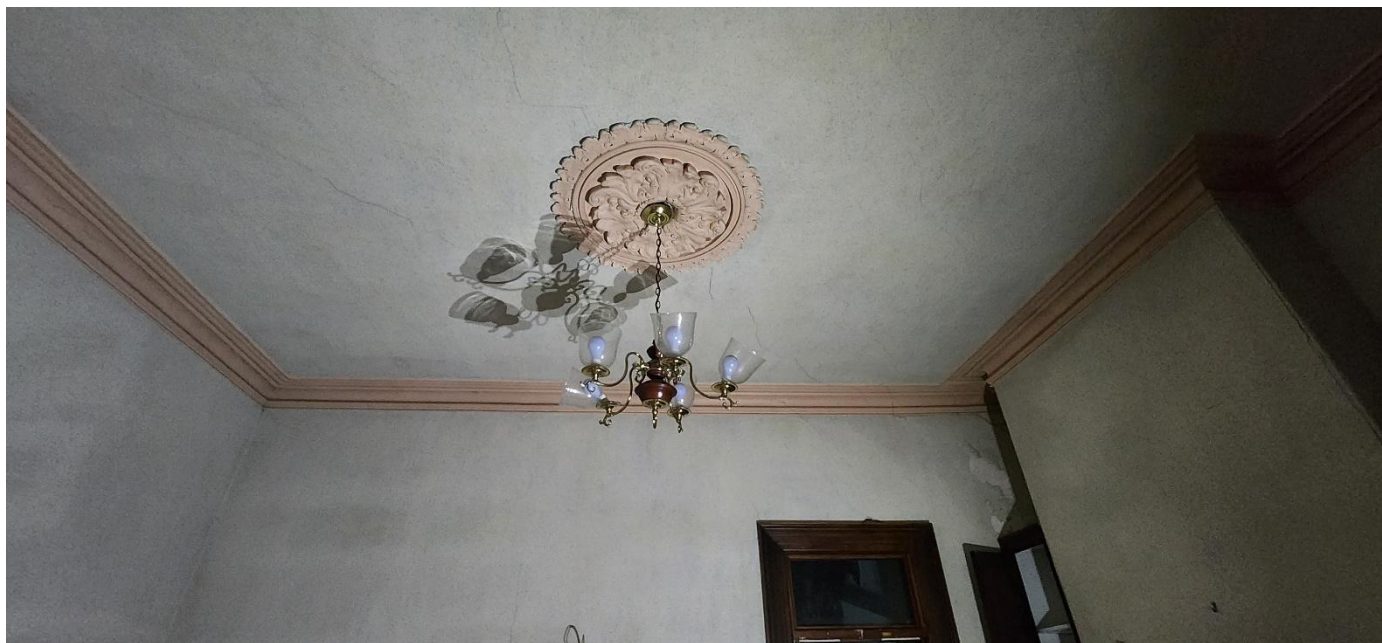
Room 103 contains pink-painted plaster crown moulding, and wooden door casings and baseboards that exhibit moderate wear and are likely all original. The crown moulding appears similar to that found in the stairwell but finished in pink, while the baseboards and most door casings are of simpler design except at the doorway to the stairwell, which uses the same brown casing found in the front entryway. This trim is all in **fair** condition and could be restored.

Photo 21: Ceiling medallion Room 103 looking south

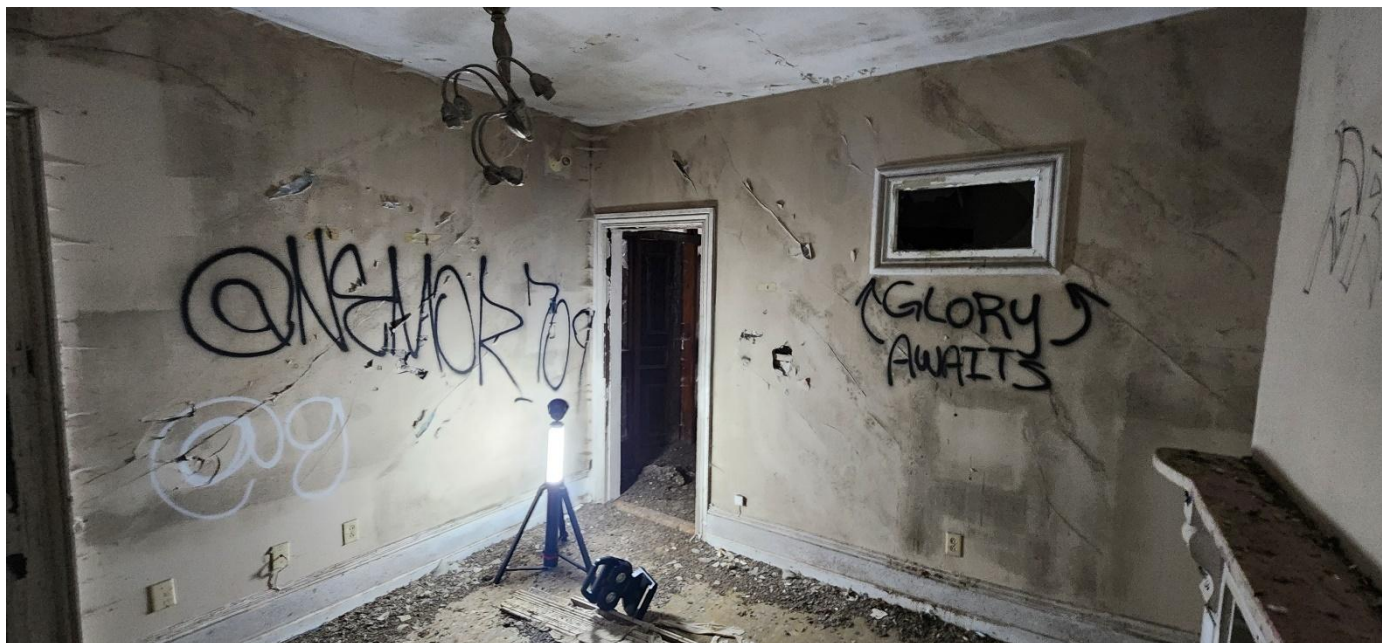
Photo 29: Room 303 looking southwest

Corridor-adjacent rooms in the front of the building retain lath-and-plaster walls in **fair** condition that are mostly painted light blue and are likely original, though these surfaces are peeling, cracked, and covered in cobwebs. Room 301 has a hole in the wall, while room 303 has been heavily vandalized, with peeling, white-painted surfaces that are in notably worse condition than the other rooms. Room 304 features an old exterior window on its north wall looking into room 305 that was left in place when the addition was added. These walls are all structurally sound and have the potential to be restored to significantly extend their life.

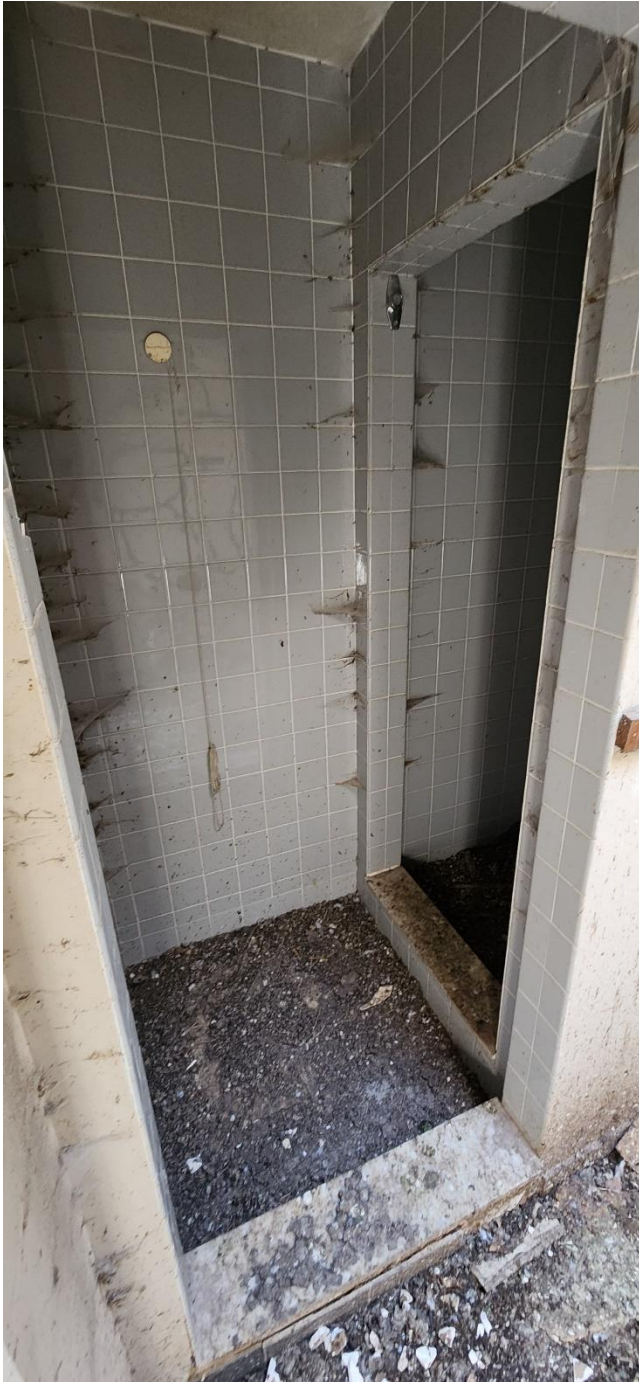
Photo 34: Room 406 looking south

The finishing on these walls will likely need to be redone, it is hard to tell from site observations if the moisture damage has affected the structure as well. Despite surrounding water damage, the bathroom shower retains its original tile, which appears to be in **fair** condition.

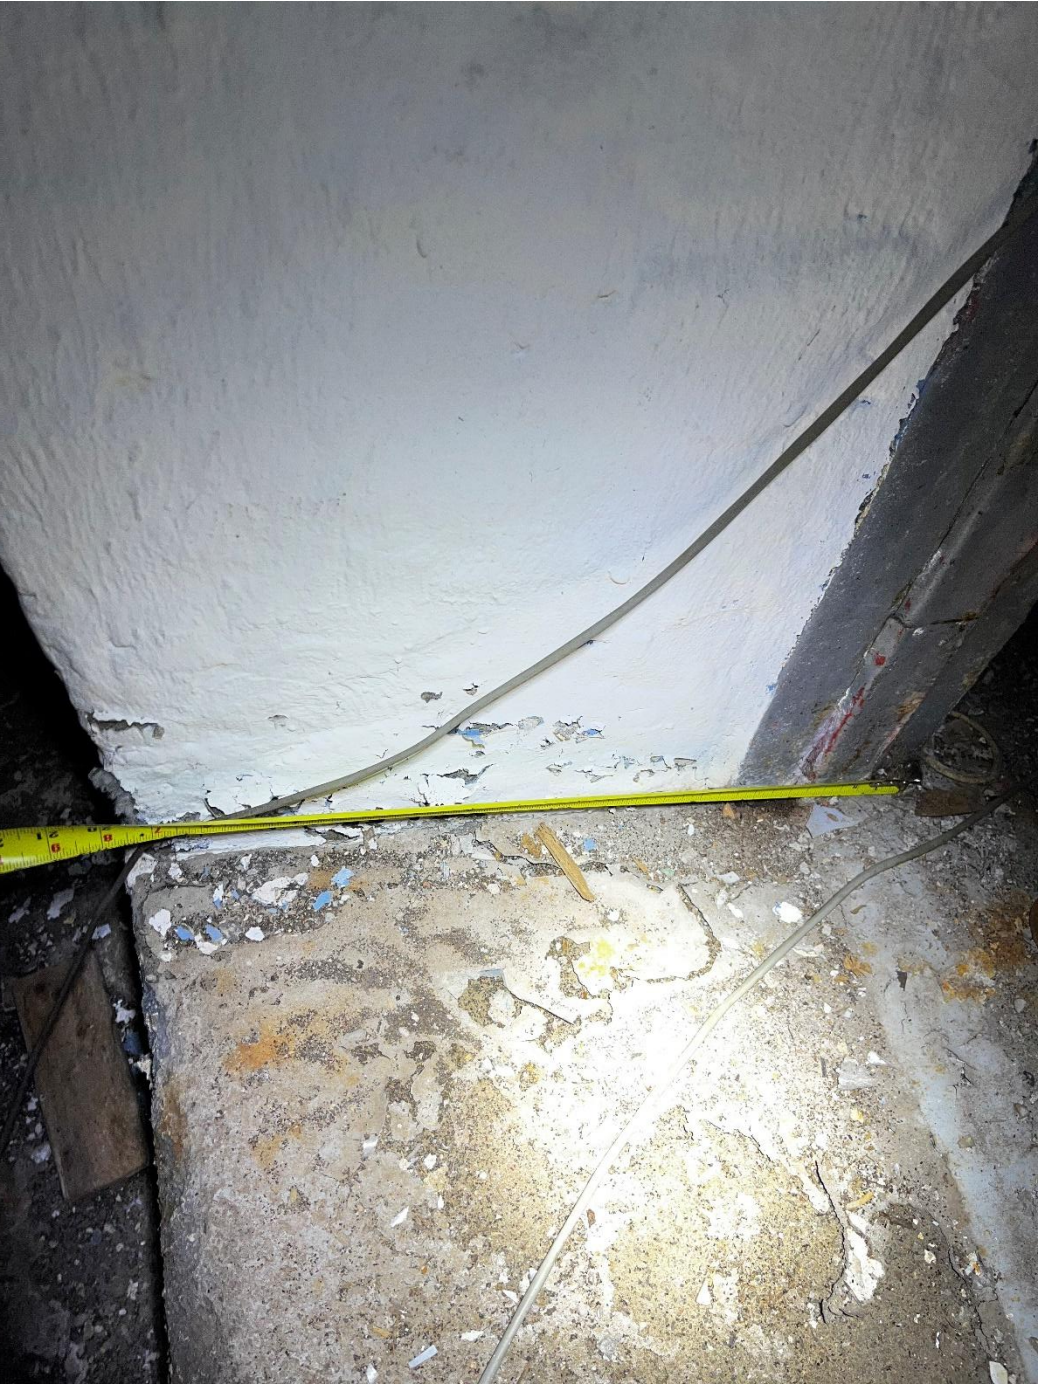
Photo 38: Old exterior wall in basement along demarcation of Area 1 and Area 2

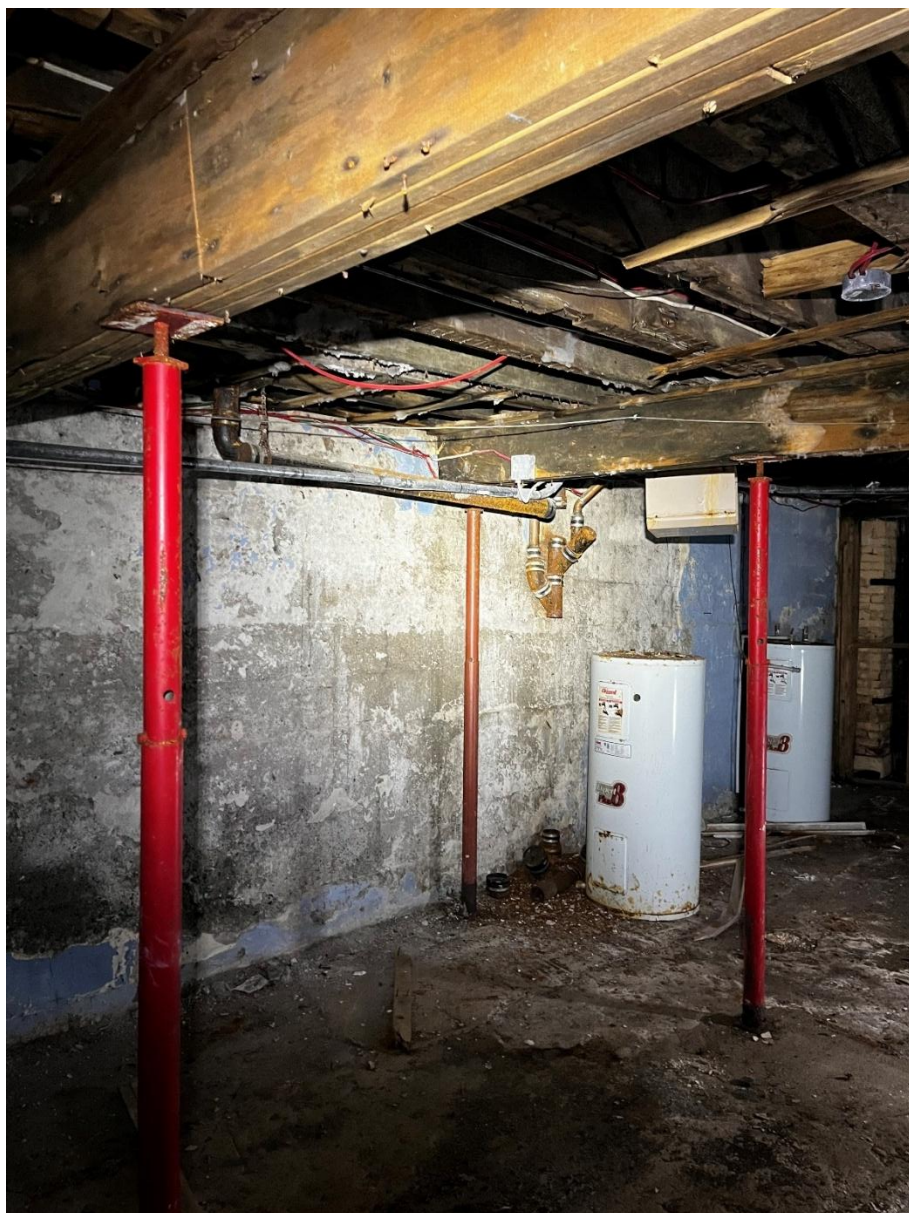
Photo 40: Level 1 floor framing Area 1

Exterior masonry walls of the building contribute to the building's structure in two distinct ways. Vertical loads are resisted through the wall assemblies as floor joists are pocked into the interior face course of the assembly. Horizontal loads from wind are collected at the floor and roof levels and resisted by the solid masonry walls to provide structural stability. The exposed masonry presented in **good** condition, with a high likelihood of significant useful life remaining. Interior structural light-framing members are entirely concealed beneath wall finishes; however, the observed condition was not suggestive of significant concealed structural damage. Consequently, it is reasonably inferred the concealed timber framing elements are also in **good** condition.

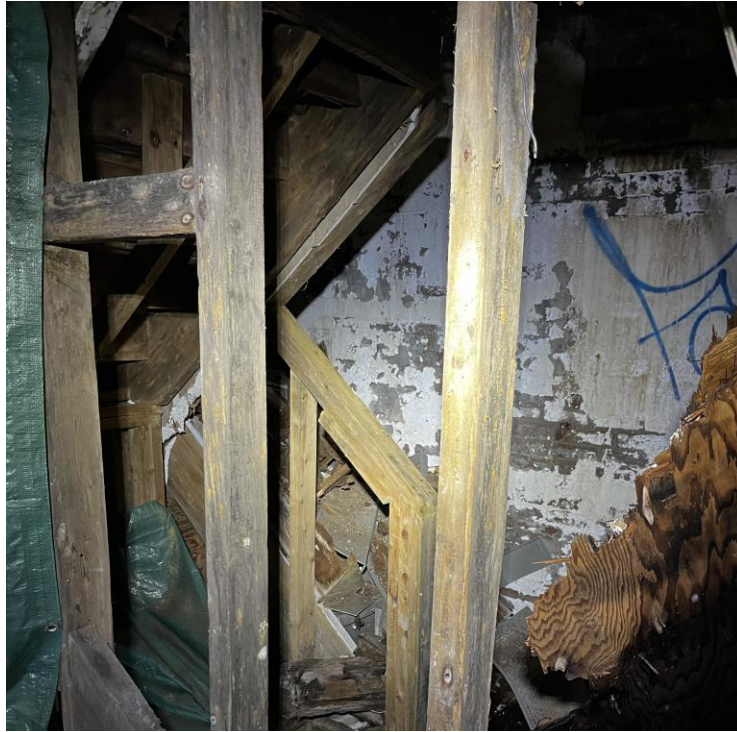
Photo 38: B04 Basement - Cracked Framing Below Tunnel and Corridor
