| | | GOVERNMENT OF<br>NEWFOUNDLAND<br>AND LABRADOR<br>Department of Transportation and Infrastructure | | <b>BRIDGE INSPECTION REPORT</b><br><b>B09012023-8</b> | |
| Site: | 2-128 - GEORGE'S BROOK BRIDGE #2 | | | | |

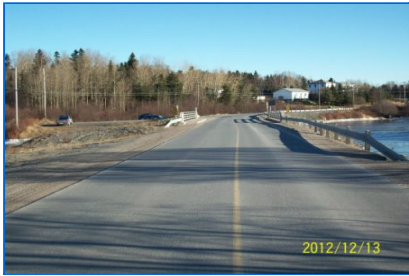
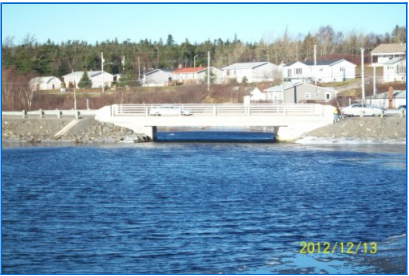
| <b>Comments:</b> | Aluminum bridge rail with concrete end blocks. Asphalt wearing surface. Extensive potholing and exposed waterproofing in left lane. Deck covered in sand. New inspection - Asphalt continuing to rut, ravel and pothole. Wood blocks in curb fascia - some popping out. | | |
| <b>Additional Observations:</b> | Approach 2 right has washout near wingwall. Municipal water supply suspended from left curb fascia. | | |

| <b>Recommendations:</b> | Approach 2 right required gutter at wingwall. Clean sand from gutter | | |
