| | | GOVERNMENT OF<br>NEWFOUNDLAND<br>AND LABRADOR<br>Department of Transportation and Infrastructure | | <b>BRIDGE INSPECTION REPORT</b><br><b>B11282023-4</b> | |
| Date: 11/28/2023 | | Inspected By: Darrell Avery | | Category: Eng. - Engineering | |
| Site: | 2-043 - NORTHWEST BROOK BRIDGE | | | | |

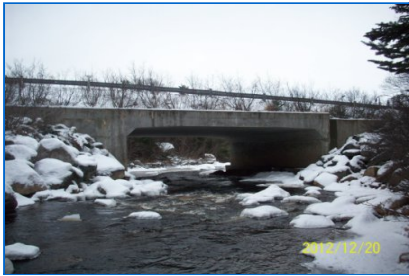
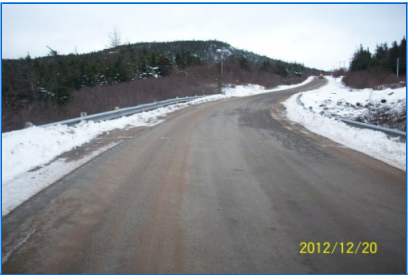
| Comments: | Previous inspection - Concrete abutments and wing walls. Some light cracking throughout (1-2mm width) continuous through roof. Concrete erosion evident on both abutments below high water mark. Abutment 2 is scoured at solid rock base. New inspection - efflorescence at concrete cracks | | | | |
| Comments: | Rigid frame construction. New inspection - Some cracks in frame ceiling with efflorescence. | | | | |

| <b>Comments:</b> | Abutment 2 is scoured at solid rock base. Abutment 2 left and #1 right appears to be losing armor stone into the brook. | | |

| <b>Recommendations:</b> | Previous inspection - Repair bent steel guiderail post and re-attach rail. Monitor scour at Abutment 2. Replace all wooden rail posts and all rail. | | |
