| | | GOVERNMENT OF<br>NEWFOUNDLAND<br>AND LABRADOR<br>Department of Transportation and Infrastructure | | <b>BRIDGE INSPECTION REPORT</b><br><b>B08212024-1</b> | |
| Site: | 2-166 - ROUNDABOUT BRIDGE (OLD) | | | | |

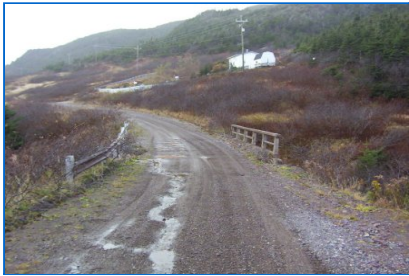
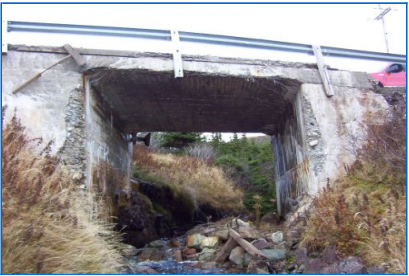
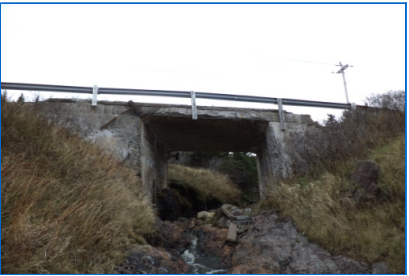
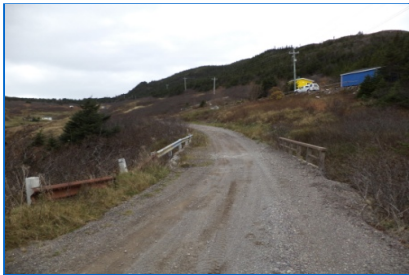
| Comments: | Abutments and wingwalls have severe cracking, disintegration, and efflorescence staining. Abutment towards | | | | |

| right side when looking down-stream has bulging at the base of concrete near bedrock foundation and has visible cavities. This is higher than water levels, monitor in the future. | | | |
| Comments: | Deck soffit has severe cracking with seeping efflorescence near abutments. Middle of soffit is in better condition than sides, however still seeping efflorescence with longitudinal cracking. Both fascia have severe disintegration exposing reinforcement. | | |
| Comments: | All deck features are in poor condition. Downstream rail is completely detached from fascia and is unstable. Upstream concrete rail is missing some members and cracking otherwise. Curbs have disintegration and spalling. Some minor potholes in granular roadway. Located on class 4 unmaintained road. Missing end blocks, guiderail, hazard markers, id signs, warning signs. | | |
| Additional Observations: | Tall abutments and limited access. Warning that downstream handrail is unstable. Overall in poor condition. | | |

| Recommendations: | Monitor as required. Add structure not maintained and use at low risk signs. Remove structure when structure no longer serviceable. Replacement year is estimated demolition year. | | |
