Marystown Harbour Bridge

Condition Assessment Report

223049.10 | April 2023

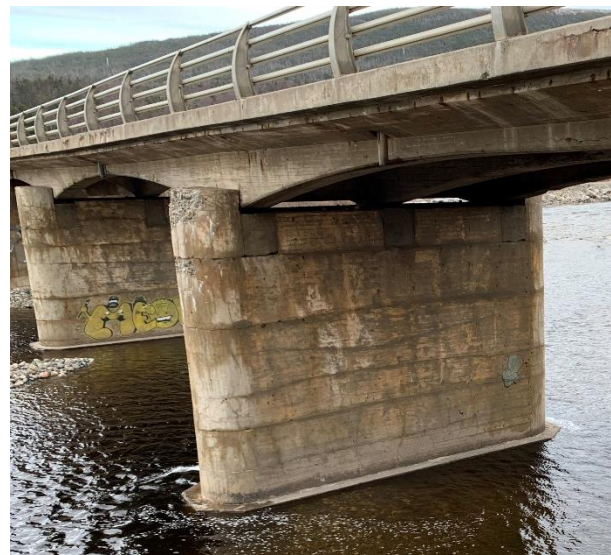
Figure 9-2 – Condition of rounded bullnose on existing pier in service for over 50 years

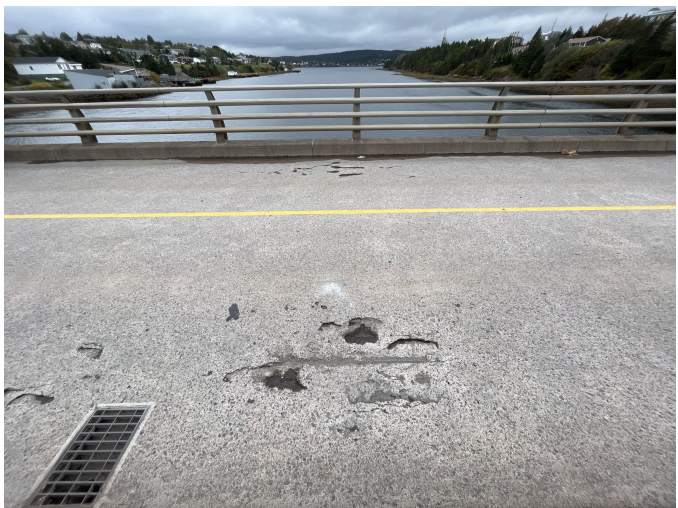
Deck core 3 and defects post 21

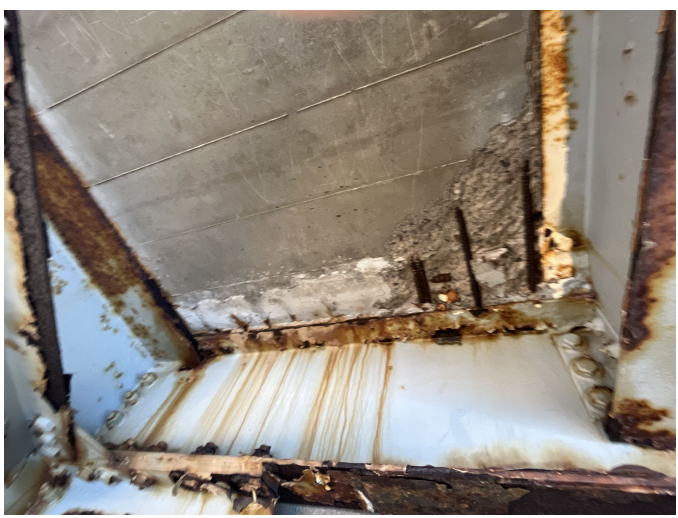
Slab deterioration between east girder and stringer

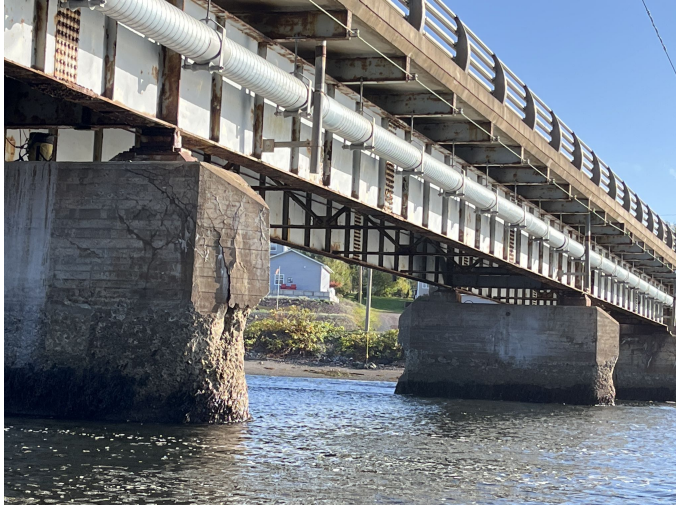
Erosion on piers 1 and 2

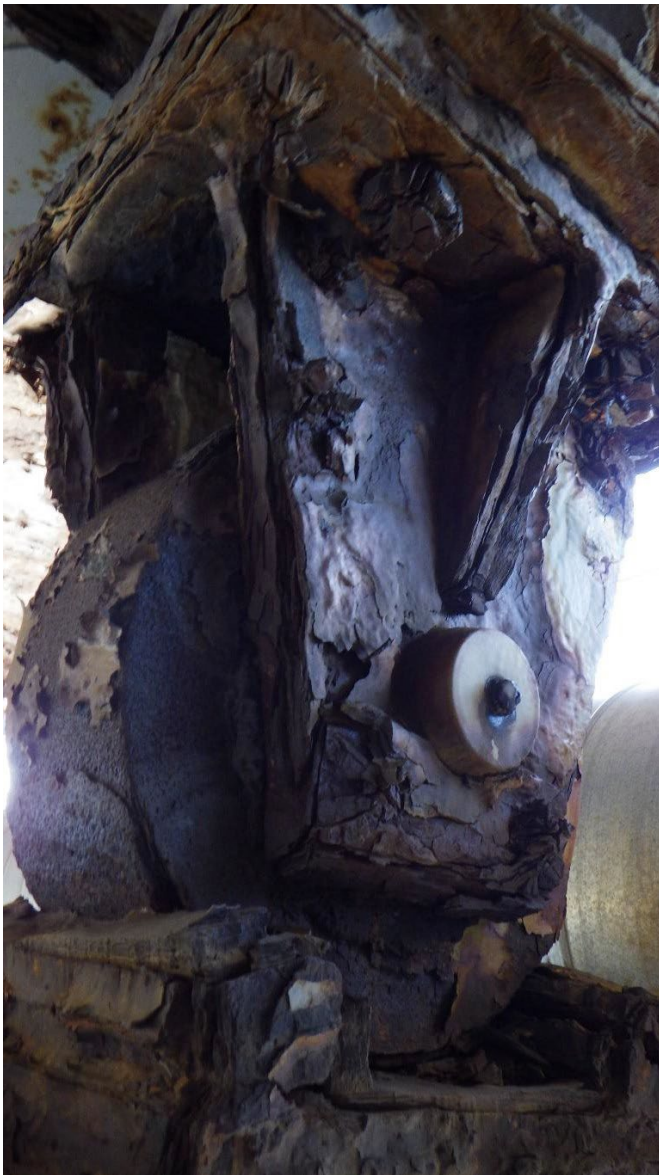
Figure 5. Swing stage pier bearing. Severe corrosion

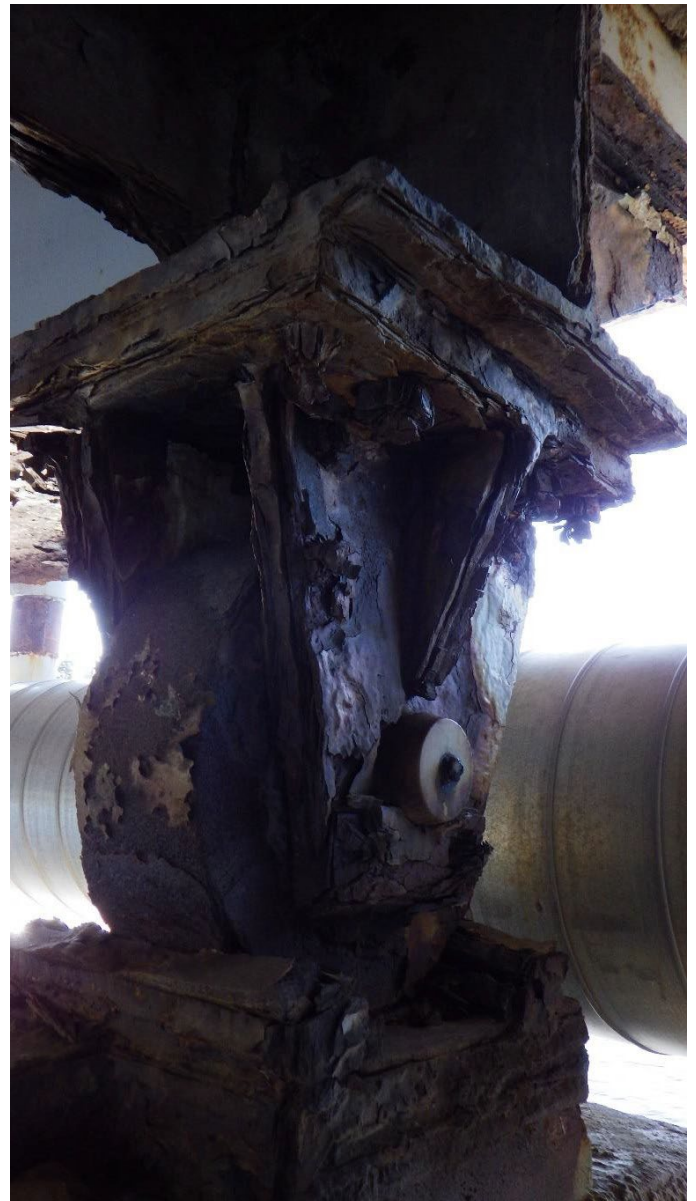
Figure 6. Swing stage pier bearing. Severe corrosion

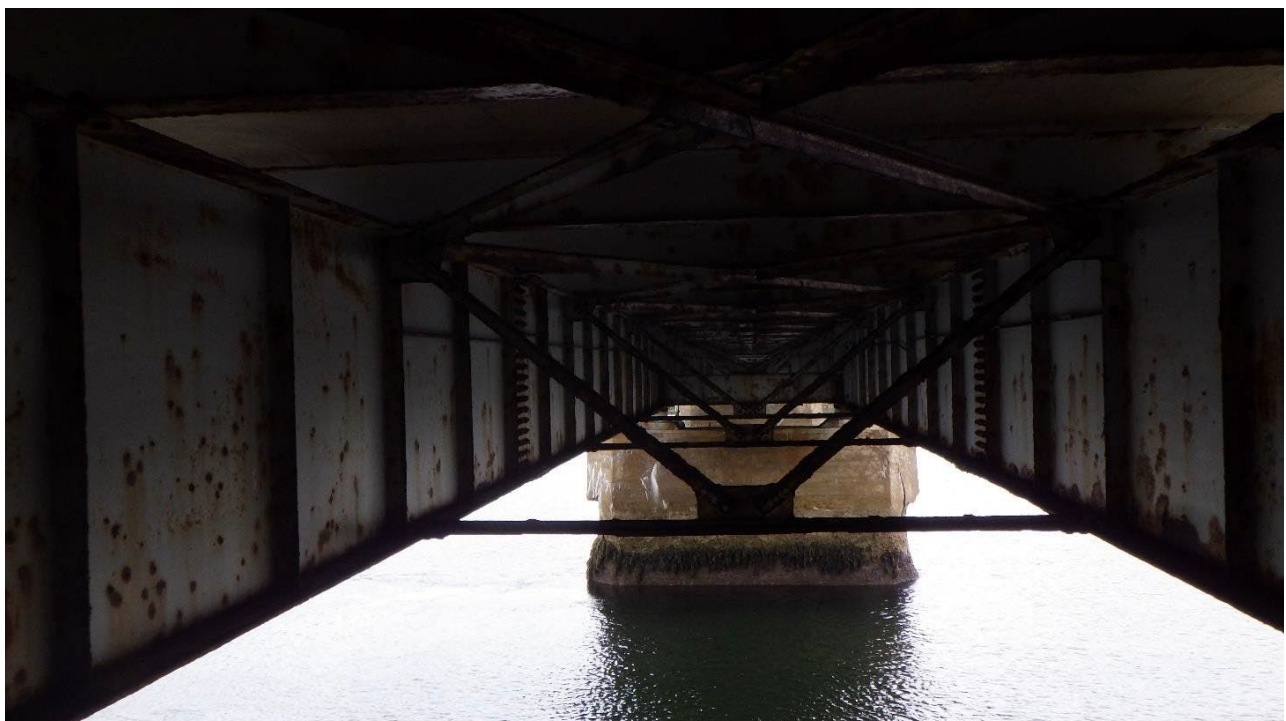
Figure 14. Major corrosion on these braces throughout continuous section of bridge.

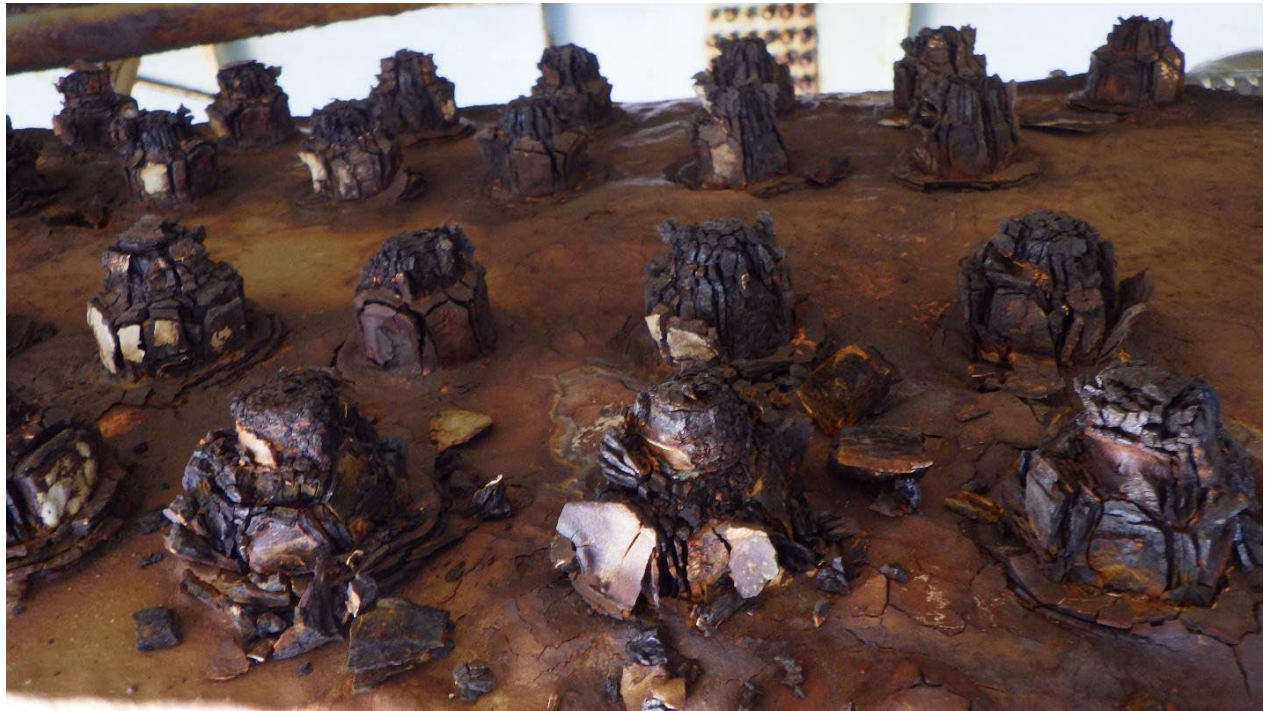
Figure 15. Typical condition of splice plate bolts and nuts, throughout whole bridge.

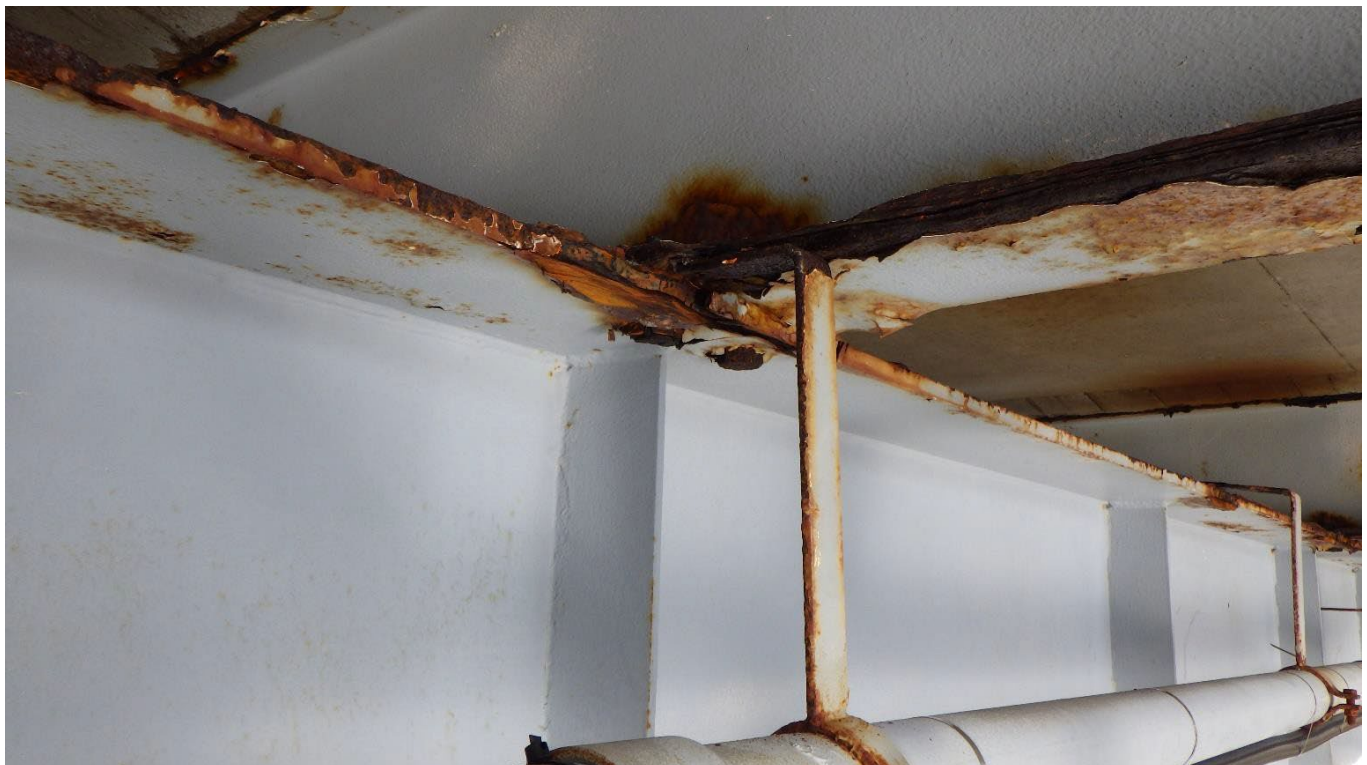
Figure 16. Bracket that has separated from girder.

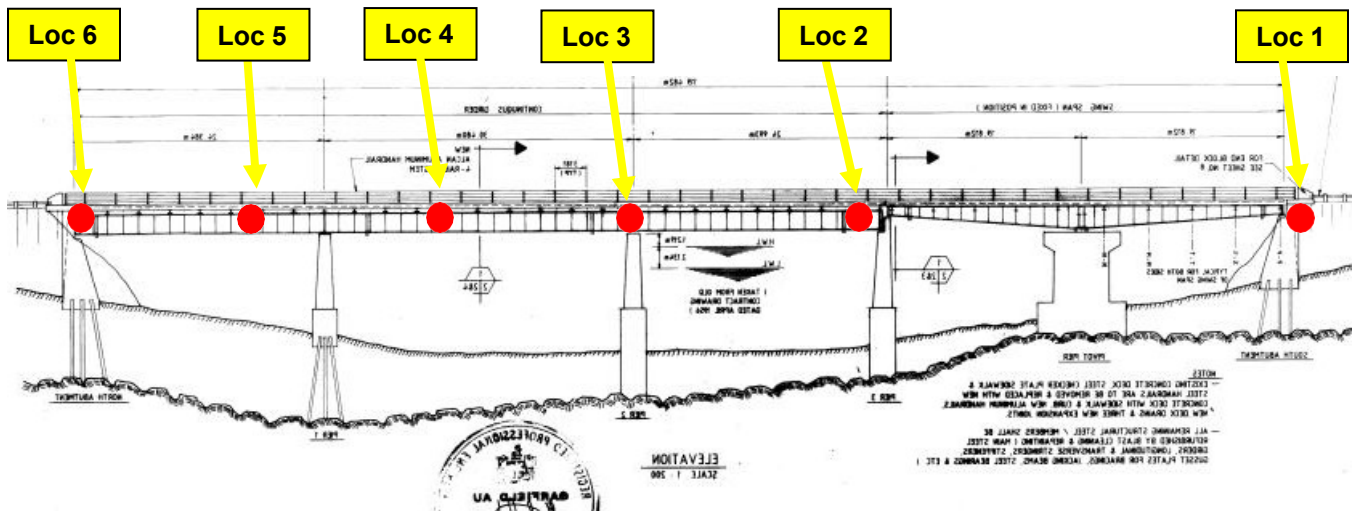
West Girder			
Location	Top Flange	Webbing	Bottom Flange
UT-1	20.4	8.4	17.1
UT-2	20.2	11.2	17.7
UT-3	21.0	8.7	19.2
UT-4	21.4	10.8	17.9
UT-5	22.0	9.2	21.1
UT-6	21.7	10.1	20.1

UT Readings not obtainable due to severe material loss/ corrosion

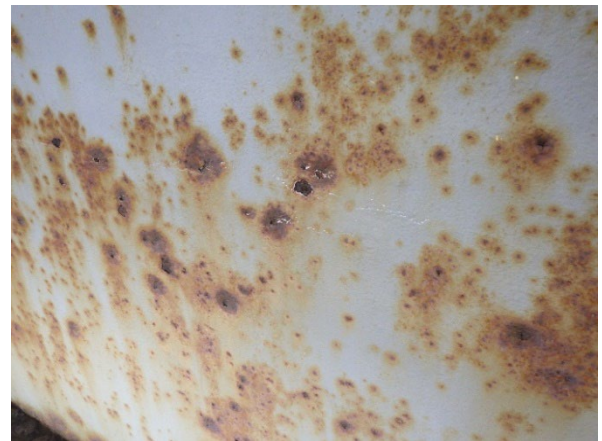
Fig #2 - Example of Blistering, Staining

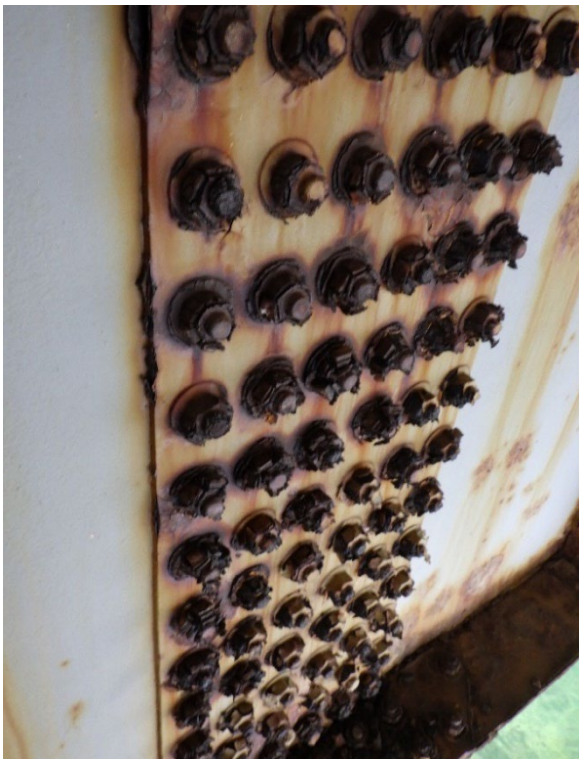
Fig #3 - Corrosion on the hardware of the splice plate

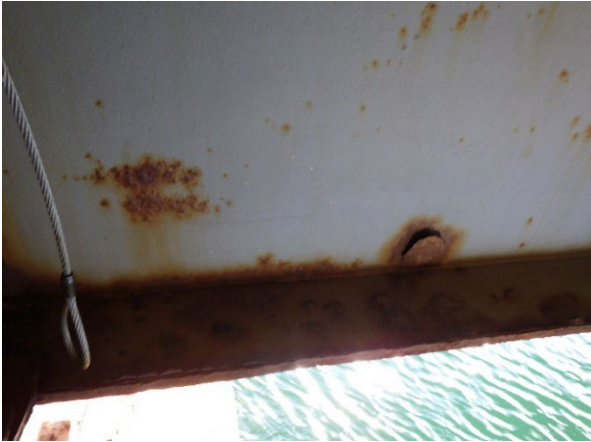
Fig #6 – Typical coating condition on the main bridge beams.

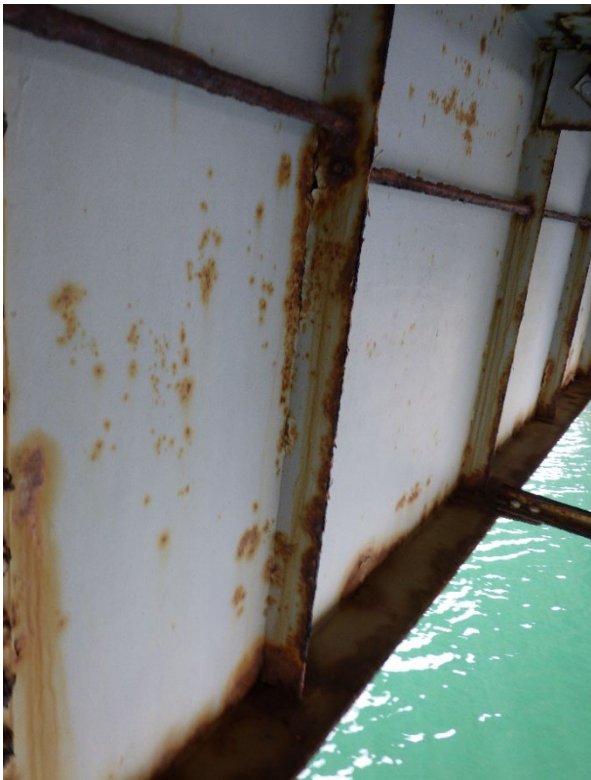
Fig #7 – Typical coating condition on the main bridge beams.

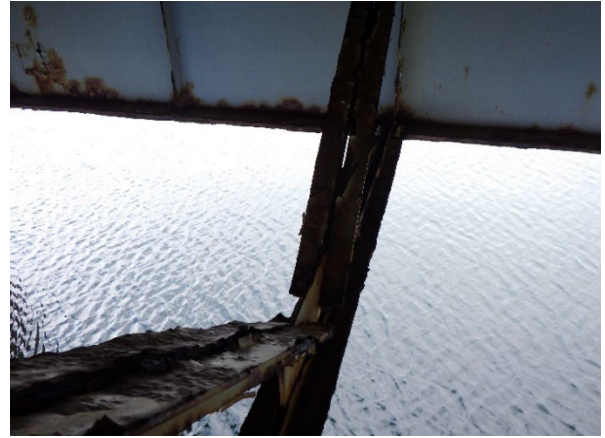
Fig #9 – Typical coating condition on cross bracing.

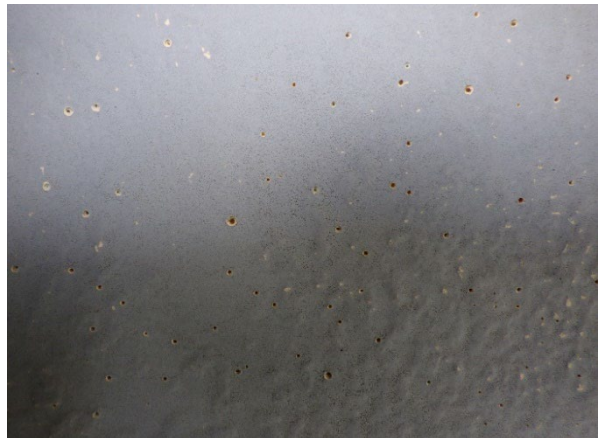
Fig #11 – Rust spots through all coating layers.

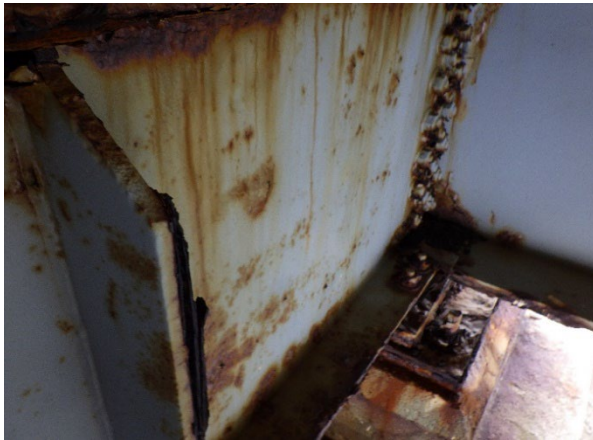
Fig #12 – Rust staining and delamination of coating.

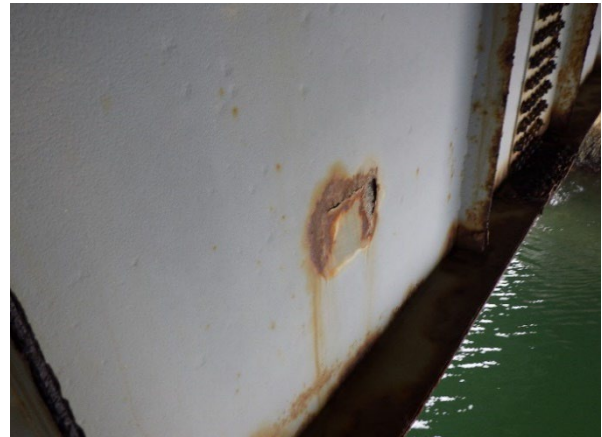
Fig #13 - Example of heat damage, caused by a bracket being welded on the opposite side after initial coating.

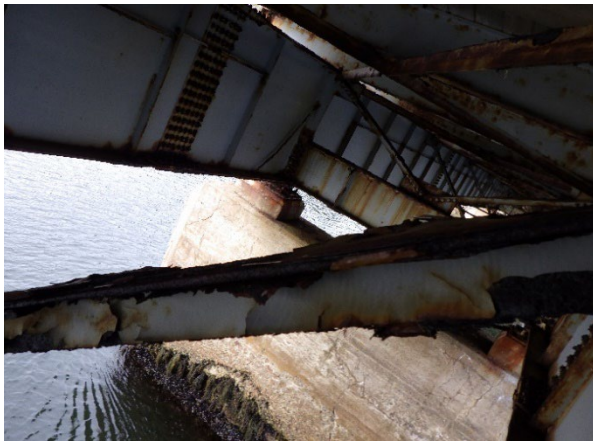
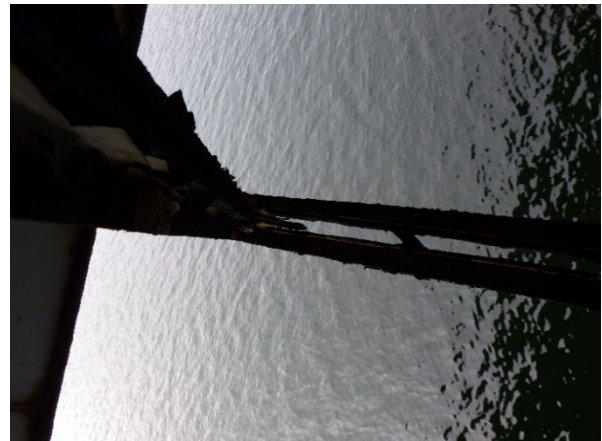
Fig #15

Fig #14 - Heavy corrosion shown causing diagonal connection being disconnected from horizontal piece (Fig #15)

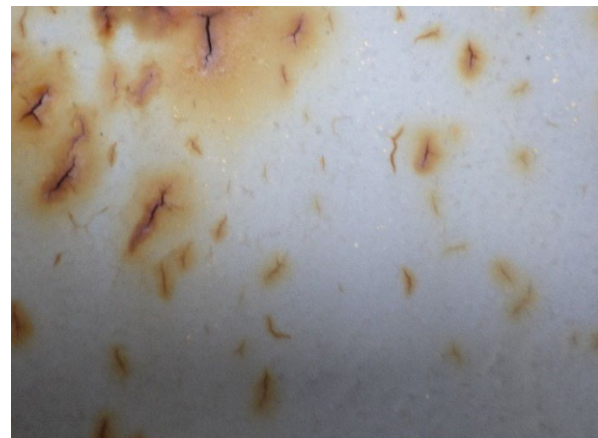
Fig #19 – Rust Blistering and staining.

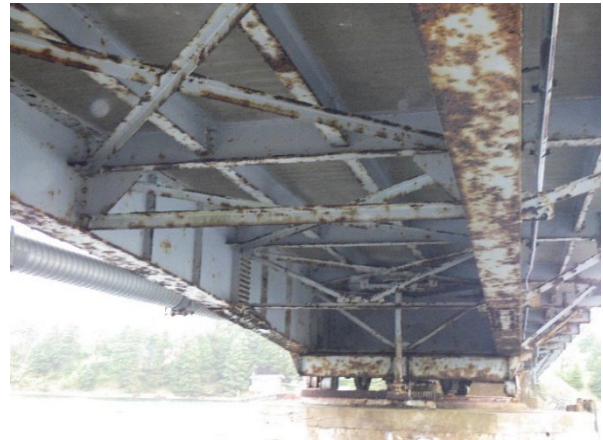
Fig #25 – Rust staining and blistering of coating.

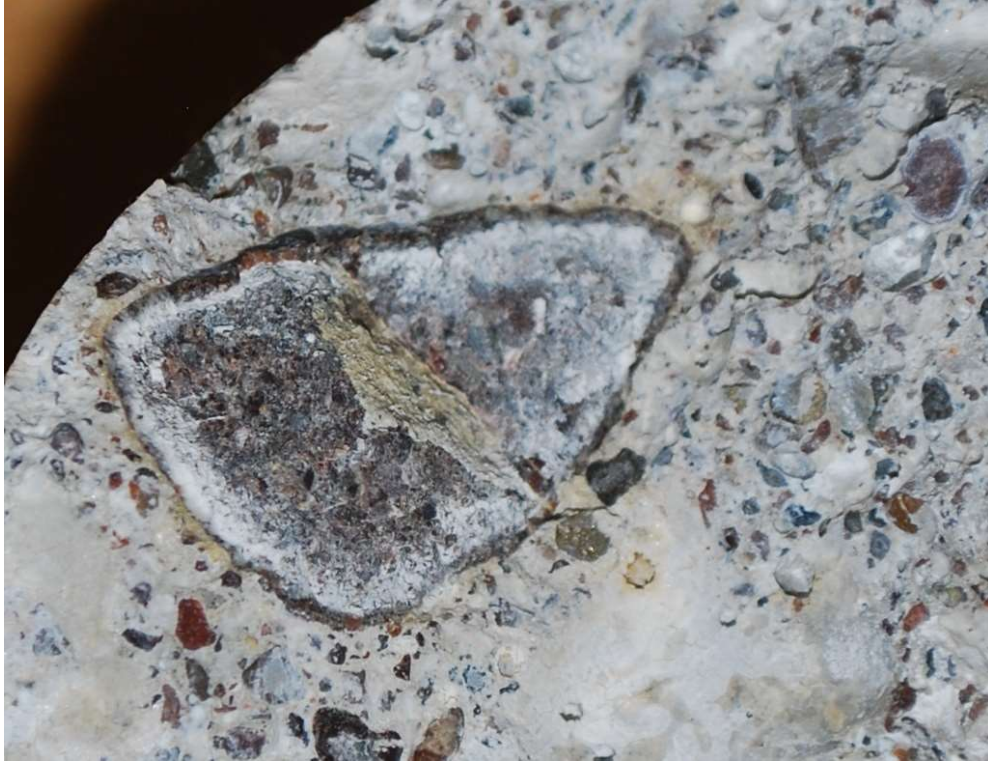
Figure 5: Fracture surface showing dark rim of alkali-silica gel on edge of coarse aggregate particle with white soft AS reaction product in interior of fracture surface through the particle. Field of view = 35mm.
